1 **The catastrophic landfill flowslide at Hongao dumpsite on December 20, 2015 in Shenzhen, China**

6 **Abstract** A catastrophic flowslide occurred at Hongao dumpsite at approximately 11:40 AM on Dec 20,
7 2015, in Guangming New District of Shenzhen, China. The flowslide damaged 33 buildings and caused
8 total death toll of 69 and 8 missing, with the absence of extreme weather condition and seismic activity.
9 The slope failure was analyzed on the basis of multi-temporal remote sensing images, site investigation, *in-*
10 *situ* tests, laboratory experiment, and numerical analysis. The preliminary results showed that the volume
11 of the flowslide deposit was 2.32×10^6 m³ and the volume of dumpsite filling was 6.27×10^6 m³ at the time
12 of the event, which is three times larger than the maximum design capacity. The flowslide had the
13 characteristics of high travel speed and long run-out distance, of which the displaced material was primarily
14 silty soil from nearby construction sites with high moisture content. The primary causes of the failure were

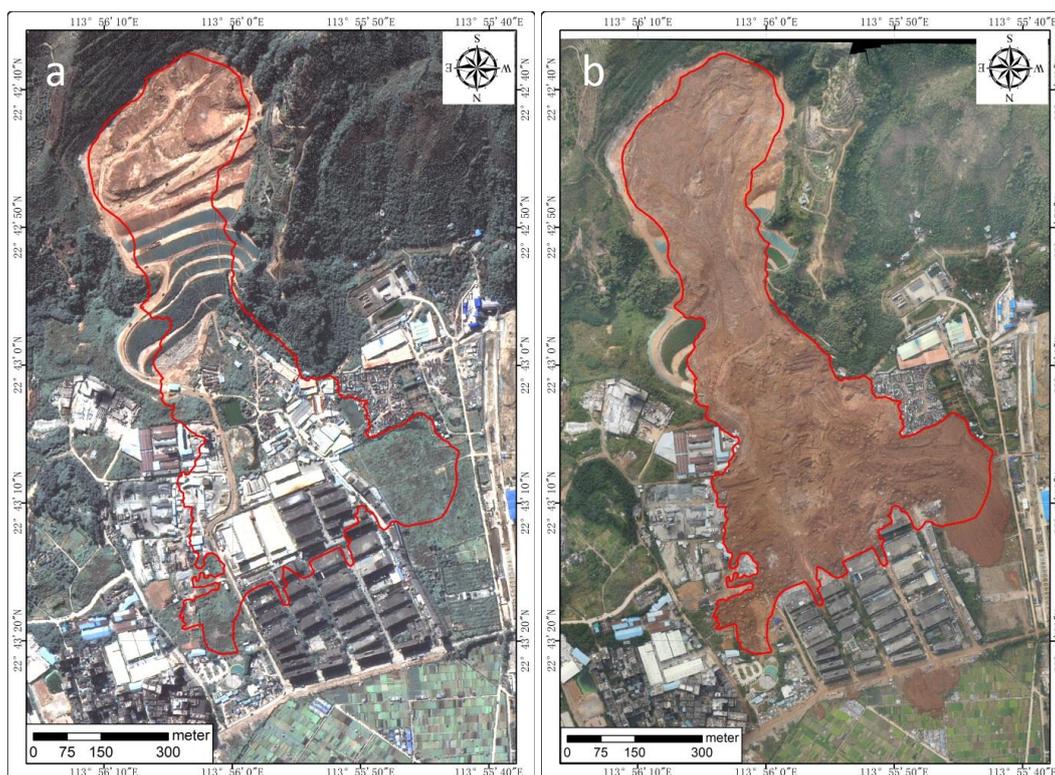
95 Fig. 1 Images for the Pre- and Post-sliding dumpsite. The boundary of the flowslide is indicated by the red
96 line. **a** Pleiades satellite image (Dec 18, 2015); **b** Aerial photo (Dec 23, 2015).

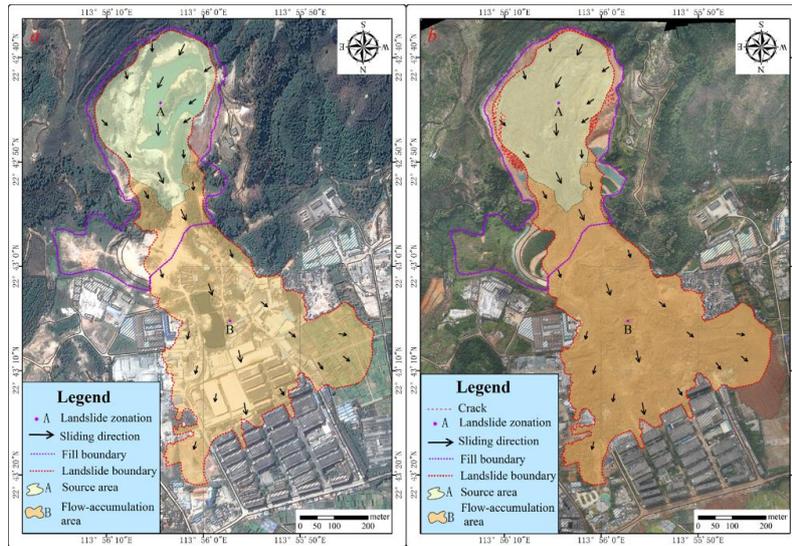
Fig.10 The direction of flowslide and distribution of the displaced material. **a** Flowslide overlying the pre-sliding industrial park showing the impact area and flow direction; **b** Aerial view of the flowslide.

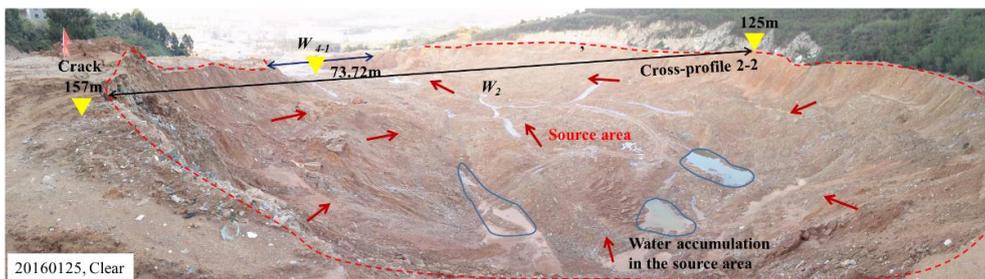
216 With the ingress of rainwater and groundwater in the dumpsite, pore water pressure increases due to the
 217 low permeability of the underlying granite in the Cretaceous system. It is appeared that the lack of drainage
 218 resulted in waste filling saturation in the lower portion of the dumpsite, which in turn formed the sliding
 219 bed of the flowslide (Fig. 15 and Fig. 16).

221 Fig.15 An overview of the source area (image taken at the flowslide crown facing north). A large opening
 222 ($W_{4.1}$) formed due to the failure of the retaining slope (the exit of the original quarry pit), which provided
 223 passage for the flowslide and permitted rapid release of kinematic energy.

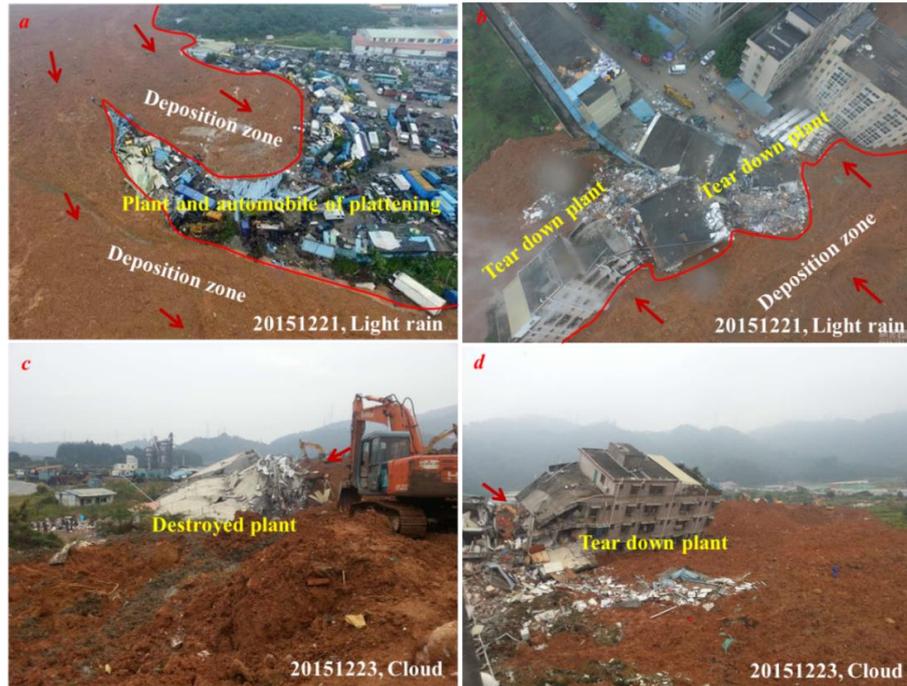
Fig. 22 The damage of buildings in the industrial park (Photo courtesy of China News Agency).
