## Lessons learnt from analysing the causes of casualties in the Sichuan Changning $M_s$ 6.0 earthquake

**Abstract.** This paper summarizes the  $M_s$  6.0 earthquake disaster that occurred in Changning, Sichuan Province, China, on 17  
10 June 2019. Additionally, a description of the disaster emergency response is provided. As determined by on-site investigation  
and analysis, the direct causes of earthquake casualties are summarized. Among them, 66% of the casualties can be attributed  
to substandard seismic protection, 25% to improper earthquake risk avoidance, 6% to earthquake-induced geological disasters,  
and 3% to pre-existing diseases exacerbated by the earthquake. Responding to the causes of these four casualty types, we  
15 summarize 4 lessons, which are to build in accordance with seismic protection requirements; strengthen publicity and  
education awareness of earthquake emergency evacuation and training for the population; investigate and evaluate potential  
geological disaster sources in the stricken area, along with conducting prevention and control; establish cooperation with health

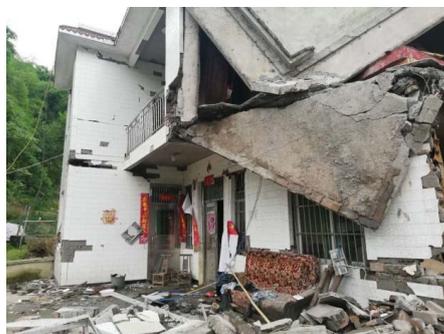
Among the 13 deaths, one person in Gong County was killed by the collapse of a house that was self-built with prefabricated panels, as shown in Fig. 7. In this village, there remained a large number of self-built prefabricated houses without constructional columns, and their anti-seismic performance was poor. All of these houses were damaged at different levels in this earthquake.

Figure 7: Victim's house in Yuchi village, Gongquan town, Gong county.

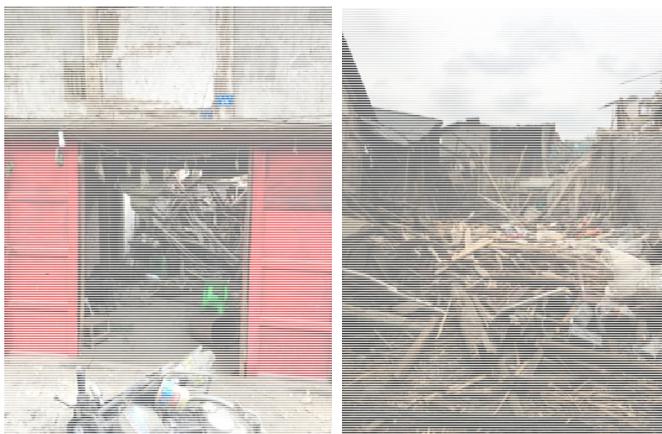
The deaths of 9 people in Shuanghe Town were caused by the serious destruction or complete destruction of the house structures, and the people were buried under pieces of debris. The houses in which some of the deceased had lived were houses with masonry-timber structure aged more than 50 years; these houses had almost no ability to resist medium-sized earthquakes, as shown in Fig. 8.

130 **Figure 8: Shuanghe town, where some of the Masonry-timber structures collapsed or were completely destroyed.**

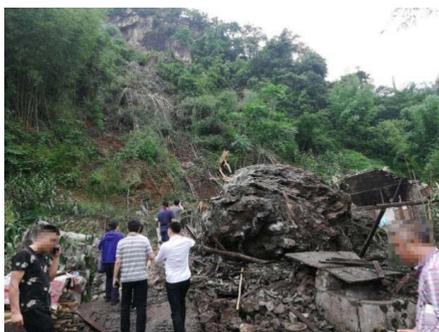
Two people died in Xunchang Town, Gong County, because the self-built houses were located on the unstable side of the slope. The earthquake caused a rockfall that destroyed the houses, as shown in Fig. 9.

**Figure 9: Xunchang town, Gong county: rockfall and a victim's house.**
