# Earthquake Response of Heavily Damaged Historical Masonry Mosques after Restoration

Ahmet Can Altunışık<sup>1</sup>, Ali Fuat Genç<sup>1</sup>

<sup>1</sup>Department of Civil Engineering, Karadeniz Technical University, Trabzon, 61080, Turkey

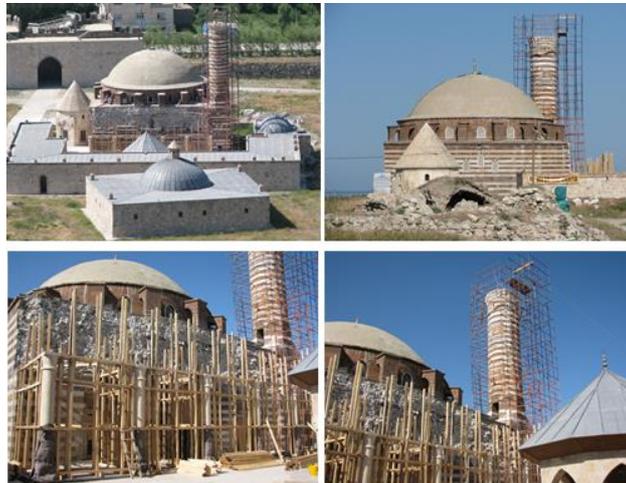
Today there are some cases which affect the structural performance of the mosque detrimentally. These cases are structural cracks, material deformations, destroyed parts of carrier system, environmental issues-algae and humidity. Some views of these cases and damaged views of the mosque are shown in Fig. 2.

10 **Figure 2: Damaged views of Hüseyin Pasha Mosque.**

Earthquakes. The minaret and last prayer area were heavily damaged in these earthquakes. Today the prayer area and shrine are healthy but rest of the complex highly damaged or destroyed. For this reason the mosque was closed for praying and it is aimed to open the mosque for praying with restoration project. Undamaged views of the mosque are given in Fig. 1.

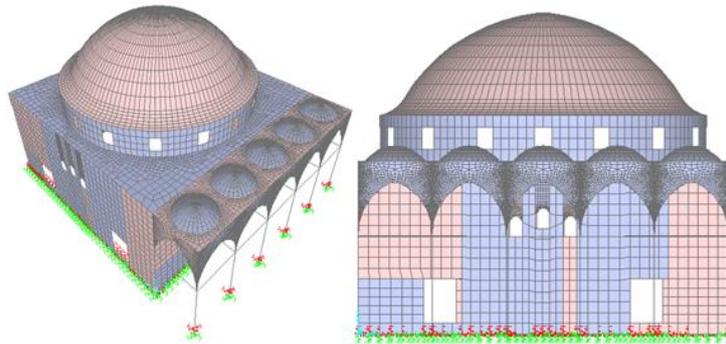
- 15       The mosque has 16 window openings before the restoration so finite element model of the mosque was constituted with 16 window openings. The model of the mosque has 27297 nodes, 127 bar elements, 25653 area elements and 102460 3D solid elements. Finite element model of the mosque with 16 window openings is shown in Fig. 3.

**Figure 3: Finite element model of the mosque with 16 window openings.**

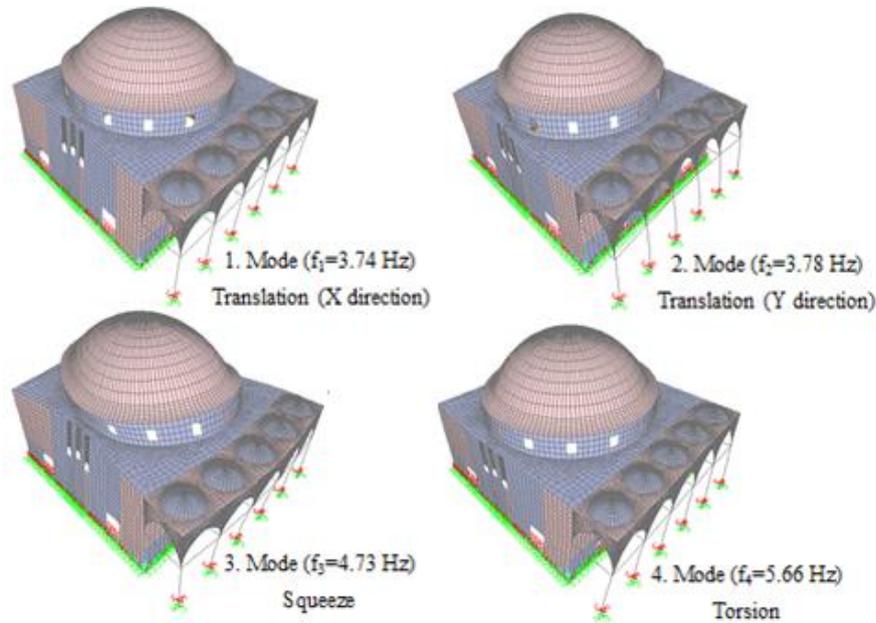
Dynamic characteristics were obtained with modal analysis. %5 damping ratio was used in the analysis. 20 mode shapes were obtained after analyses. First four mode shape and frequency are given with Fig. 4.

**Figure 4: First four mode shape and frequency.**

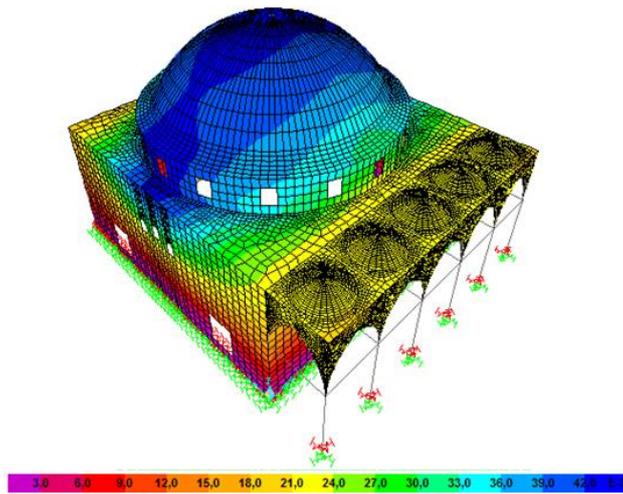
The maximum displacements contour diagram of Hüsrev Pasha Mosque with 16 window openings under dead load and earthquake load (G+EX) is shown in Fig. 5. It can be seen from the Figure 5 that the maximum displacement occurred at the middle point of the big dome as 42.0 mm. Beside this displacements have a decreasing trend from top of the dome to lower part of the mosque.

Figure 5: Maximum displacements contour diagram of the mosque with 16 window openings under dead load and earthquake load (G+EX).

| Analyses Data | Analyses | | | | | | |
|---|--|---|--|---|--|---|---|
| Displacement(mm) | 42.0 | 36.0 | 44.0 | 39.0 | 19.6 | 9.80 | |

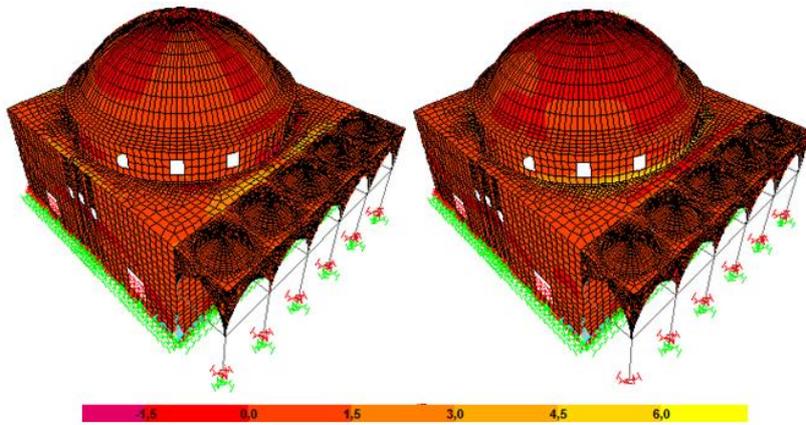
The maximum tensile stresses contour diagram is shown in Fig. 6. It is seen from the Figure 6 that maximum values of the tensile stresses for outer surface of the mosque occurred at side and lower part of big dome, near the window spaces and transition areas of between side walls as 1.05 MPa. Maximum tensile stresses for inner surface of the mosque occurred as 1.00 MPa.

5 Figure 6: Maximum tensile stresses contour diagram for outer and inner surfaces of the mosque with 16 window openings under dead load and earthquake load (G+EX).

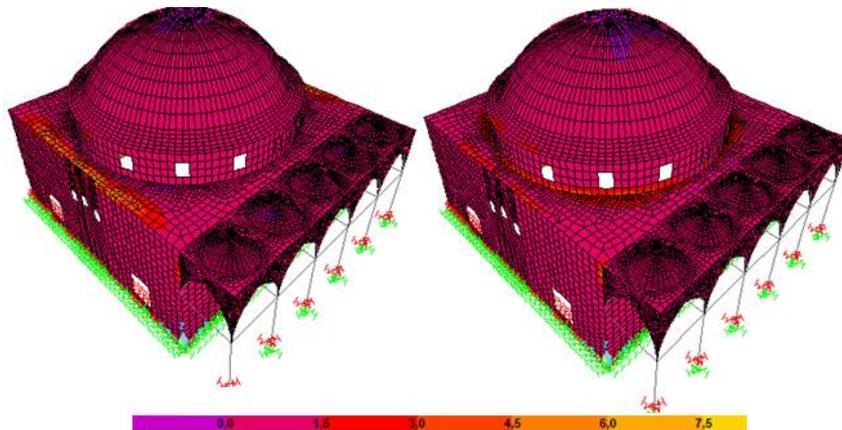
The maximum compression stresses contour diagram for outer and inner surfaces of Hüsrev Pasha Mosque with 16 window openings under dead load and earthquake load (G+EX) is shown in Fig. 7. It is seen from the Figure 7 that maximum values of the compression stresses for outer surface of mosque occurred at between the dome and side walls transition areas and near window spaces at dome as 2.05 MPa. Beside this maximum compression stresses for inner surface of the mosque, occurred as 1.85 MPa.

Figure 7: Maximum compression stresses contour diagram for outer and inner surfaces of the mosque with 16 window openings under dead load and earthquake load (G+EX).

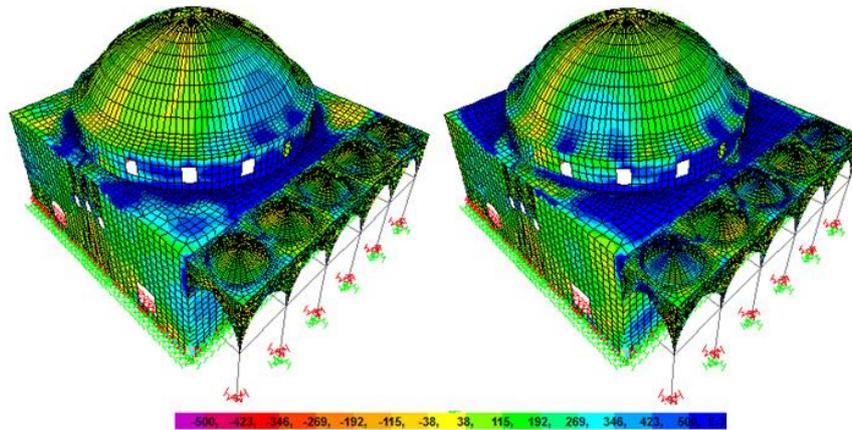
The maximum shear stresses contour diagram for outer and inner surfaces of Hüsrev Pasha Mosque under dead load and earthquake load (G+EX) is shown in Fig. 8. It is seen from the Figure 8 that maximum values of the shear stresses for outer and inner surfaces of the mosque are 0.65 MPa and 0.60 MPa respectively.

**Figure 8: Maximum shear stresses contour diagram for outer and inner surfaces of the mosque with 16 window openings under dead load and earthquake load (G+EX).**

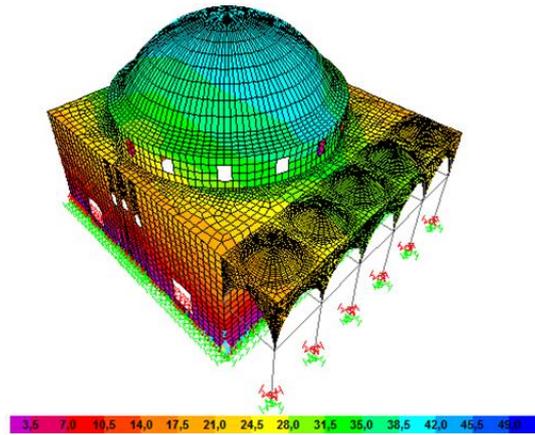
The maximum displacements contour diagram of Hüsrev Pasha Mosque with 16 window openings under dead load and earthquake load (G+EY) is shown in Fig. 9. It can be seen from the Figure 9 that the maximum displacement occurred at the middle point of the big dome as 44.0 mm. Beside this displacements have a decreasing trend from top of the dome to lower part of the mosque.

Figure 9: Maximum displacements contour diagram of the mosque with 16 window openings under dead load and earthquake load (G+EY).

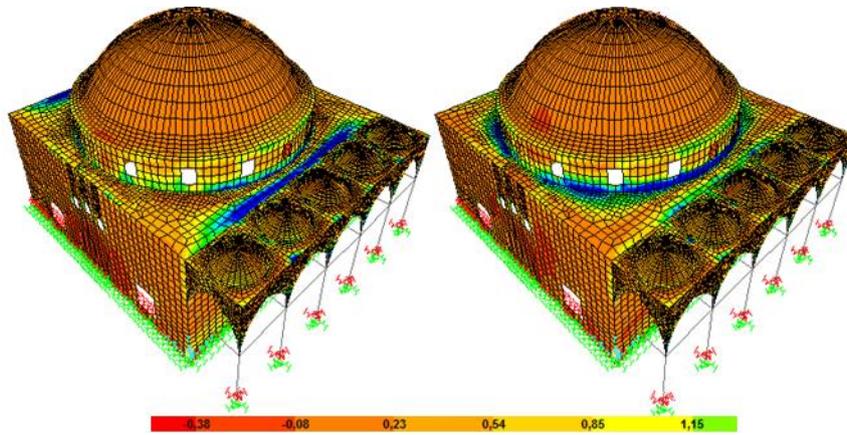
The maximum tensile stresses contour diagram is shown in Fig. 10. It is seen from the Figure 10 that maximum values of the tensile stresses for outer surface of the mosque occurred at side and lower part of big dome, near the window spaces and transition areas of between side walls as 0.95 MPa. Maximum tensile stresses for inner surface of the mosque occurred as 0.75 MPa.

5 Figure 10: Maximum tensile stresses contour diagram for outer and inner surfaces of the mosque with 16 window openings under dead load and earthquake load (G+EY).

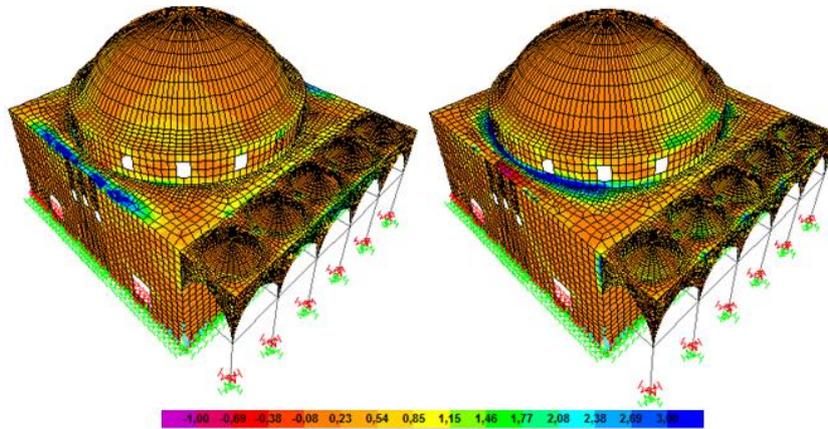
The maximum compression stresses contour diagram is shown in Fig. 11. It is seen from the Figure 11 that maximum values of the compression stresses for outer surface of mosque occurred at between the dome and side walls transition areas and near window spaces at dome as 1.15 MPa. Beside this maximum compression stresses for inner surface of the mosque, occurred as 1.10 MPa.

Figure 11: Maximum compression stresses contour diagram for outer and inner surfaces of the mosque with 16 window openings under dead load and earthquake load(G+EY).

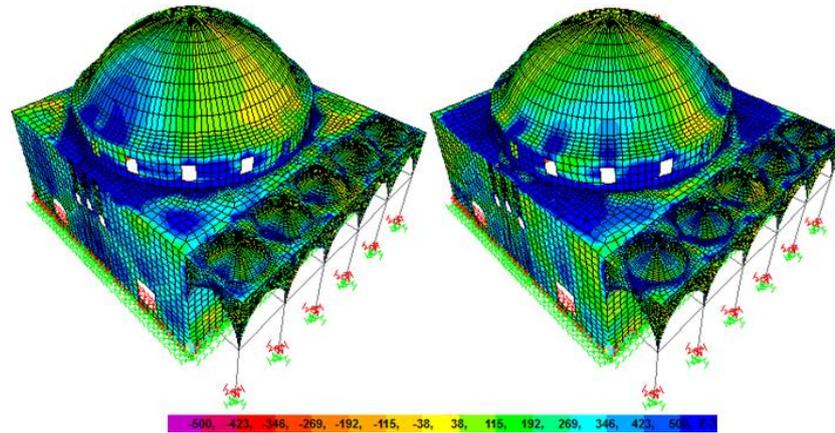
The maximum shear stresses contour diagram for outer and inner surfaces of Hüsrev Pasha Mosque under dead load and earthquake load (G+EY) is shown in Fig. 12. It is seen from the Figure 12 that maximum values of the shear stresses for outer and inner surfaces of the mosque are 0.60 MPa and 0.55 MPa respectively.

**Figure 12: Maximum shear stresses contour diagram for outer and inner surfaces of the mosque with 16 window openings under dead load and earthquake load (G+EY).**

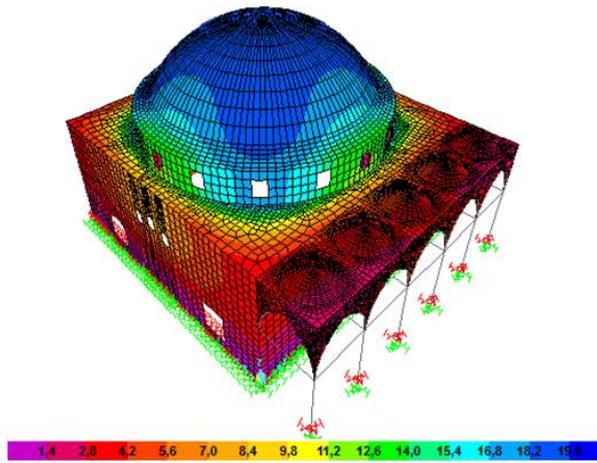
The maximum displacements contour diagram of Hüsrev Pasha Mosque with 16 window openings under dead load and earthquake load (G+EZ) is shown in Fig. 13. It can be seen from the Figure 13 that the maximum displacement occurred at the middle point of the big dome as 19.6 mm. Beside this displacements have a decreasing trend from top of the dome to lower part of the mosque.

Figure 13: Maximum displacements contour diagram of the mosque with 16 window openings under dead load and earthquake load (G+EZ).

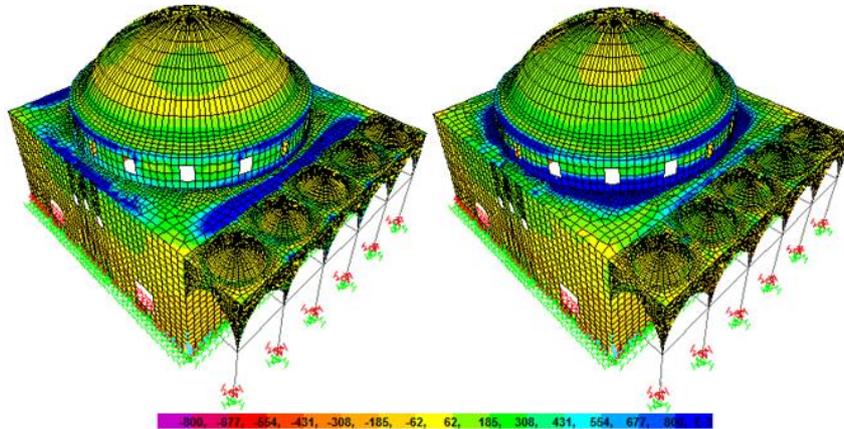
The maximum tensile stresses contour diagram is shown in Fig. 14. It is seen from the Figure 14 that maximum values of the tensile stresses for outer surface of the mosque occurred at side and lower part of big dome, near the window spaces and transition areas of between side walls as 0.85 MPa. Maximum tensile stresses for inner surface of the mosque occurred as 0.80 MPa.

5 Figure 14: Maximum tensile stresses contour diagram for outer and inner surfaces of the mosque with 16 window openings under dead load and earthquake load (G+EZ).

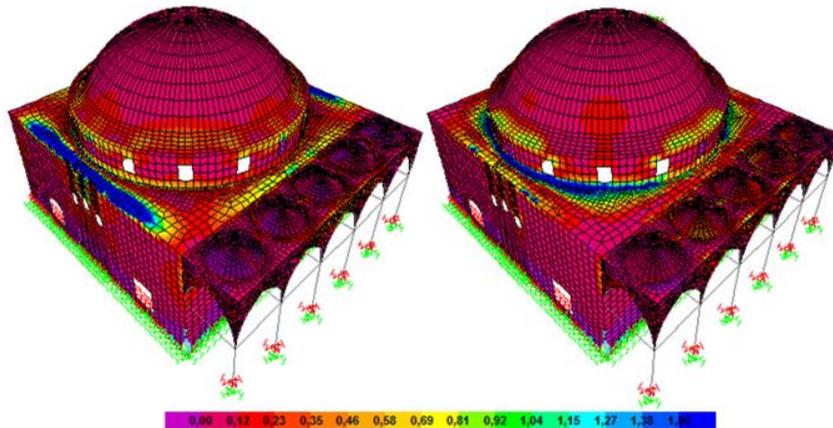
The maximum compression stresses contour diagram is shown in Fig. 15. It is seen from the Figure 15 that maximum values of the compression stresses for outer surface of mosque occurred at between the dome and side walls transition areas and near window spaces at dome as 1.35 MPa. Beside this maximum compression stresses for inner surface of the mosque, occurred as 1.25 MPa.

Figure 15: Maximum compression stresses contour diagram for outer and inner surfaces of the mosque with 16 window openings under dead load and earthquake load (G+EZ).

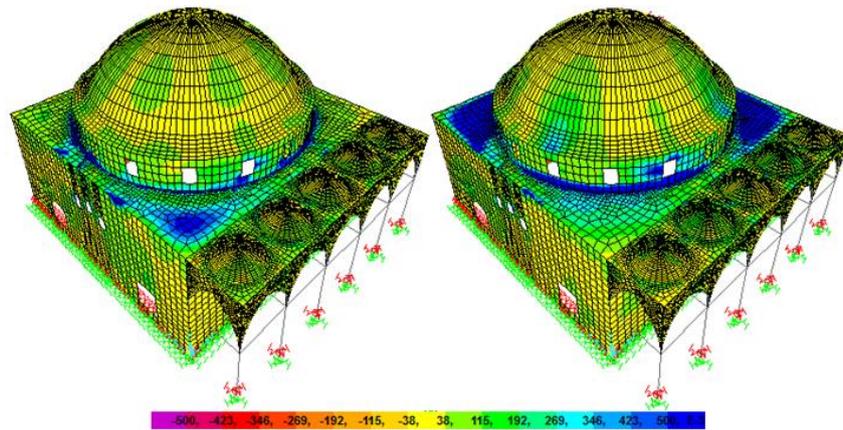
The maximum shear stresses contour diagram for outer and inner surfaces of Hüsrev Pasha Mosque under dead load and earthquake load (G+EZ) is shown in Fig. 16. It is seen from the Figure 16 that maximum values of the shear stresses for outer and inner surfaces of the mosque are 0.50 MPa and 0.45 MPa respectively.

Figure 16: Maximum shear stresses contour diagram for outer and inner surfaces of the mosque with 16 window openings under dead load and earthquake load (G+EZ).

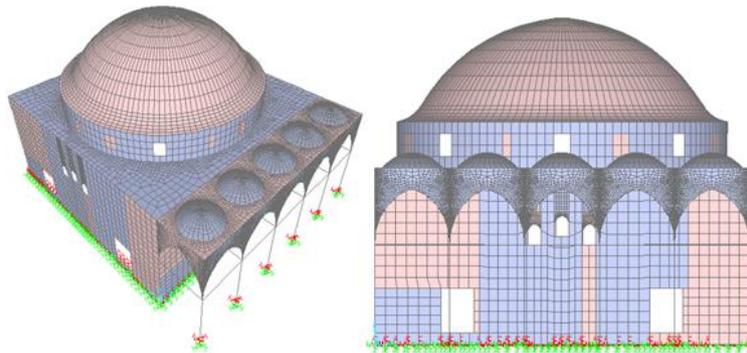
5 The mosque has 8 window openings before the restoration case so finite element model of the mosque was constituted with 8 window openings. Finite element model of the mosque with 8 window openings is shown in Fig. 17. According to the modal analysis first four natural frequencies were obtained as 3.81Hz, 3.87Hz, 4.81Hz and 5.78Hz respectively. Mode shapes were obtained as translation X direction, translation Y direction, squeeze and torsion respectively. Results of earthquake analyses are given in Table 3.

Figure 17: Finite element model of the mosque with 8 window openings.
