Earthquake Response of Heavily Damaged Historical Masonry Mosques after Restoration

Ahmet Can Altunışık¹, Ali Fuat Genç¹

¹Department of Civil Engineering, Karadeniz Technical University, Trabzon, 61080, Turkey

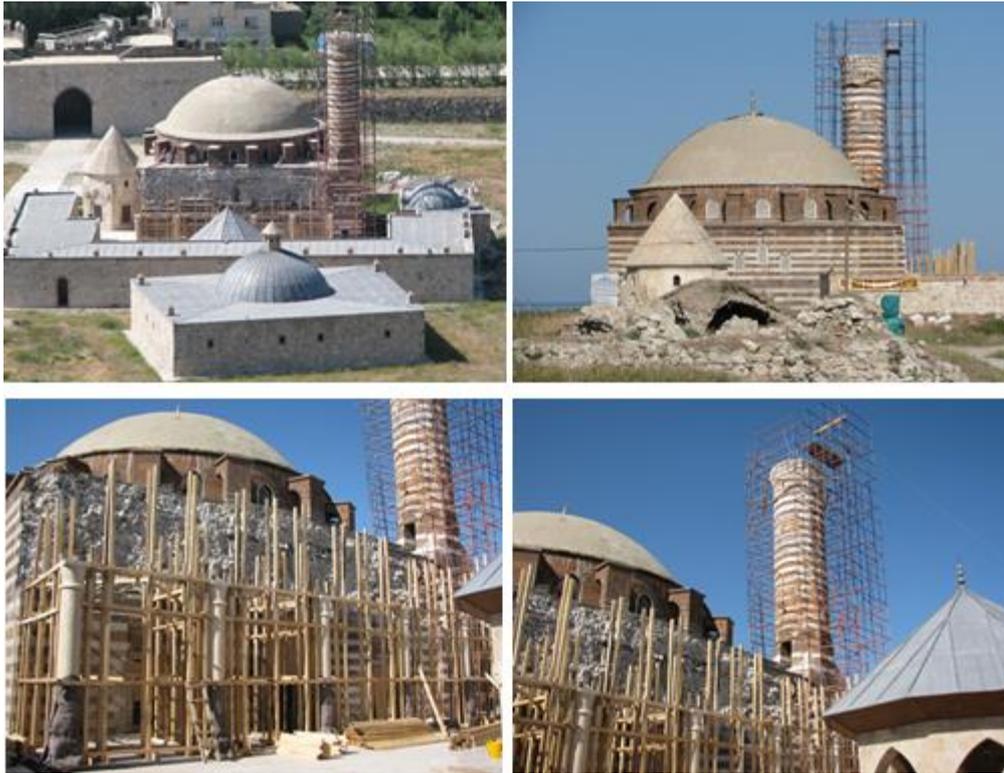
Today there are some cases which affect the structural performance of the mosque detrimentally. These cases are structural cracks, material deformations, destroyed parts of carrier system, environmental issues-algae and humidity. Some views of these cases and damaged views of the mosque are shown in Fig. 3.

5 **Figure 3: Damaged views and dangerous cases of Hüsrev Pasha Mosque.**
