Author's Response – Review 2 - NHESS-2017-194 Salvini et al. “Use of a remotely piloted aircraft system for hazard assessment in a rocky mining area (Lucca, Italy)”

Use of a remotely piloted aircraft system for hazard assessment in a rocky mining area (Lucca, Italy)

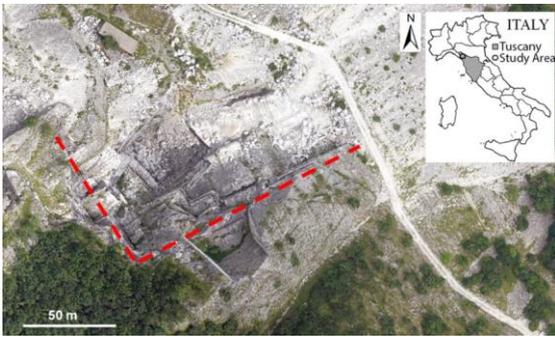
Figure 1. Plan view of the Piastrone open pit with indication of the two principal slope directions (dotted lines). Inset map shows the location of the study area.

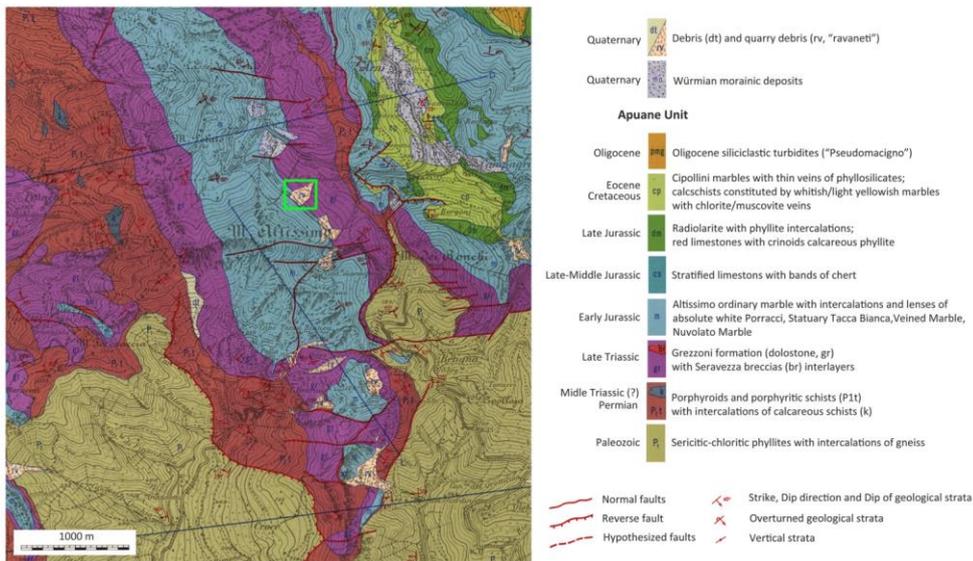
Figure 2. Geological map of the Mt. Altissimo area. The [green](#) rectangle indicates the location of the quarry (modified from Giglia and Paiotti, 1963).

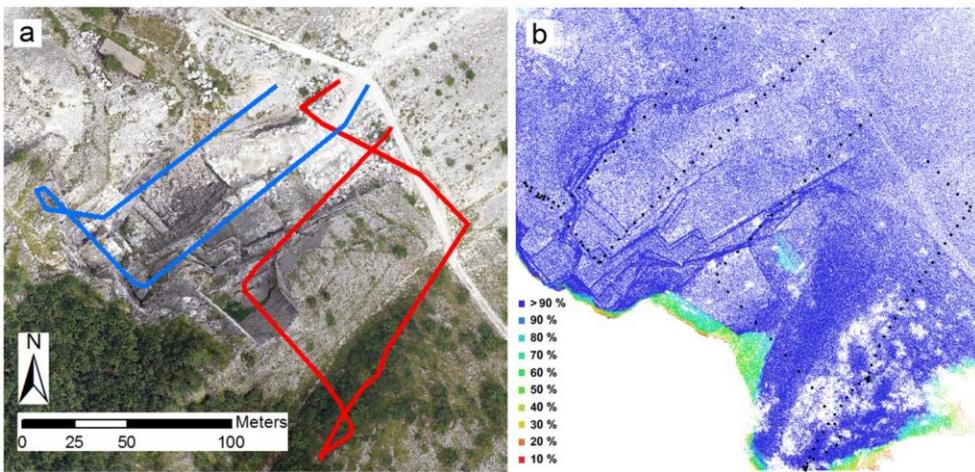
Figure 3. Flight paths of the RPAS zenithal surveys (a). Plan view of the area with indication of camera locations (black dots) and image overlap percentage (b).

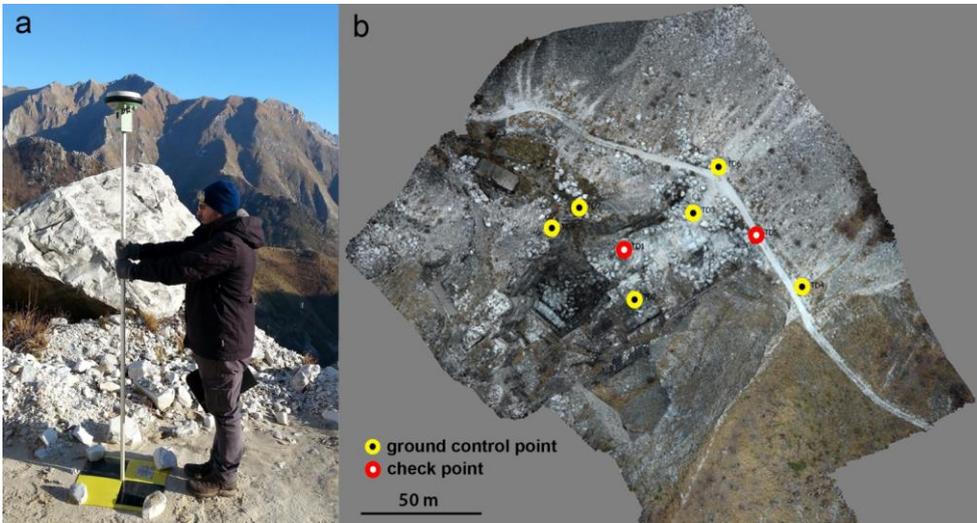
Figure 4. Example of a GCP measured during the RTK GNSS field survey (a) and spatial distribution of GCPs and check points for the RPAS zenithal flights (b).

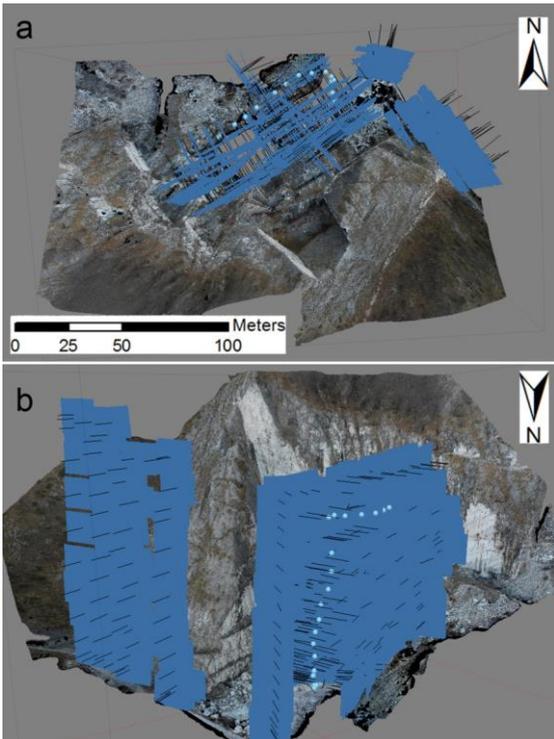
Figure 5. Plan view (a) and perspective view (b) of the RPAS frontal surveys (blue rectangles correspond to the photographs locations, black lines to normals). Corresponding [3D](#) point clouds, produced [with-by the](#) photogrammetric processing of [natural colour](#) digital images is shown in background.

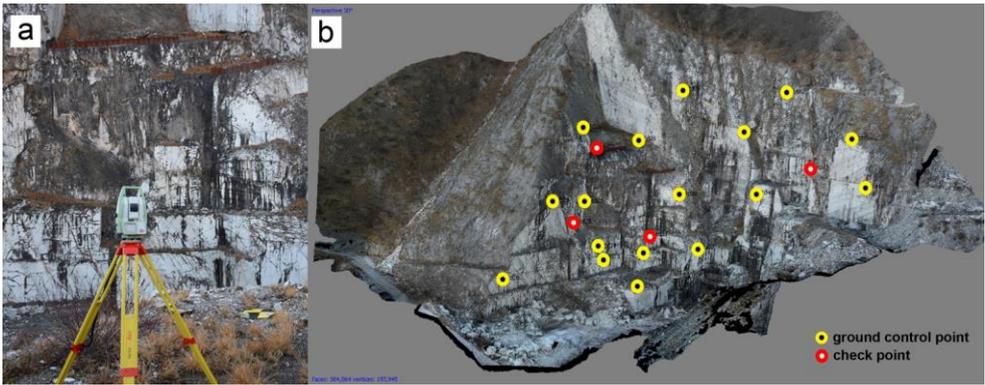
Figure 6. Topographic survey with TS (a) and spatial distribution of GCPs and check points for the RPAS frontal flights (b).

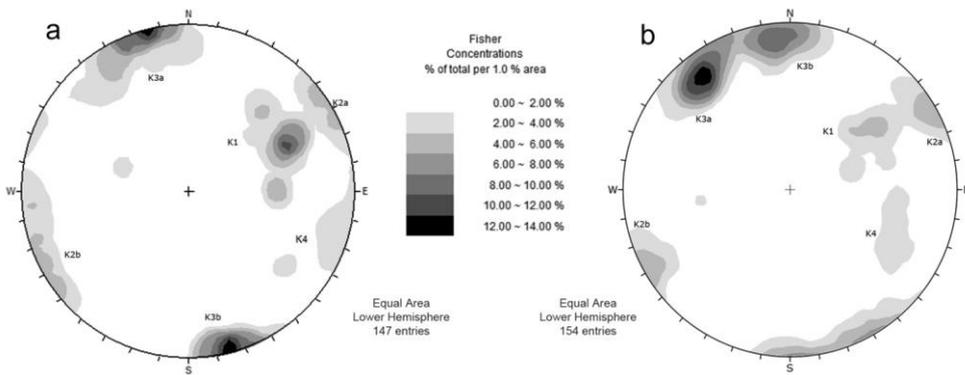
Figure 7. Stereonet plot of poles (Schmidt, equal area, lower hemisphere) of the discontinuities manually collected through classical engineering geological survey (a) and remotely collected by using photogrammetric data from RPAS surveys (b).

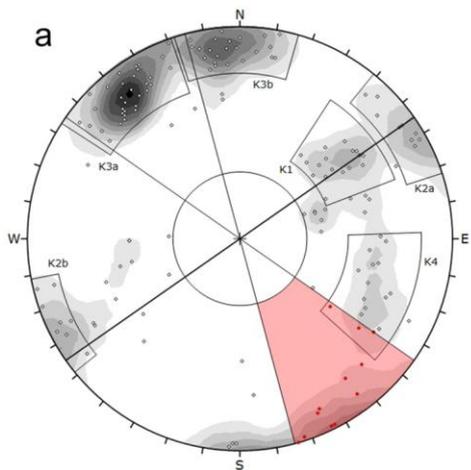
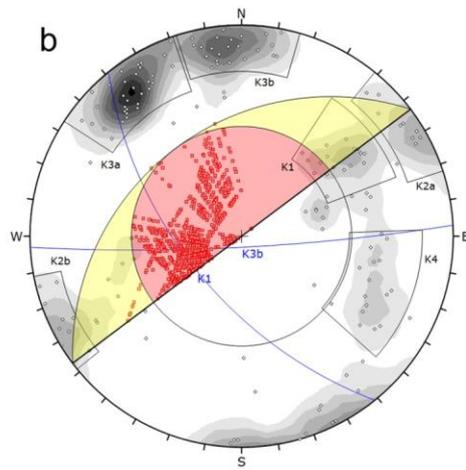
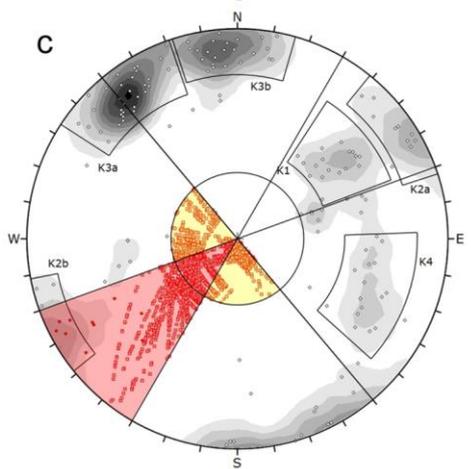
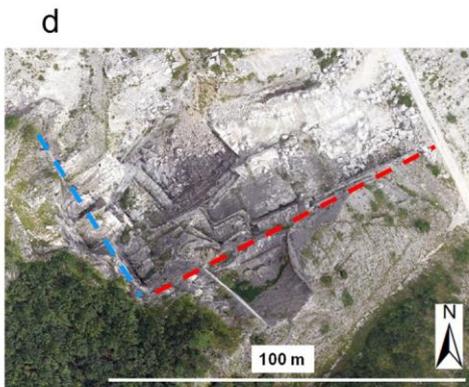
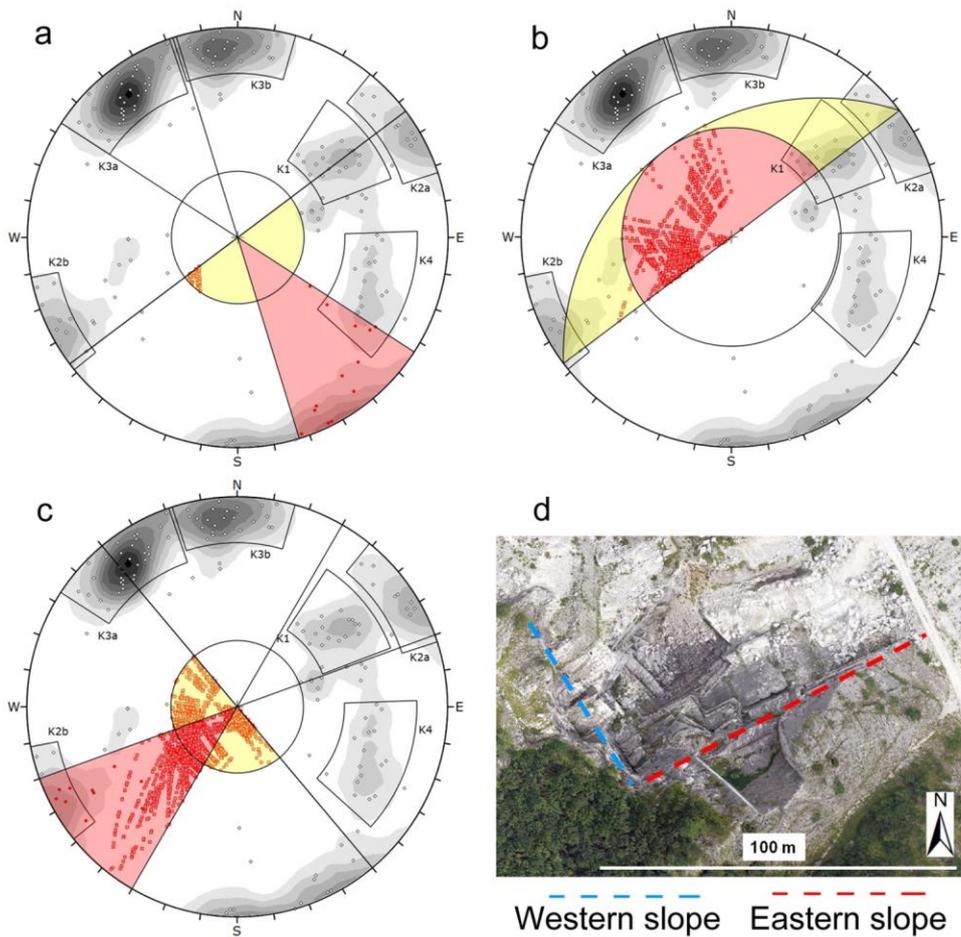
Figure 8. Examples of kinematic stability analysis carried out using Rocscience™ Dips 6.0 stereographic projection through the Wulff equal-angle method (lower hemisphere); a) Planar sliding on the eastern slope; b) Wedge sliding on the eastern slope (with highlighted great circles of intersection K1/K3b as example); c) Direct toppling on the western slope; d) Aerial photo showing the two principal slope orientations.

- Figure 8a: why are the authors using the direct toppling method and not the usual planar sliding method? Please modify as appropriate.

That was actually a mistake. We have corrected the images including the correct planar sliding analysis.

- Figure 8b: the analyses are correct. The stereonet show that a number of intersections fall within the failure envelopes, but does not explicitly show which joint set combinations make these intersections. Although the possible intersections are listed in Table 5, it could be useful to plot the great circles of one intersection as an example.

We agree with the suggestion; therefore, we have modified Figure 8b and the relative caption accordingly.

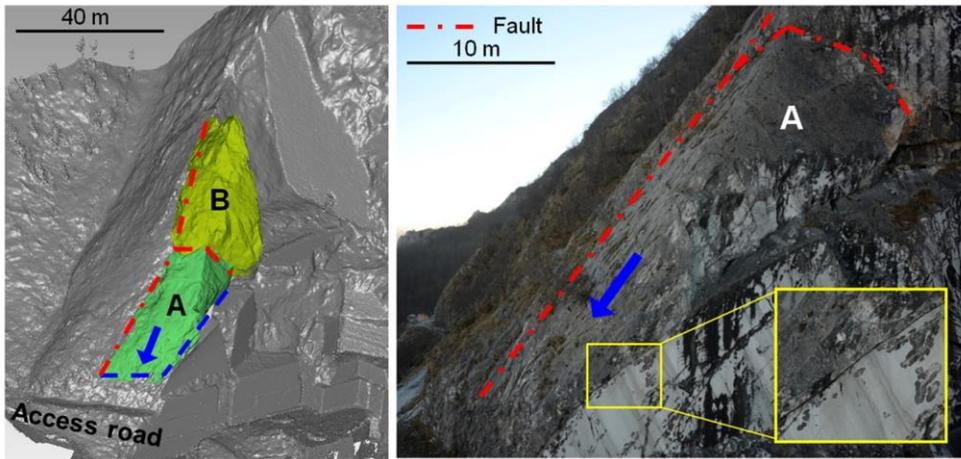
Figure 9. Identification of two large blocks with potential for sliding; inset photo highlights the visible aperture of the basal plane.

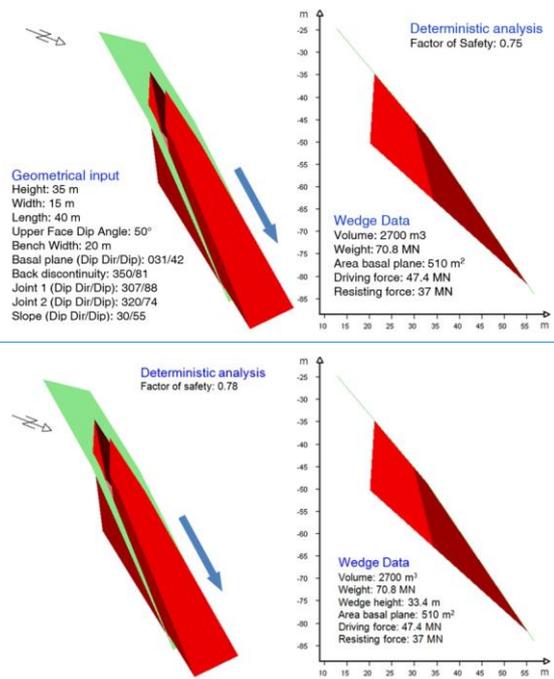
5
 Figure 10. Result of Rocscience™ Swedge 3D preliminary slope stability analysis.

Following the Reviewer suggestion, information about the geometry of the block analysed in Swedge has been added in Fig. 10. Information about Joint 1, Joint 2 and back discontinuity has also been added. The text has been modified for clarifying the joints used for the wedge reconstruction: “In addition, the lateral and rear or back surfaces correspond to geological faults and can be therefore considered fully persistent. In this regard, the western lateral surface has been included in the Swedge model has a discontinuity (Joint 1 in Fig.10; Dip Dir/Dip 307/88), while the back surface has been included as a tension crack (Back discontinuity in Fig.10; Dip Dir/Dip 350/81). It should be also noted that the eastern lateral surface observable in the model (Joint 2 in Fig.10; Dip Dir/Dip 320/74) was also necessary to re-create the block geometry in the software. It was assigned 0° friction angle so as not to induce a resisting force in the simulation.”

The geometry of Block A was deterministically re-created in Swedge using the geometrical information ~~obtained from the point cloud provided~~ exposed shown in Fig. 10 in table 6, with a slope direction of 30 degrees. Initially the discontinuities were assumed to be fully persistent. This is a common approach in engineering geology, since reliable values of persistence are almost impossible to obtain from field mapping and most rock slope stability analysis assume that the 100-% persistent joint exists on failure surface (Park, 2005). ~~The basal plane is a joint and the possible presence of rock bridges should be carefully~~

The adopted limit equilibrium solution for the slope stability analysis was based on the Mohr-Coulomb shear strength model with a friction angle of 35.35° and a unit weight of 0.026 MN/m³ (Ertag, 1980; Dumas, 1999). It should be noted that the western lateral surface observable in the model was also necessary to re-create the block geometry in the software. It was assigned 0° friction angle so as not to induce a resisting force in the simulation. Water forces were also initially ignored within the preliminary analysis (Fig. 10).

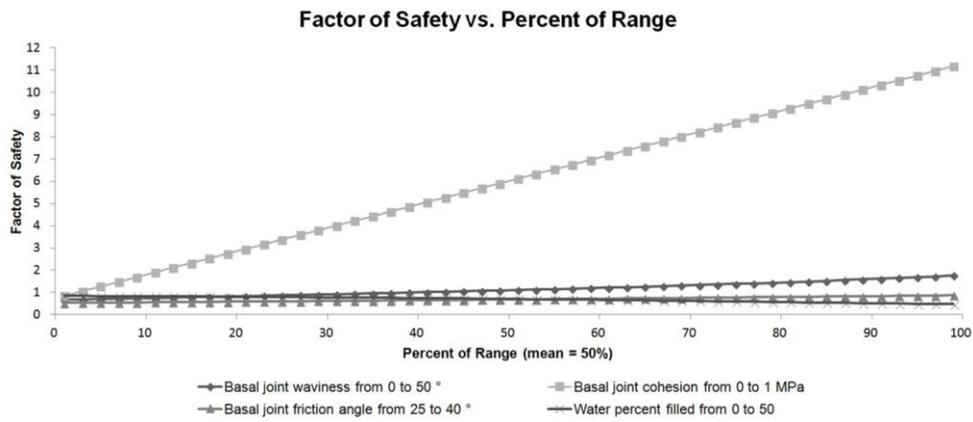
Figure 11. Result of sensitivity analysis relative to the parameters basal joint waviness, friction angle, cohesion and water percent filled. Result of sensitivity analysis relative to basal joint waviness, friction angle, cohesion and water percent filled parameters.

As observed, Results of the sensitivity analysis (Fig. 11), show that the cohesion is clearly the parameter that has the most effect on block stability. For this reason, the effect of this parameter was investigated in more detail in the following analyses. Application of Eq. (3) makes it possible to determine an effective cohesion dependent on the continuity of jointing. From this the contribution of eventual rock bridges on the block stability can be investigated starting from intact rock cohesion material value, that has been determined to be approximately 16 MPa (Lorenzoni, 2012; Dumas, 1999; data from Geomechanical Laboratory of the Centre of GeoTechnologies of Siena University). Table 7 shows the results in terms of Factor of Safety factor of safety obtained from a parametric stability analysis performed with increased values of effective cohesion, corresponding to 0, 0.5, 1, 2, 5, and 10-% of rock bridges on the basal plane (total area of 510 m²), and a 20-% of water filled fissures (considered reliable after field observation and high-resolution high-resolution images analysis).

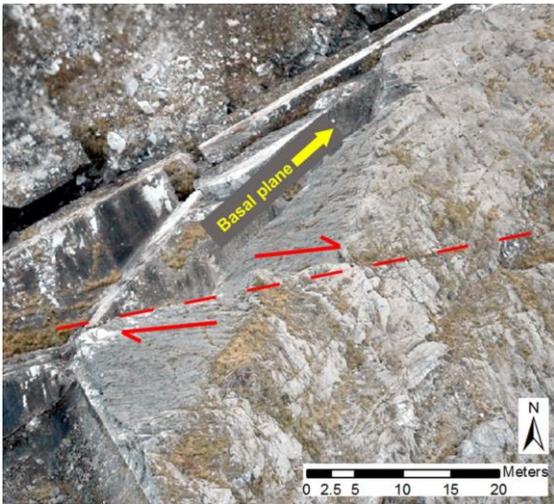
15 **Figure 12.** Detail of the zenithal orthophoto with indication of apparent [motion offset](#) of a major fault acting as back release surface for block A of figure 9.

~~In this stability analysis~~ ~~In the preliminary limit equilibrium analysis~~ ~~analysis~~, the major uncertainty is on the basal plane (Fig. 12). Despite the presence of a continuous trace line on the rock exposure, its full persistence in the rock mass is not clear. In general, the presence of rock bridges plays an important role in stabilizing ~~the removable~~ rock blocks. ~~In particular~~ ~~Indeed~~, a rock block cannot fall or slide from a slope until the rock bridges have failed. ~~The rock bridge failure involves the collapse or failure of the intact rock~~ Rock bridge failure involves fracturing of intact rock, which can be an order of magnitude stronger than the rock mass (Kemeny and Donovan, 2005). From the ~~undertaken~~ sensitivity analysis ~~undertaken~~, cohesion of the basal plane was the parameter that had the most significant influence on the block ~~Factor of Safety~~ ~~factor of safety~~. This suggests that it may not be completely persistent in this case, since the block has remained stable over time. In this regard, the parametric analysis carried out increasing the cohesion values show ~~esd~~ how a small rock bridge, corresponding to 1% of the basal plane surface (5.1 m² of intact rock) is sufficient for guaranteeing the stability of the block. ~~This is mainly due to the fact that, despite the basal plane dipping more than the friction angle of the surface, its inclination is not sufficient to avoid the generation of a high normal force that increases the shear strength of the discontinuity.~~ Cohesion induced by the supposed rock bridge leads to an actual stability condition that seems not influenced by the higher dip of the basal plane respect to the friction angle of the surface that, commonly, can causes the failure of a rock block. ~~Therefore, even a small area of intact rock increases the resisting force that leads to a condition of stability.~~ In this case, 5.1 m² of rock bridge corresponds theoretically to a resisting force of

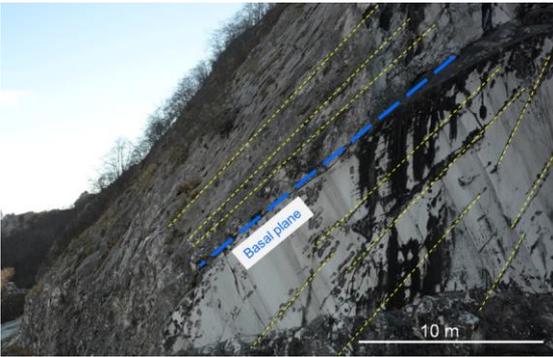
Figure 13. Details of a series of high-tight discontinuities over-above and below the basal plane under study.

preferential direction of weakness exists within the rock mass. In this case, the cohesion of rock bridges along intermittent joints could be much lower than that of the intact rock, and consequently the percentage of rock bridges could be greater. This could be the case of Block A, and the presence of a series of discontinuities with similar dip and dip direction to the basal plane seems to confirm the hypothesis of a preferential plane of weakness due to the geomechanical characteristics of the marble material in that portion of the mining area (Fig. 13).”
