Use of a remotely piloted aircraft system for hazard assessment in a rocky mining area (Lucca, Italy)

5 Riccardo Salvini¹, Giovanni Mastrorocco¹, Giuseppe Esposito¹, Silvia Di Bartolo¹, John Coggan²,
Claudio Vanneschi²

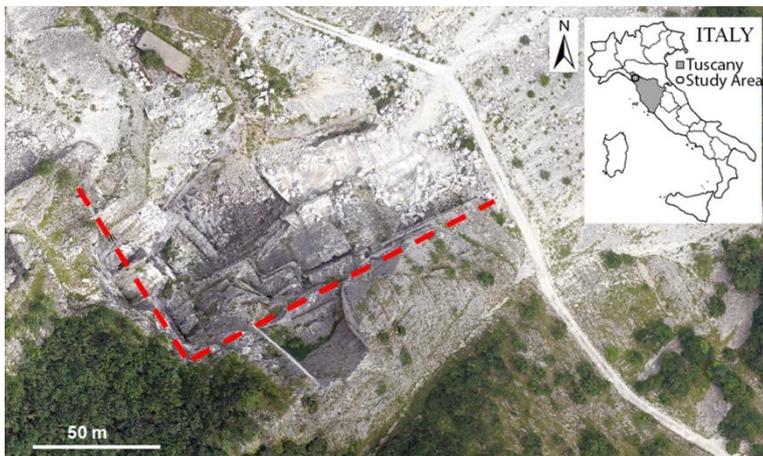
Figure 1. Plan view of the Piastrone open pit with indication of the two principal slope directions (dotted lines). Inset map shows the location of the study area.

The study area is located in the Apuan Alps marble district, in the province of Lucca (Tuscany, Italy - Fig. 1). The open pit or quarry, named "Piastrone", is characterized by a V shape, with two principal slope directions oriented 50/90 and 323/90 (dip direction/dip). The bottom of the pit is located at 1,180 meters above sea level (m.a.s.l.) and the top of the excavated rock face is at 1,300 m.a.s.l.. The rock mass is characterized by different sets of discontinuities with persistence values that can vary from a few meters up to decameters.

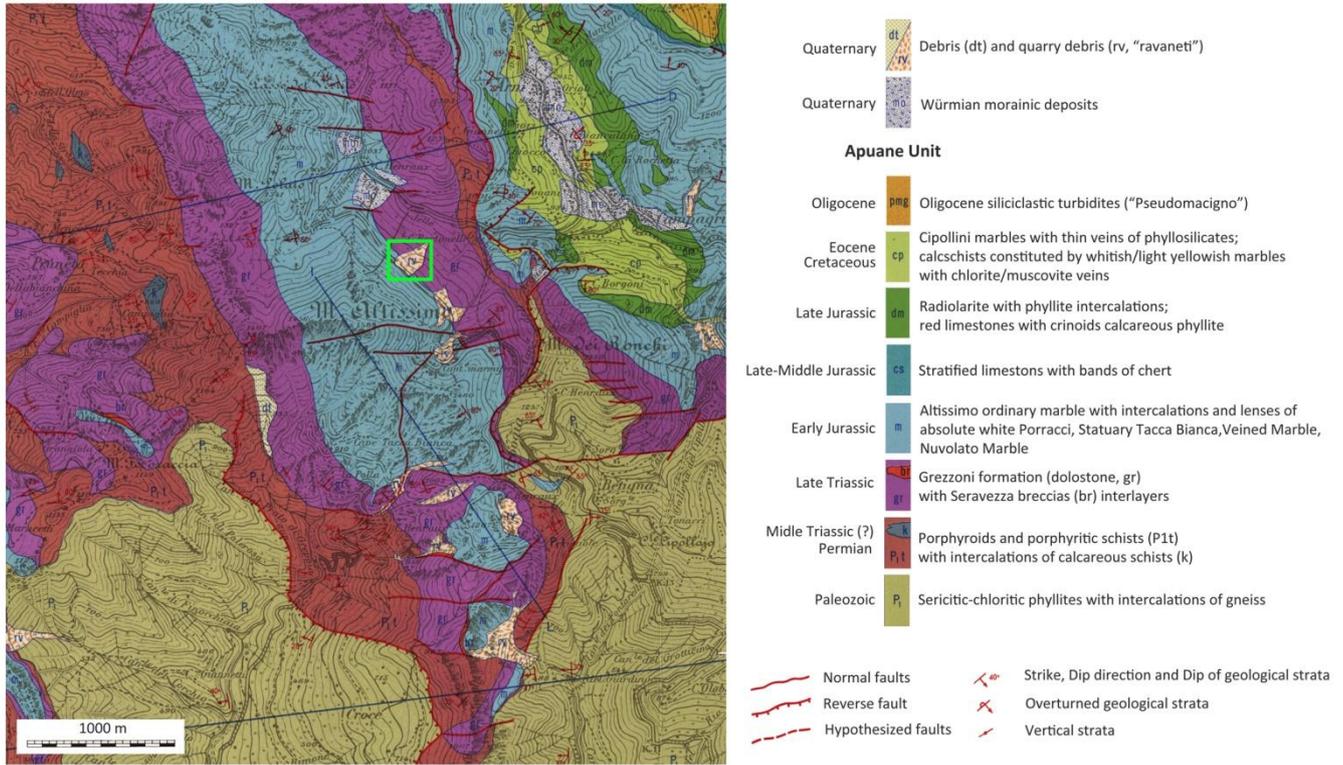
Mt. Altissimo Geological map

Figure 2. Geological map of the Mt. Altissimo area. The green rectangle indicates the location of the quarry (modified from Giglia and Paiotti, 1963).

From a geological point of view (Fig. 2) the Piastrone open pit is located in the Apuan Alps metamorphic complex, precisely in the Mt. Altissimo Syncline (AS), belonging to the Apuane Unit (Meccheri et al., 2007). According to classical interpretation (Carmignani and Kligfield, 1990) AS resulted from a compressive tectonic phase which originated during the Tertiary continental collision between the Sardinia-Corsica block and the Adria plate (Upper Oligocene-Lower Miocene). Successively, during the Early Miocene, a new ductile to brittle-ductile deformation caused by a post-compression tectonic uplift overprinted the earlier structures and generated a widespread network of joints and faults. In the Mt. Altissimo area, the main set of brittle deformation strikes SW-NE to W-E with sub-vertical dip, generally with negligible displacement except for a few cases where offsets of some ten meters have been observed (Meccheri et al., 2007).

plane appears not to correspond with any of the identified discontinuity sets, but is probably connected to planes of weakness of the marble in correspondence with a particular orientation of minerals crystallographic axes. The lateral and rear faults, however, may be associated with the K3a and K3b systems respectively. The rear fault may also be associated with the E-W fault system that characterizes the geology of this area of the Apuan Alps complex (Fig. 2).

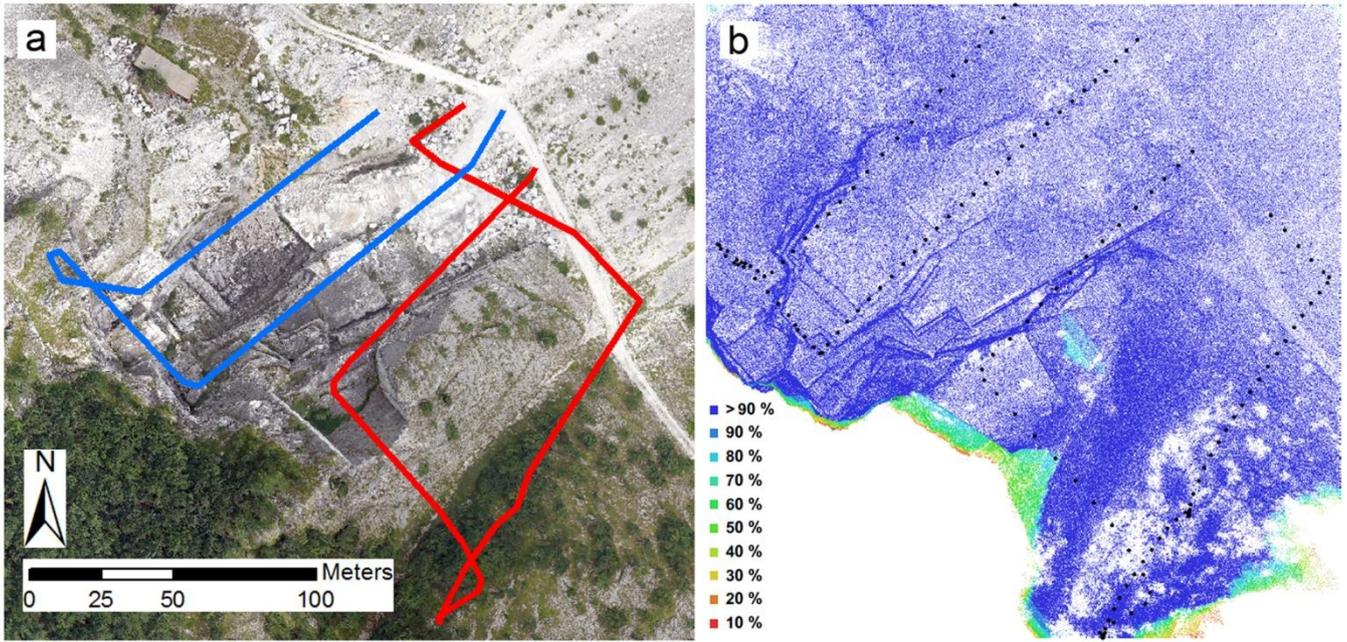
Figure 3. Flight paths of the RPAS zenithal surveys (a). Plan view of the area with indication of camera locations (black dots) and image overlap percentage (b).

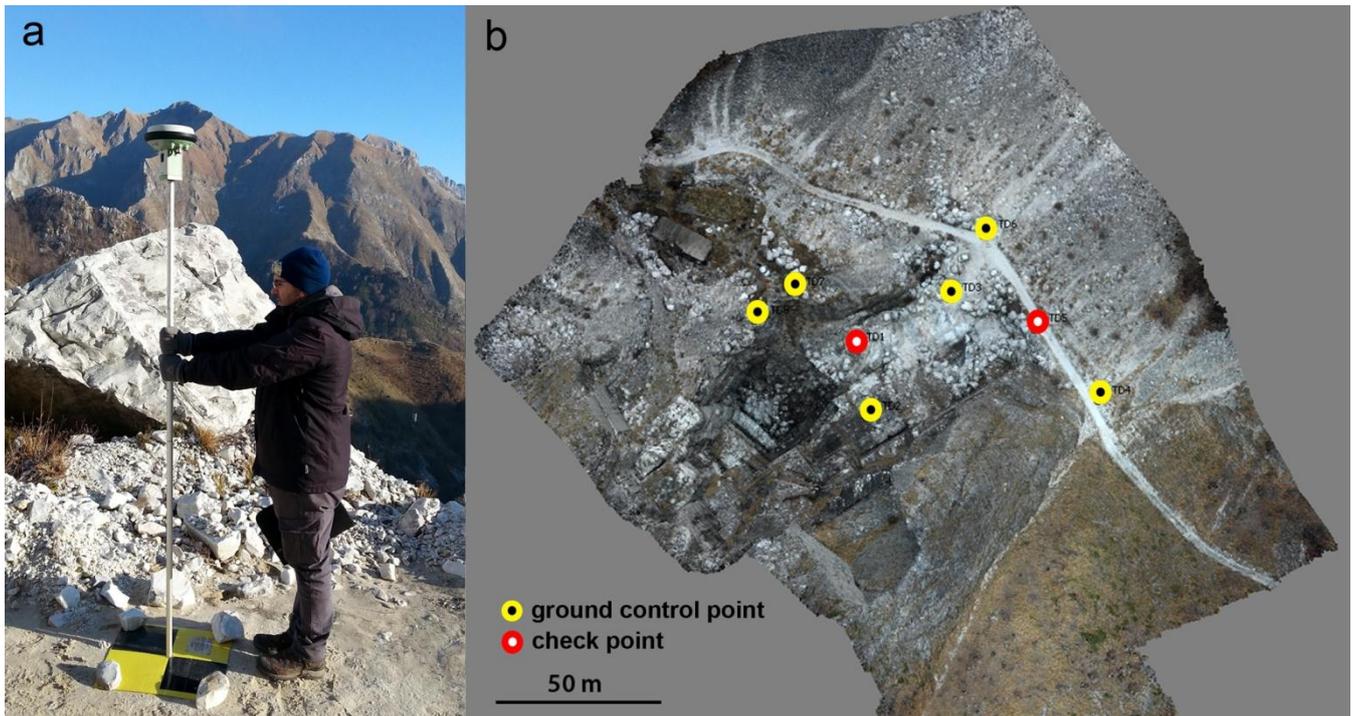
Figure 4. Example of a GCP measured during the RTK GNSS field survey (a) and spatial distribution of GCPs and check points for the RPAS zenithal flights (b).

The zenithal survey was preliminarily designed in the laboratory with the AibotixTM AiProfliight planning software, and manually performed through single quasi-parallel flight lines. A total of 151 aerial images were acquired with a nominal overlap and sidelap of 80% and 60%, respectively. Two flights were required to cover all sectors of the mining area (Fig. 3). An average estimated distance between pixel centers measured on the ground (i.e. ground sample distance - GSD) of 2.4 cm was calculated. During the flight, a GNSS field survey was also carried out in order to ensure the necessary spatial accuracy of the resultant images. Eight artificial targets, 50x50 cm large, were placed on the ground with the purpose of obtaining an optimum spatial distribution on the accessible zones of the study area (Fig. 4) and used as GCPs and check points.

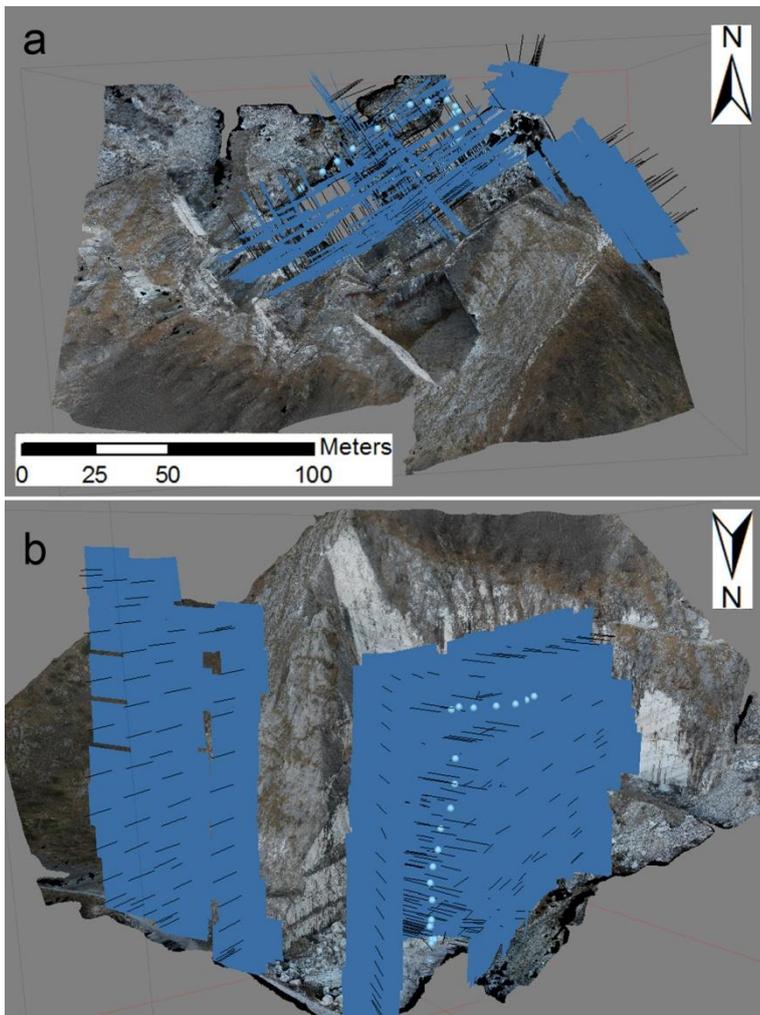
Figure 5. Plan view (a) and perspective view (b) of the RPAS frontal surveys (blue rectangles correspond to the photographs locations, black lines to normals). Corresponding 3D point clouds produced by the photogrammetric processing of natural colour digital images is shown in background.

The frontal survey, with direction of acquisition parallel to the rock face, was carried out manually, without the use of the AibotixTM AiProfliight planning software. Six flights were needed in order to cover all sectors of the mining area, resulting in a total of 448 overlapping images. The flights were executed in sub-parallel straight lines approximately 60 meters distant from the rock face (Fig. 5), providing an average estimated GSD of 1.5 cm.

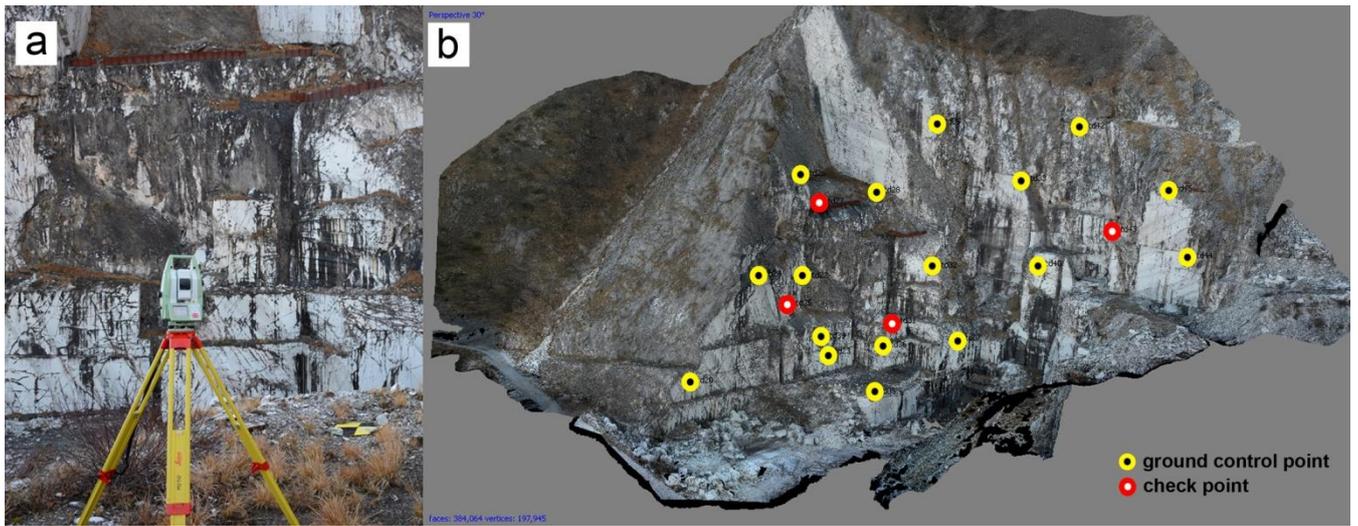
Figure 6. Topographic survey with TS (a) and spatial distribution of GCPs and check points for the RPAS frontal flights (b).

As for the zenithal flight, a series of GCPs and check points (21 targets in total - Fig. 6) were measured using a reflectorless TS. Their location was decided considering a balance between an optimum spatial distribution (Fig. 6), both in space and elevation from the open pit floor, and easy identification of points on the images. Due to the complex morphology of the slopes and the extent of the mining area, a large number of GCPs were used to orient the photogrammetric model. Two GNSS receivers, operating in static modality, were used to obtain the geographic coordinates of two points: the origin of the

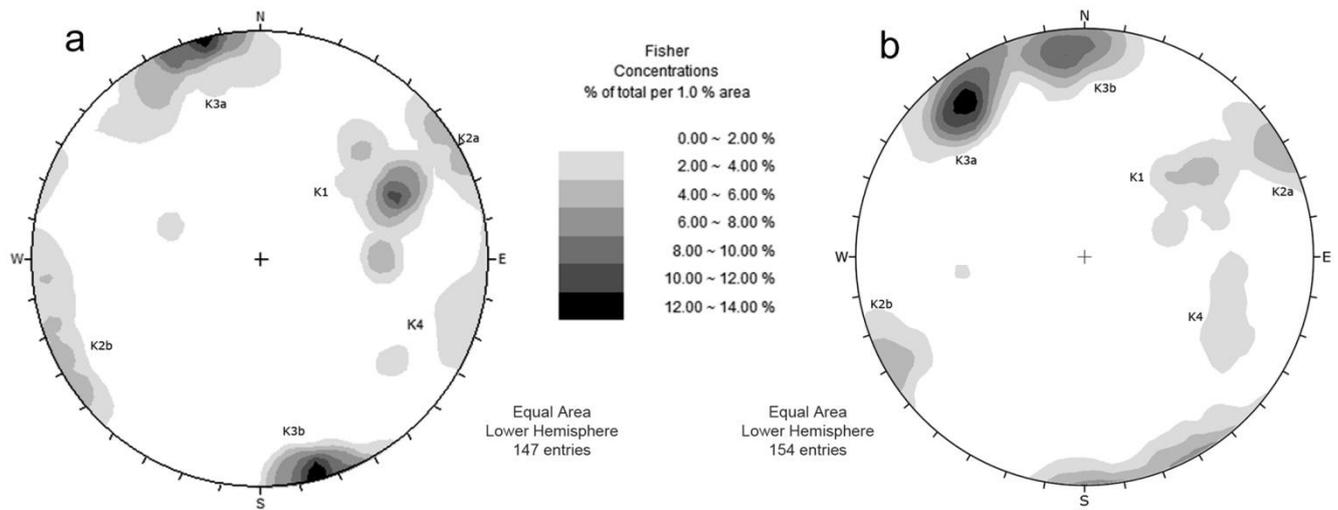
Figure 7. Stereonet plot of poles (Schmidt, equal area, lower hemisphere) of the discontinuities manually collected through classical engineering geological survey (a) and remotely collected by using photogrammetric data from RPAS surveys (b).

10 | By comparing the discontinuity planes obtained through traditional manual engineering geological survey (a in Fig. 7) and that identified on the point cloud (b in Fig. 7) a good level of congruence has been highlighted, confirming the quality of the taken approach.

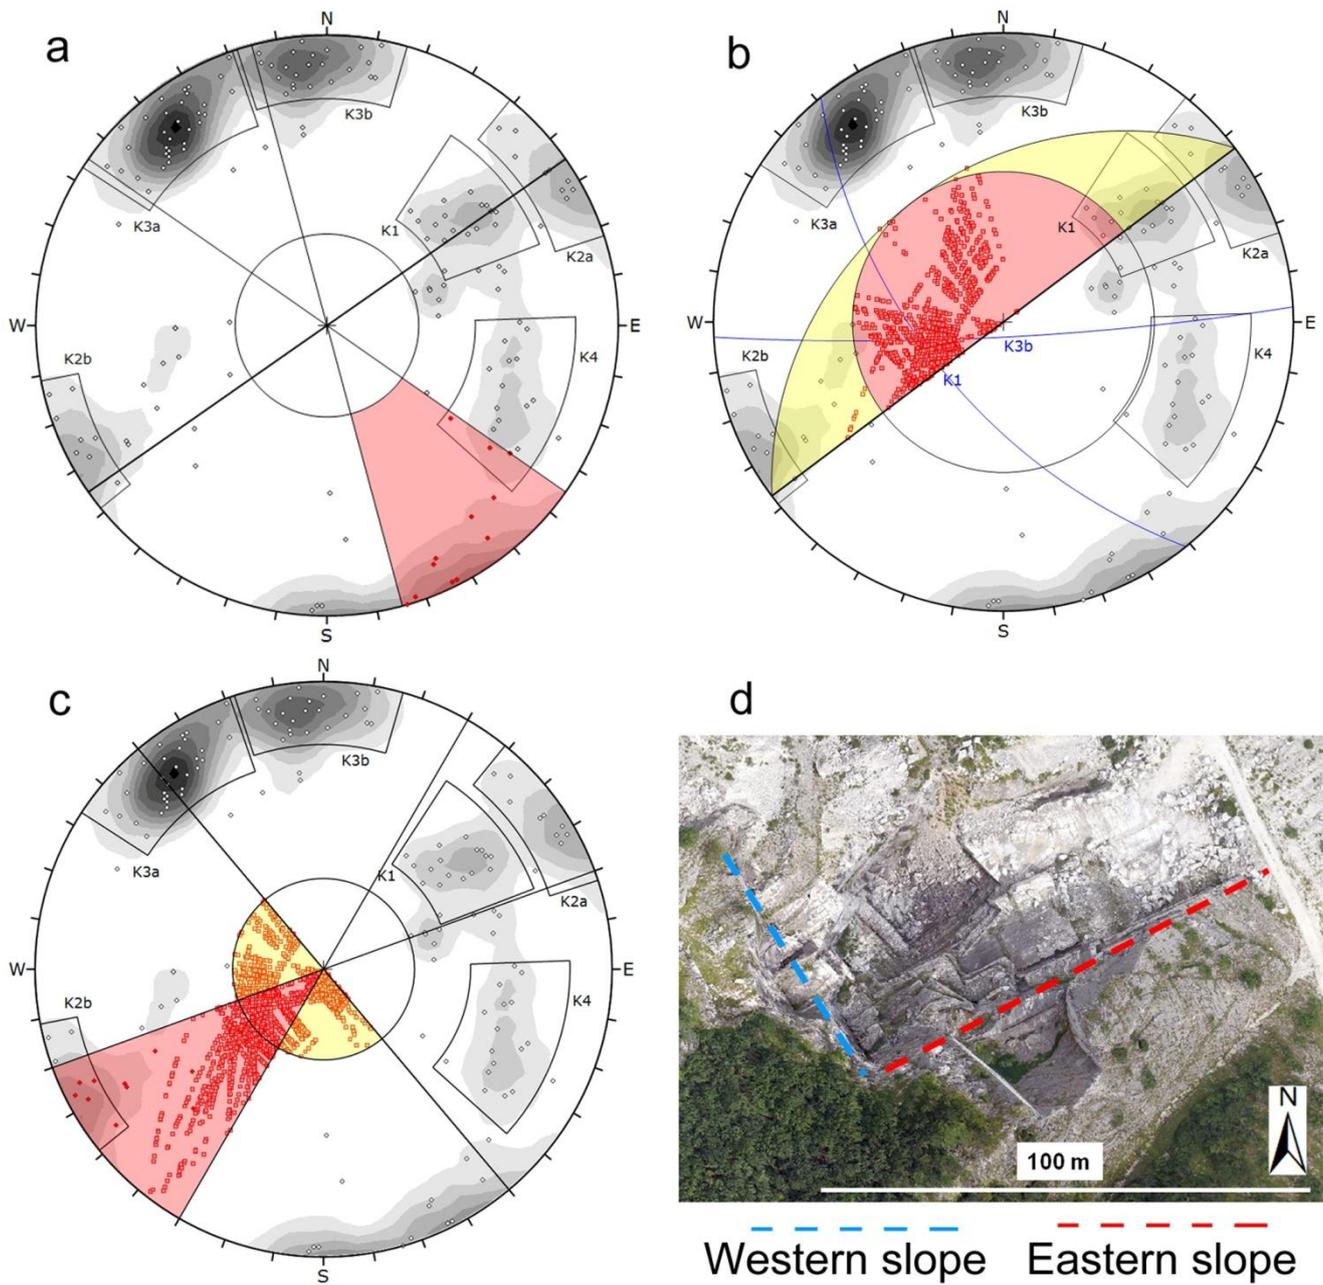
5 **Figure 8.** Examples of kinematic stability analysis carried out using Rocsience™ Dips 6.0 stereographic projection through the Wulff equal-angle method (lower hemisphere); a) Planar sliding on the eastern slope; b) Wedge sliding on the eastern slope (with highlighted great circles of intersection K1/K3b as example); c) Direct toppling on the western slope; d) Aerial photo showing the two principal slope orientations.

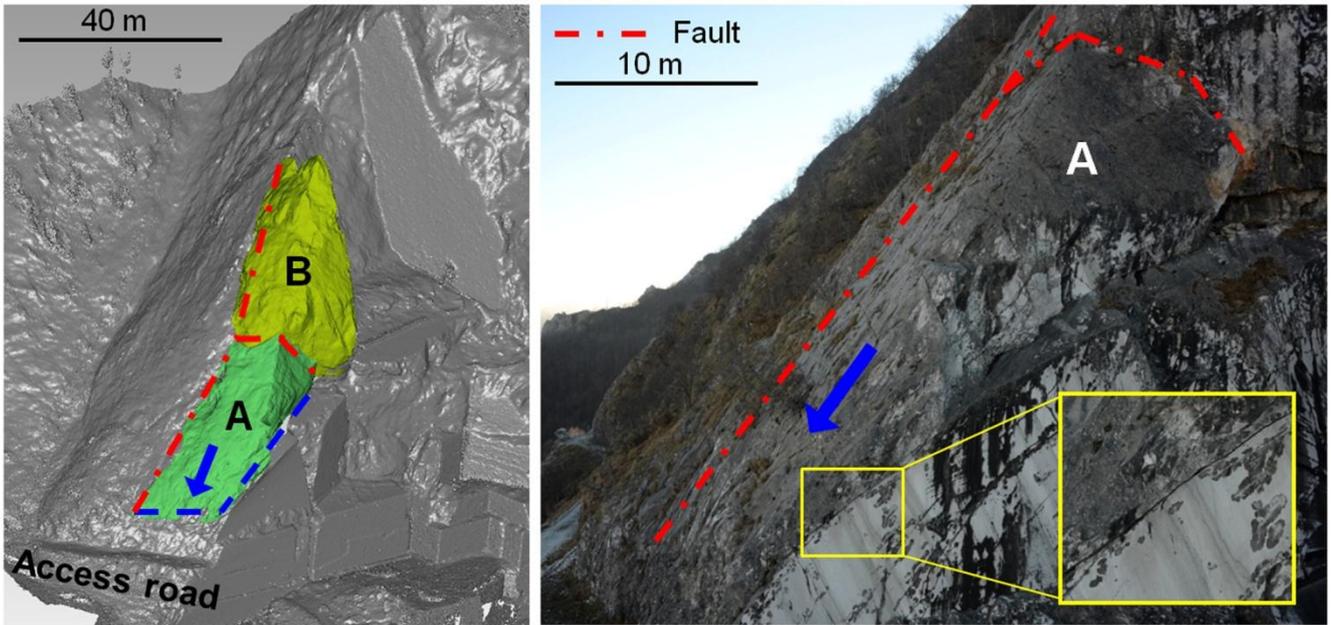
Figure 9. Identification of two large blocks with potential for sliding; inset photo highlights the visible aperture of the basal plane.

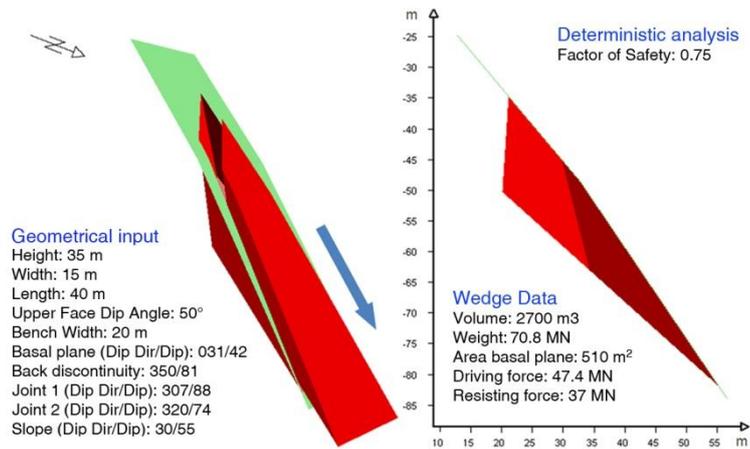
Figure 10. Result of Rocscience™ Swedge 3D preliminary slope stability analysis.

15 The geometry of Block A was deterministically re-created in Swedge using the geometrical information shown in Fig. 10. Initially the discontinuities were assumed to be fully persistent. This is a common approach in engineering geology, since reliable values of persistence are almost impossible to obtain from field mapping and most rock slope stability analysis assume that the 100% persistent joint exists on failure surface (Park, 2005). The basal plane is a joint and the possible presence of rock bridges should be carefully considered. In this case the basal plane did not show the presence of segments
20 of intact rock along its trace on the rock exposure, consequently application of Eq. (2) confirms a 100% persistence of the basal plane, that was used in the first analysis. In addition, the lateral and rear or back surfaces correspond to geological faults and can be therefore considered fully persistent. In this regard, the western lateral surface has been included in the Swedge model has a discontinuity (Joint 1 in Fig.10; Dip Dir/Dip 307/88), while the back surface has been included as a tension crack (Back discontinuity in Fig.10; Dip Dir/Dip 350/81). It should be also noted that the eastern lateral surface

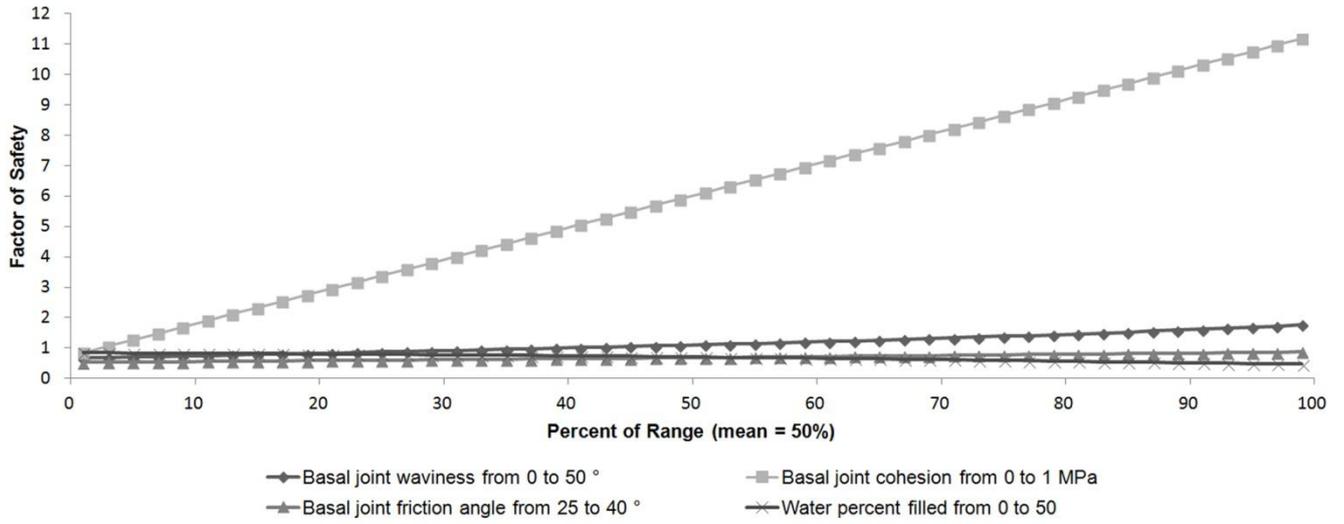
Factor of Safety vs. Percent of Range

Figure 11. Result of sensitivity analysis relative to the parameters basal joint waviness, friction angle, cohesion and water percent filled.

parameters that have the most effect on block stability. Since the geometrical inputs are well defined through the accurate 3D model, the subsequent analysis focused on waviness angle (it accounts for the undulations of the joint surface, observed over distances on the order of 1 m to 10 m; Miller, 1988), cohesion and friction angle of the basal plane, and water pressure. These are also the parameters with the higher input uncertainty.

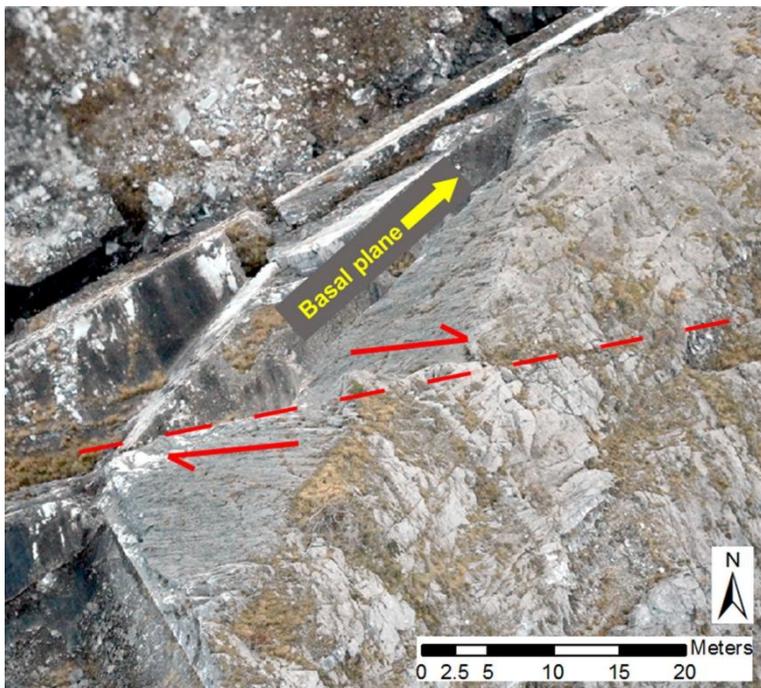
Figure 12. Detail of the zenithal orthophoto with indication of apparent offset of a major fault acting as back release surface for block A of figure 9.

In the preliminary limit equilibrium analysis, the major uncertainty is on the basal plane (Fig. 12). Despite the presence of a
30 continuous trace line on the rock exposure, its full persistence in the rock mass is not clear. In general, the presence of rock bridges plays an important role in stabilizing removable rock blocks. Indeed, a rock block cannot fall or slide from a slope until the rock bridges have failed. Rock bridge failure involves fracturing of intact rock, which can be an order of magnitude stronger than the rock mass (Kemeny and Donovan, 2005). From the undertaken sensitivity analysis, cohesion of the basal plane was the parameter that had the most significant influence on the block Factor of Safety. This suggests that it may not

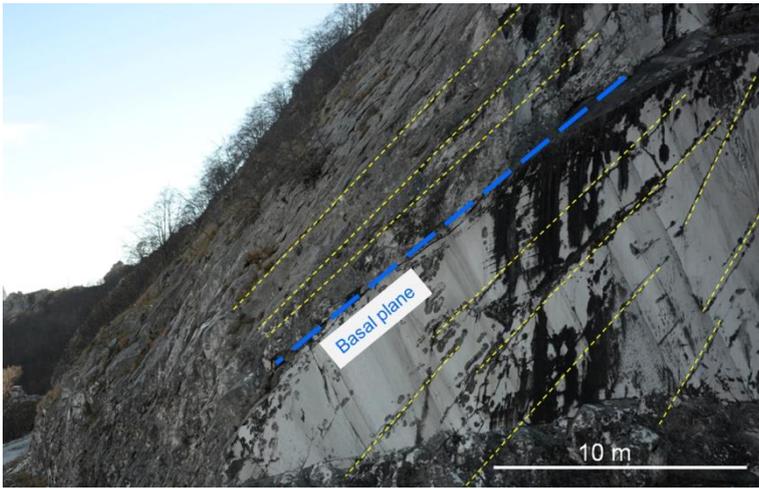
Figure 13. Details of a series of tight discontinuities above and below the basal plane under study.
