## 65 **2. Study area**

## 95 **2.2 Debris flow cases**

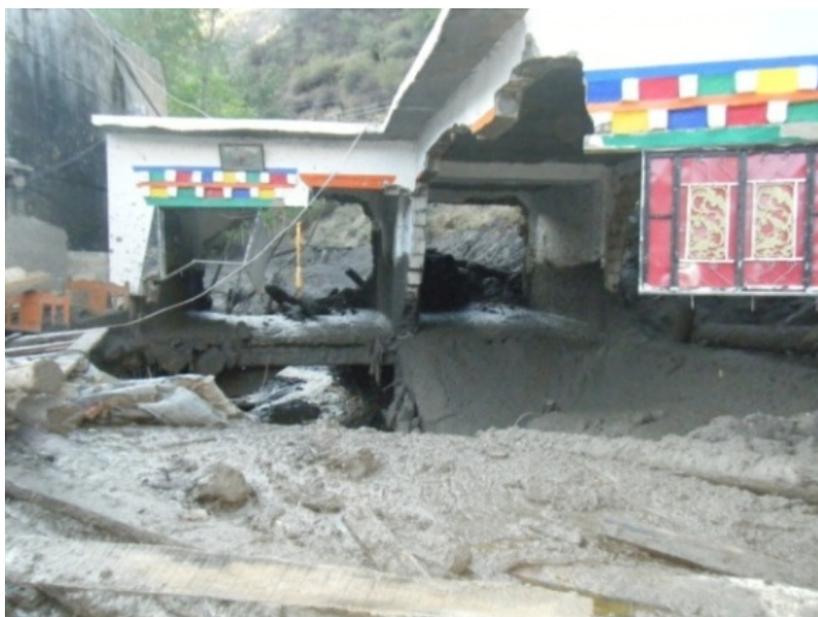
Figure 3. Houses destroyed by debris flows in the downstream

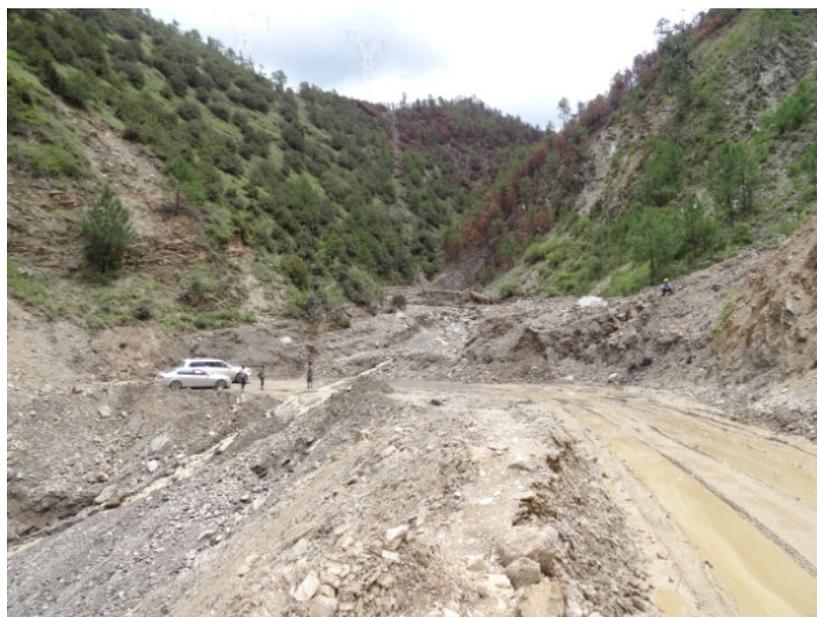
Figure 4. Road buried by debris flows from branch No. 3

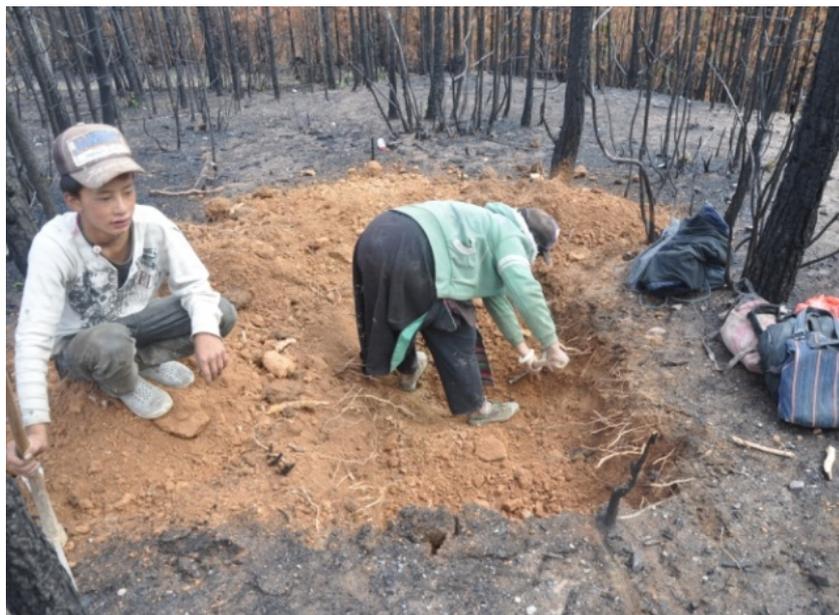
Figure 6. Trough test in the fire-affected area

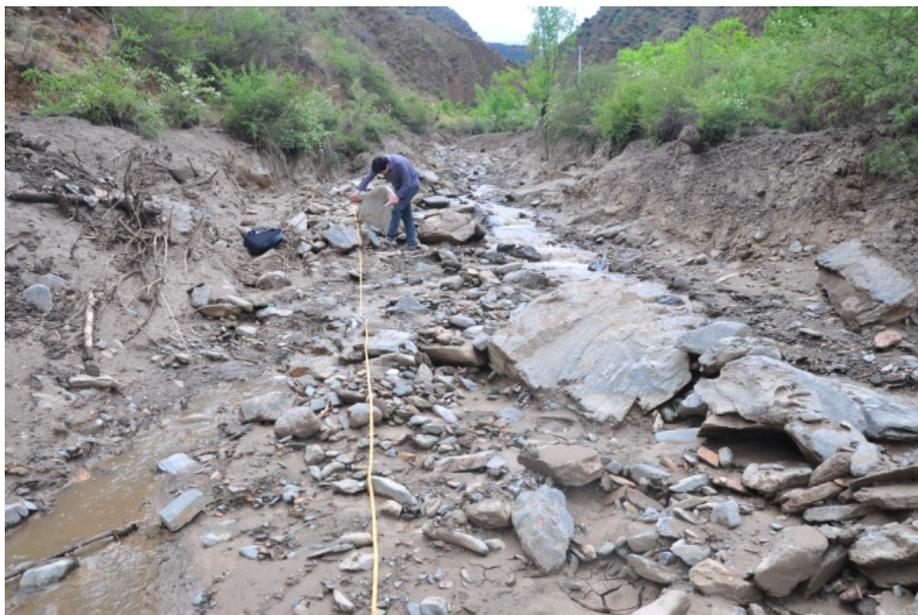
Figure 7. Particle size measurement of debris flow deposits (DF1)

184 In the deposit zone, we measured particle size and lithology. We placed a ruler of 50 m on the  
185 surface of the deposits randomly. We measured particle size and recorded the lithology of the stones at  
186 a 1-m interval along the ruler (Fig. 7). For particles larger than 60 mm, the diameter and lithology were  
187 recorded, otherwise, only the lithology was recorded. Deposits smaller than 60 mm were collected to  
188 complete particle size distribution tests in the laboratory.

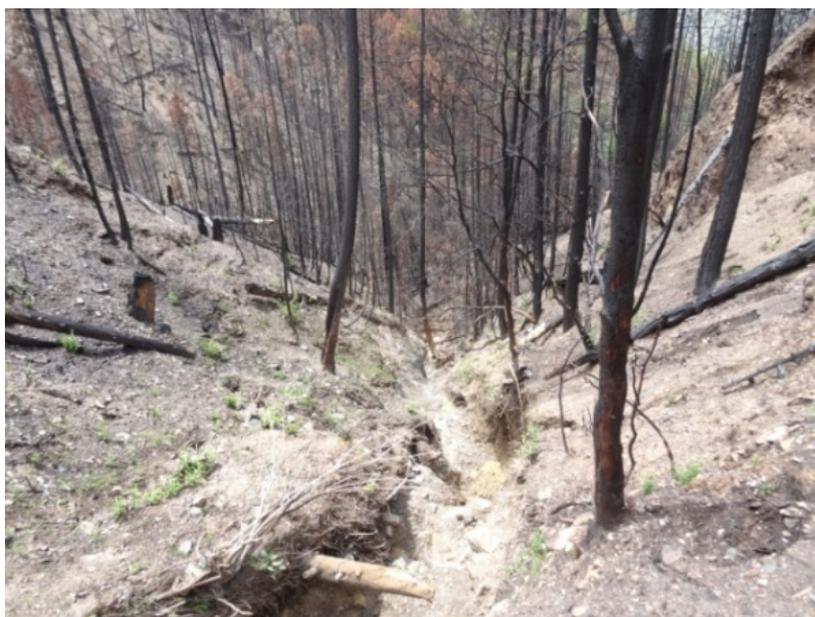
Figure 9. Upstream of branch No. 3 after DF1 (no debris flow remnants)

229 The channel is only 0.5~0.8 m wide and 0.4~0.6 m deep on a steep slope with exposed stones and no  
230 debris flow deposits (Fig. 9). Items above the channel fell parallel to the channel, suggesting that the  
231 debris flows submerged the entire channel and that the discharge was still smaller than 1 m<sup>3</sup>/s. Erosion  
232 caused by the debris flows is limited by the small discharge, and the transported soil particles were  
233 limited in the smaller debris flows. In the middle stream and downstream areas of branch No. 3, the  
234 channel gradient decreases, while the slope of both sides increases to 35~45°, forming a narrow  
235 V-shaped gully. The moving debris flows entrained the bed sediment and scored the base of the banks,  
236 leading to bank failure on both sides. The intensive scars of landslides with no vegetation can be found  
237 on both sides along the channel. These shallow landslides were meter-scale, with a volume ranging

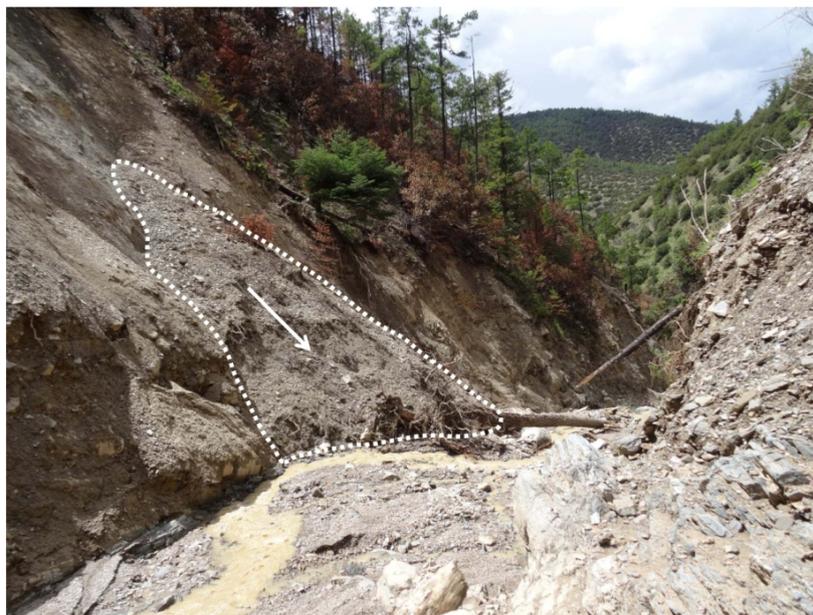
Figure 10. Middle stream of branch No. 3 after DF1

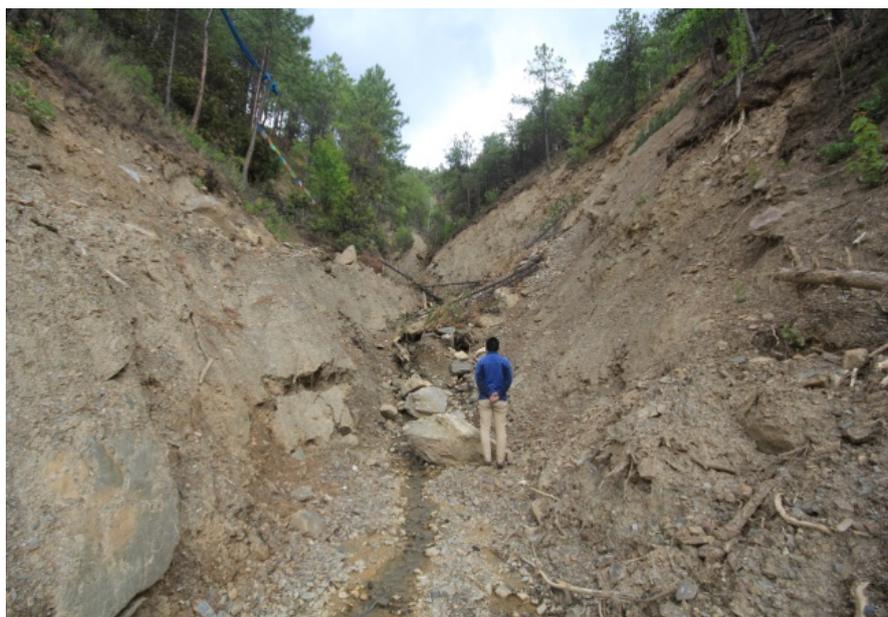
Figure 11. Branch No. 2 after DF4

245 The debris flow initiated in branch No. 2 (Fig. 11) is similar to that initiated in branch No. 3, while  
246 that initiated in branch No. 1 (Fig. 12) is slightly different. Shrubs, herbs and the lower parts of the  
247 trees were partly consumed by the wildfire. In the second summer after the wildfire, the trees were  
248 again covered by green crowns. Branch No. 1 can be divided into three parts according to the channel  
249 gradient, with the steepest gradient (32°) in the middle part, where the debris flow was initiated, and a  
250 gentle gradient in the source area. Two smaller gullies converge at the debris flow initiation zone,  
251 forming a platform between them. During the storm, the surface water runoff in the source area  
252 entrained sediment and formed a debris flood. Following the debris flow initiation zone, which is quite  
253 steep, the debris flood from the two gullies had a higher erosion ability; it scored both sides of the

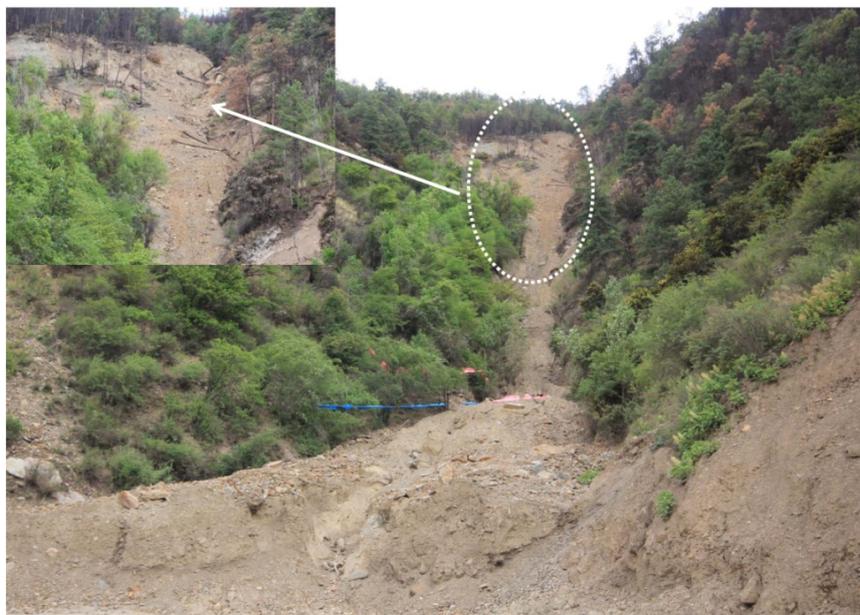
Figure 12. Branch No. 1 after DF4

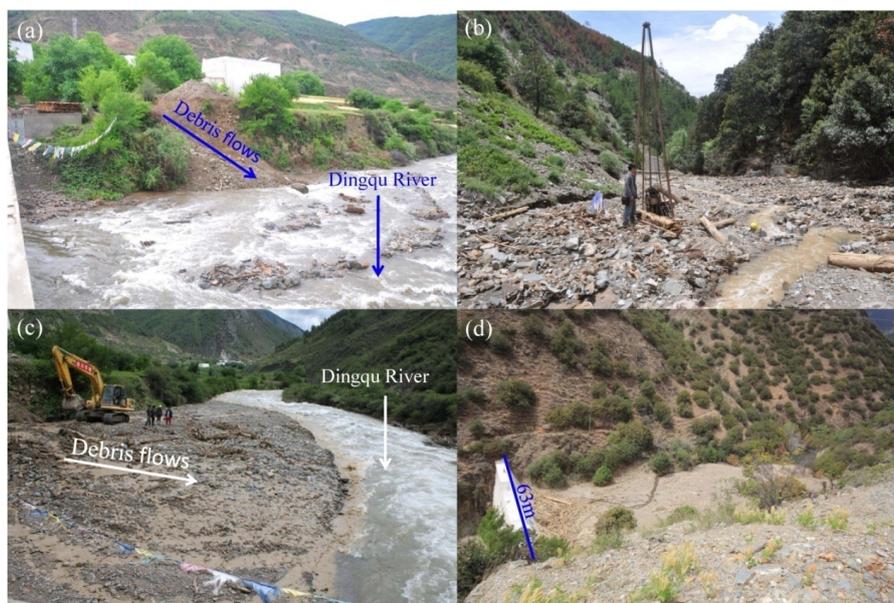
611 Figure 13. Debris flow deposits of (a) DF1 in the Dingqu River, (b) DF2 slightly striking the borehole

612 instrument, (c) DF3 partly blocking the Dingqu River, and d) DF4 intercepted by check dam 2

271 dam No. 1 (with a height of 4 m) and only the upper 6 m of check dam No. 2 was above the deposits  
272 (Fig. 13d), leaving the lower 12 m buried by the deposits.

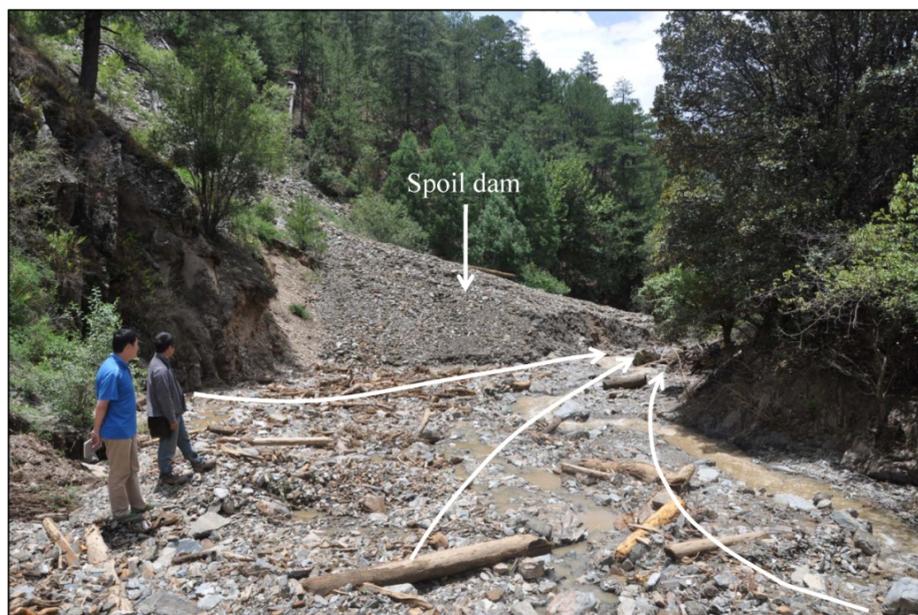
Figure 14. The main channel narrowed by spoil and spoil-induced debris flows

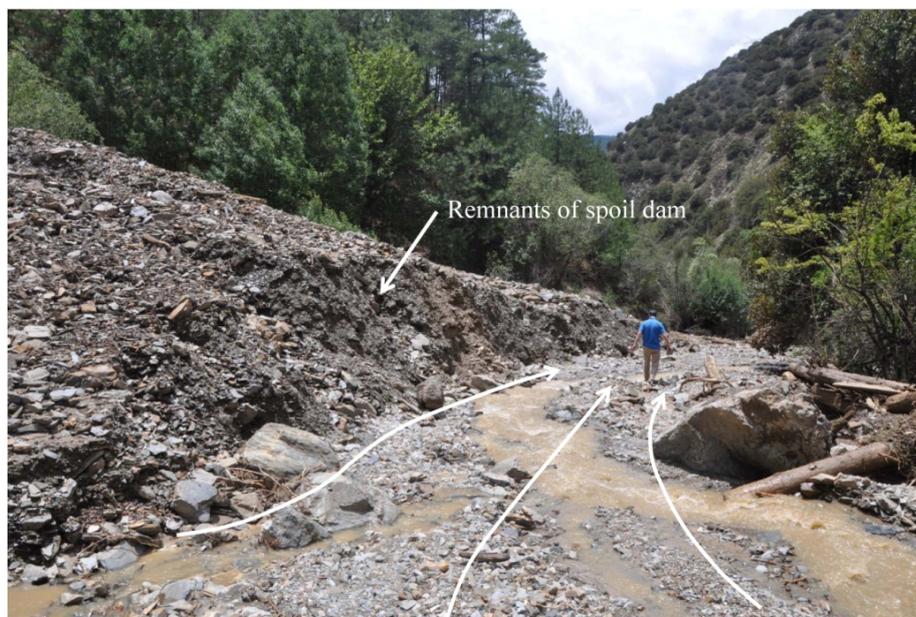
404 flows, and remnants of the deposited spoils can be found in a steep section 2~4 m high(Fig. 15). From  
405 the outlet of branch No. 3, there were more than 10 narrowed channel sections; one would induce a  
406 significant entrainment process that could amplify debris flows.
