Usability of aerial video footage for 3D-scene reconstruction and structural damage assessment

Johnny Cusicanqui, Norman Kerle, and Francesco Nex

Faculty of Geo-Information Science and Earth Observation (ITC), University of Twente, Enschede, the Netherlands

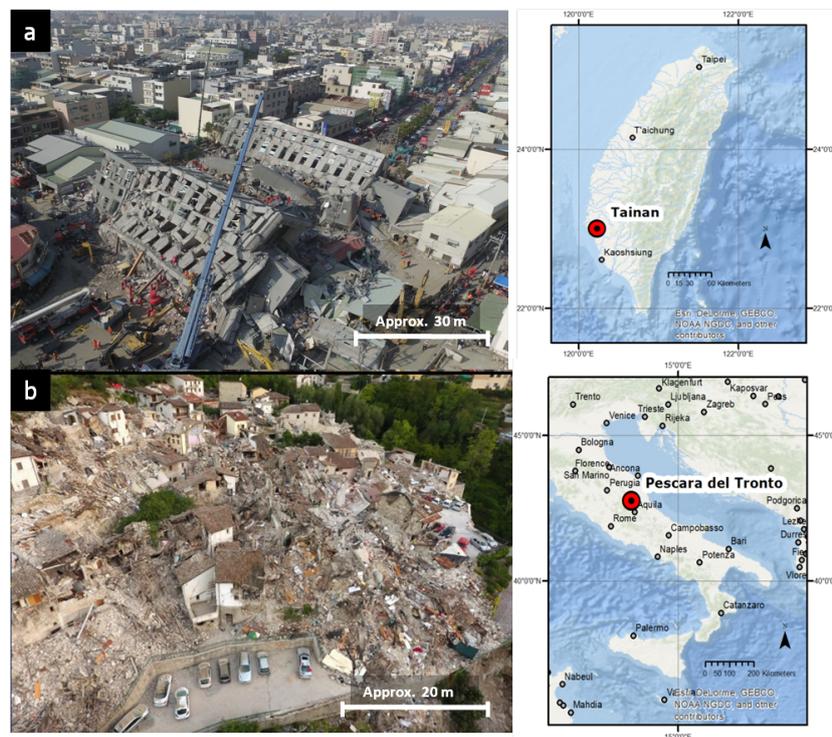
Figure 1. Study cases. (a) Taiwan earthquake February, 2016: Flat terrain, smoke presence and highly localized damage (Weiguan Jinglong collapsed building in the middle) (b) Pescara del Tronto earthquake August, 2016: Hilly terrain and more diverse, widespread damage.

Two earthquake-affected urban areas were selected for this research due to their contrasting characteristics, Tainan (Taiwan)
25 and Pescara del Tronto (Italy; Figure 1). Both cities were affected by earthquakes of similar magnitude; 6.4 and 6.2 in February and August 2016 respectively. Tainan is a large city with regular topography where most buildings are composed of reinforced-concrete. Conversely, Pescara de Tronto is a rural city settled on one hillside of the Tronto Valley, hence topography there is hilly and houses are mainly made of stone. These disparate characteristics give each case study different damage features: while in Tainan damage was largely confined to a single collapsed high-rise building, in Pescara del Tronto it was extensive and
30 highly variable (i.e., also intermediate damage levels can be found). The aim of selecting these contrasting cases is to obtain a broader understanding of video data usability in SDA.

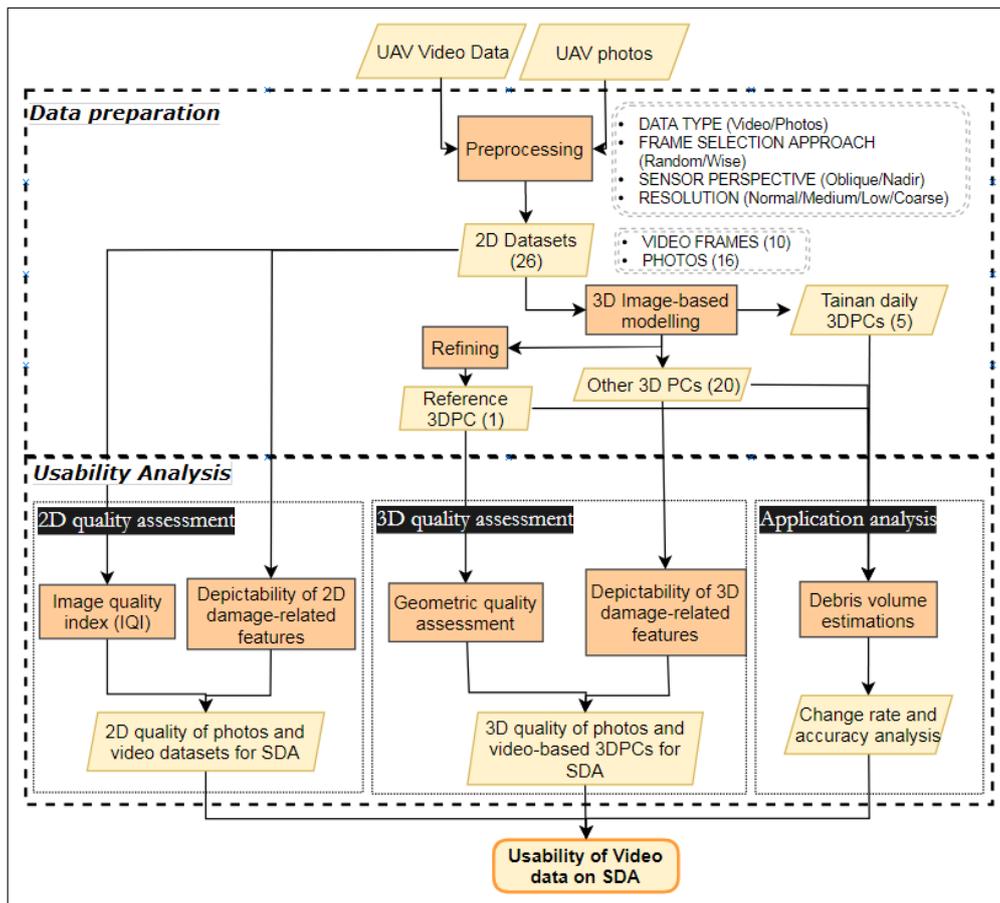
Figure 2. Workflow to determine usability of video data in 2D and 3D-based SDA. Dashed rectangles: Main phases.

Once all the datasets and 3DPCs were prepared, as described in Subsection 2.2, their usability was analyzed in three sections:

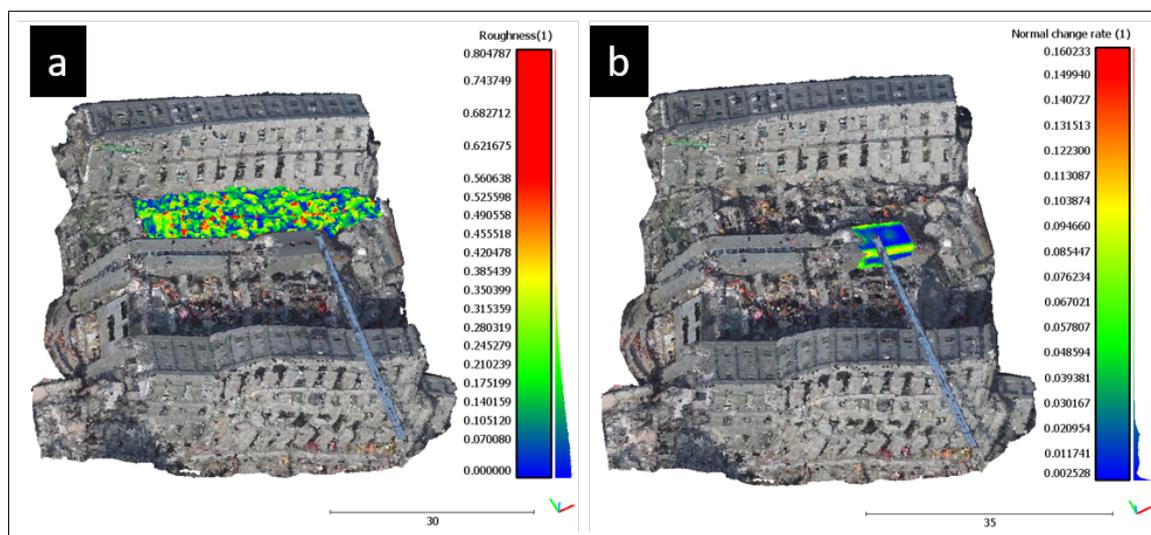
Figure 3. Segments selected for the depictability of damage-related features analysis. (a) Damage segment (Roughness values) (b) Non-Damage segment (Normal Change Rate values)

This assessment was based on previous investigations on the use of 3DPCs for SDA. Visual inspection was applied to 3DPCs for the identification of severe-damaged buildings in Fernandez Galarreta et al. (2015). In a similar manner, here different damage-related features were identified using a mesh model generated from the studied 3DPCs. Thus, the feasibility on this visual identification was compared and interpreted. As complement, a more elaborated approach using 3D damage-related features based on Vetrivel et al. (2017) was applied. This consisted of a segment-level representation of different 3D features. Three 3D features were used: Mean Curvature, Normal Change Rate and Roughness. These point-level features were estimated using a kernel (neighborhood size) of 1 m for all 3DPCs. A damaged area in Tainan was delineated to retrieve the segment-level distributions of these 3D features for every 3DPC, including the reference 3DPC (Table 2: Dataset 2). Through the use of box-plots, the segment-level distributions derived from every photo and video-based 3DPC were compared to the ones retrieved from the reference model to determine their depictability of 3D damage-related features. Additionally, non-damage segment distributions were retrieved from the reference 3DPC to confirm the relation of the chosen 3D features with damage (Figure 3).

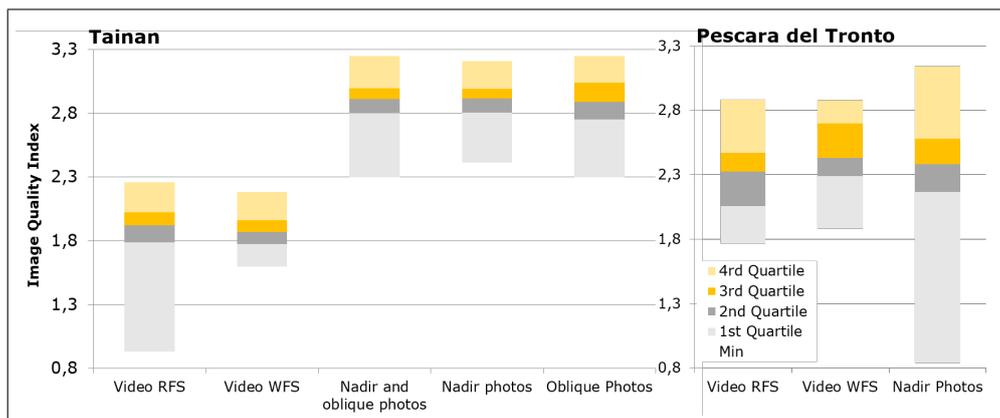
Figure 4. Boxplot of the Image Quality Index (IQI) computed for Tainan and Pescara del Tronto datasets.

Lower IQI values for video datasets were observed in the Tainan case, compared to all photo datasets (Figure 4). The WFS dataset have greatly reduced variance and in the case of Pescara del Tronto raised IQI values. Of the oblique and nadir photos, the nadir dataset showed less variance but similar IQI values in the case of Tainan. In Pescara del Tronto the nadir dataset contained substantial variance. A direct relation between IQI values with resolution was observed also when analyzing resolution-
10 degraded datasets, the better the resolution the higher IQI values.

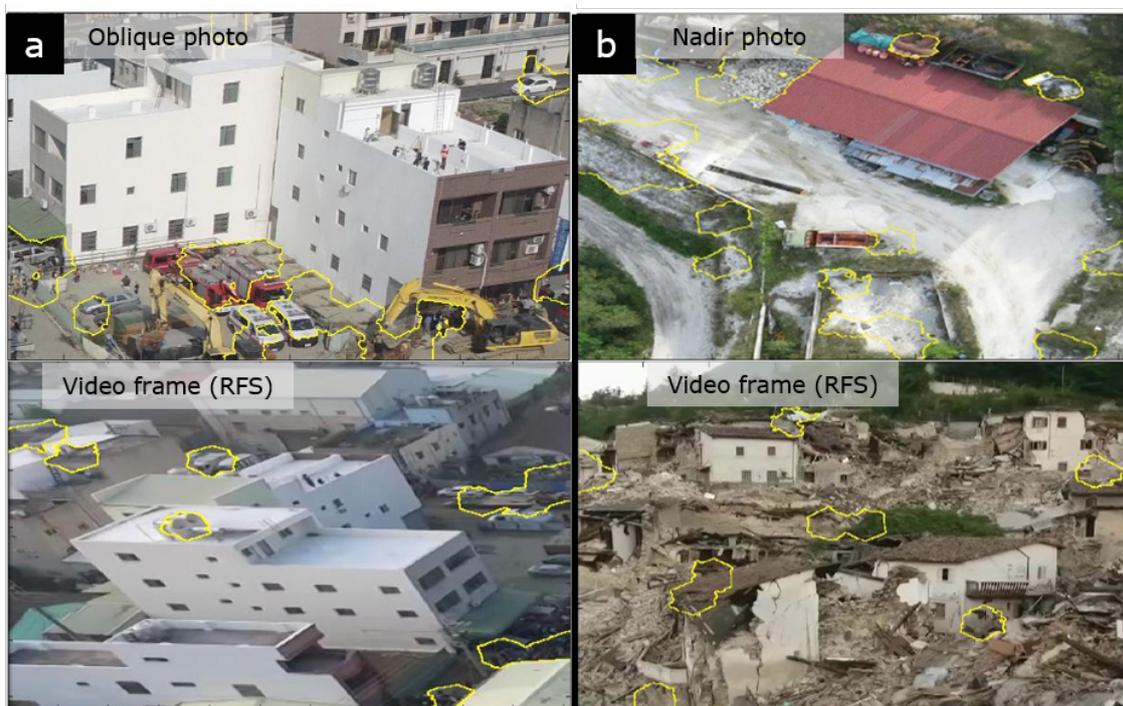
Figure 5. Extraction of 2D damage-related features using different datasets. Polygons: False positives in the extraction of 2D damage-related features for (a) Tainan oblique photo and video frame (Random Frame Selection RFS) and (b) Pescara del Tronto nadir photo and video frame (RFS).

Similar extraction and classification accuracies were obtained for both data types (Table 3). Between the two study areas, higher accuracies of 84 and 82% were achieved for the Pescara del Tronto video and photo datasets, respectively. For Tainan they were of 77 and 78%. Errors were mainly associated with false positives (i.e. misclassified and extracted damage features),
15 caused by texture-rich super-pixels with the presence of cars or people in Tainan, and low texture super-pixels, such as bare ground, in the case of Pescara del Tronto (Figure 5).

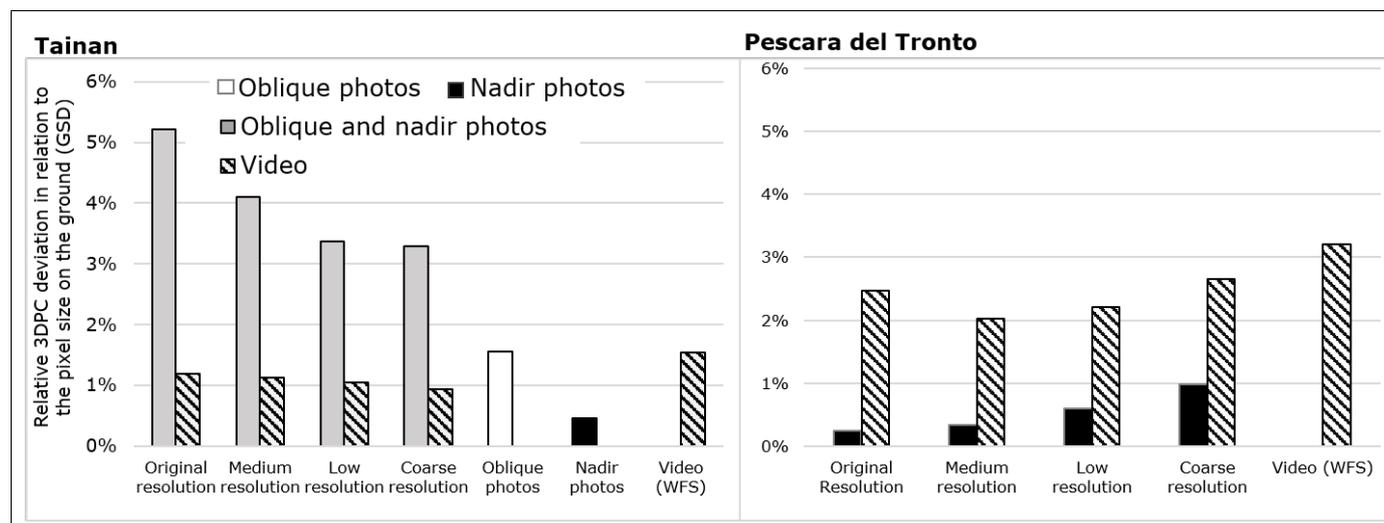
Figure 6. Planar fitting analysis of Tainan and Pescara del Tronto 3D Point Clouds as part of the internal 3D quality assessment. Comparison of the mean distance of 3D points to the theoretical planar object. Larger distance implies lower 3D point cloud precision.

from the chosen planar object, and thus low precision, were computed in the case of Tainan for the 3DPCs generated with the combined oblique and nadir photos (Figure 6). The software used was not able to merge oblique and nadir photos resulting in a highly displaced 3DPC. Improved precision was obtained when using individually the oblique or nadir photo datasets; however in the Tainan case, RFS video-based 3DPC is still more precise, or at least presents less relative 3DPC deviation than the oblique photo-based 3DPC. The 3DPCs generated with nadir photos presented the lowest deviation and were the most precise in both study cases. The 3DPC generated with the WFS video dataset presented more deviation than the one generated with the RFS

video dataset in both study cases. Contrasting effects of resolution were found between the study cases. It was observed that resolution degradation can improve precision by reducing 3DPC noise in the Tainan case, while the opposite effect occurred in Pescara del Tronto from medium resolution downwards. Besides, the completeness analysis demonstrated that the 3DPCs generated with oblique photos were denser than the video-based 3DPCs in the Tainan case. The RFS video-based 3DPC in turn was denser than the one generated from nadir photos in both study cases. However, considering the percentage of empty cell, the RFS video-based 3DPCs percentages are low, and outperform percentages of oblique and nadir-based 3DPC in the vertical and horizontal perspective, respectively (Figure 7 and Table 4). The WFS video dataset produced low-density 3DPCs with a large percentages of empty cell in both study cases and perspectives.

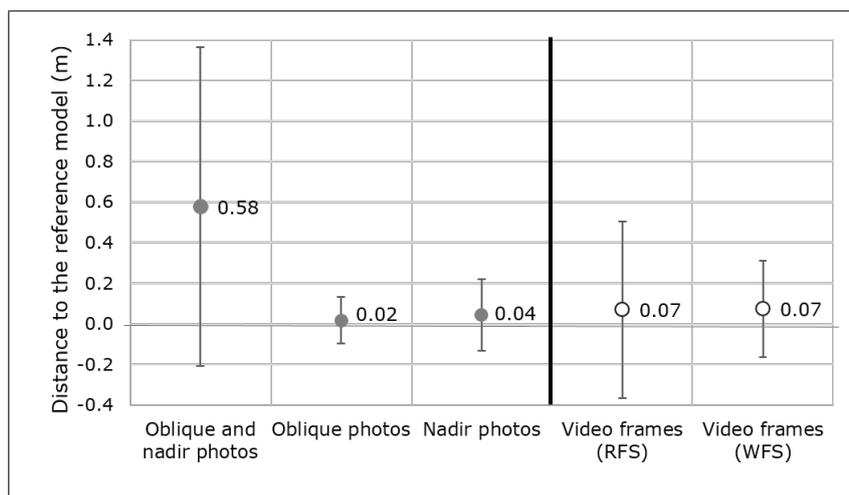
Figure 8. External accuracy assessment of video and photo-based 3DPCs of Tainan. Comparison of the mean distance of 3D points between the analyzed generated and reference 3D Point Clouds.

Concerning external accuracy, the combined oblique and nadir photos-based 3DPC also resulted highly inaccurate. Independent oblique and nadir photos-based 3DPCs registered higher accuracies of 2 and 4 cm respectively (Figure 8). Video-based 3DPCs, with an accuracy of 7 cm, resulted less accurate than individual oblique or nadir photos-based 3DPCs. It was observed that the WFS video-based 3DPCs removed some noise in 3DPCs (i.e. less variability), but its accuracy was still the same of RFS video-based 3DPCs.

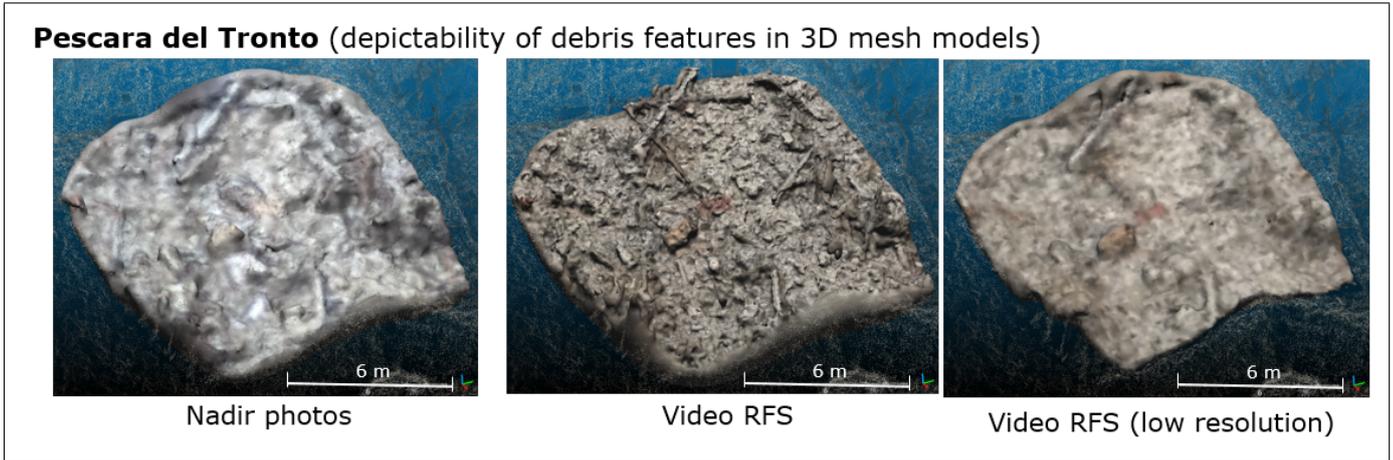
Figure 9. Comparison of the depictability of debris features in photo and video-based mesh models of Pescara del Tronto. Lower depictability in nadir photos-based mesh due to their high GSD and the presence of motion-blur effects.

In the case of Pescara del Tronto building deformations, cracks and debris features could be readily identified by visual inspection in video-based mesh models. These models outperformed representations of nadir photos-based 3DPC and even better representations were obtained using degraded-resolution video frames (Figure 9). In the Tainan case, cracks and spalling features were better represented in the oblique photos-based models than in the video-based ones; however, their identification was still difficult specially compared to the reference mesh. Other damage characteristics, such as inclined walls and spalling were only extractable from the reference model.

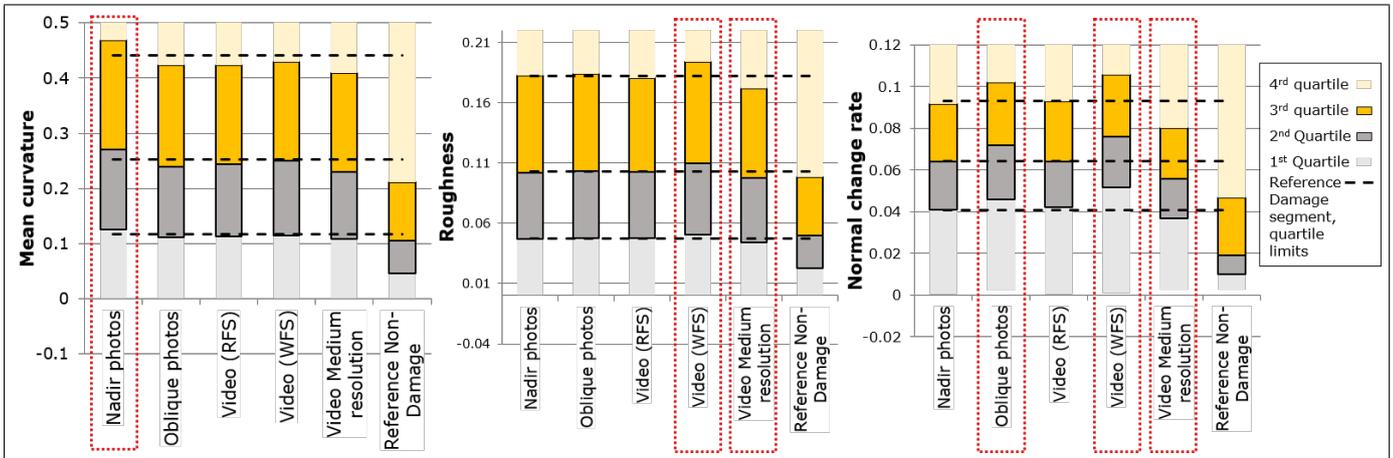
Figure 10. Tainan segment-level distributions of 3D damage-related features. Doted rectangles highlight discordant distributions from the reference damage segment and thus low depictability of 3D damage-related features.

The analysis of the distribution of 3D damage-related features showed more deviating distributions, therefore less depictability in photo-based 3DPCs (Figure 10). RFS video-based 3DPCs distributions were consistently aligned with the distributions extracted from the reference 3DPC for all 3D features analyzed. The distributions of the other 3DPCs showed deviations in at least one feature. The relation of these features with damage characteristics was confirmed by the inclusion and analysis of a non-damaged segment extracted from the reference 3DPC, which clearly presented deviations in all 3D features.

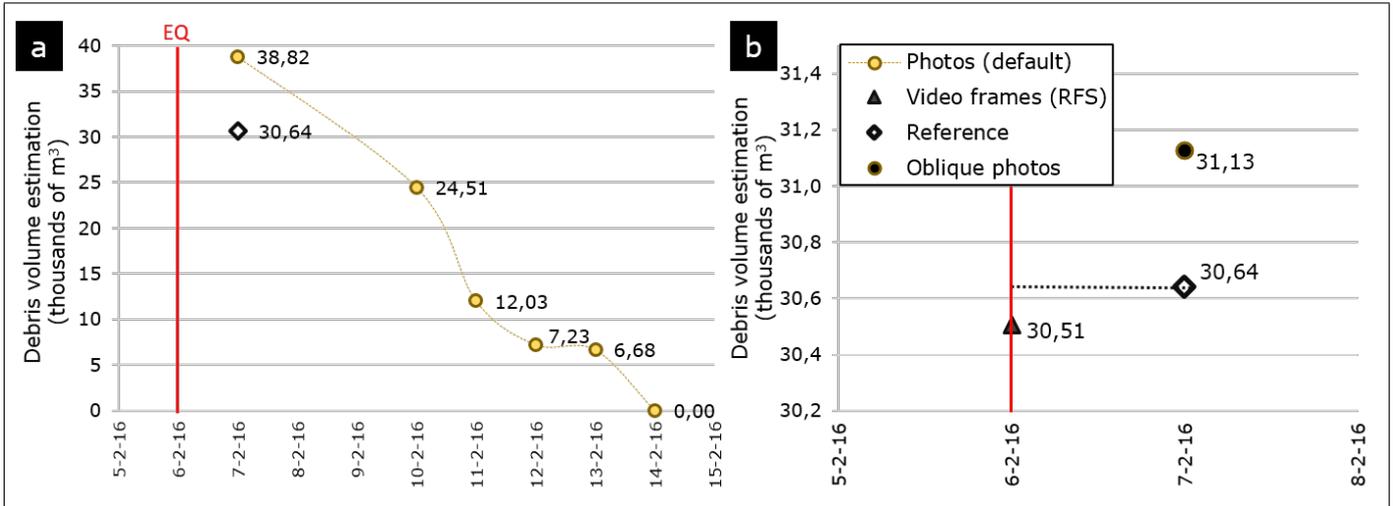
Figure 11. (a) Debris volume change analysis using the Tainan multi-temporal photo-based 3DPC and reference model. (b) Volume estimations for video-based 3DPC (Random Frame selection), oblique photos-based 3DPC and reference model. Red line: Earthquake (EQ) date.

Debris volume change was analyzed for Tainan using multi-temporal photo-based 3DPCs, and as expected a negative trend was observed in accordance with the cleanup operations (Figure 11). However, the comparison with the estimation made with the reference 3DPC for the first date (7 February, 2016), revealed a large overestimations in these series. Debris volume estimation made with the 3DCP generated from the default dataset (i.e. the combined oblique and nadir photos) was of around 8000 m³ more than the estimation done with the reference 3DPC. This is linked to the displacement effects observed in the 3D external accuracy assessment. In contrast, volume estimations made with the oblique photo-based 3DPCs and video RFS dataset for the

same date presented more accurate results. The estimation with the oblique-based 3DPC was only 486 m³ above the reference (1.6% of error); while, the most accurate estimation was obtained with the RFS video-based 3DPC, with an error of only 136 m³ (0.4%).

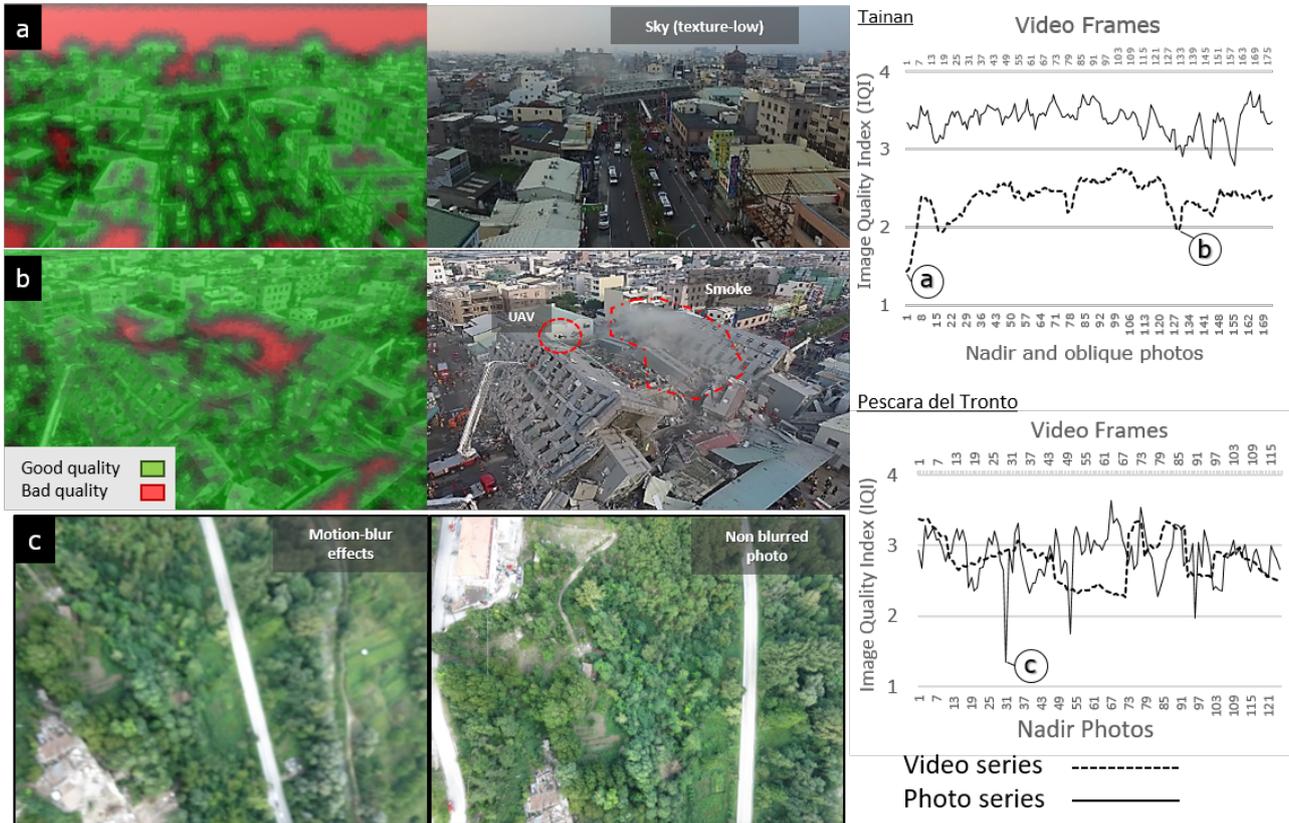
Figure 12. Image Quality Index (IQI) series for Pescara del Tronto and Tainan. (a) The sky as a low-texture area is considered a likely source of 3D modelling error in IQI maps (red area). (b) Also smoke and moving objects (UAV). (c) In Pescara del Tronto motion-blur effects result in IQI values.

- In the 2D quality analysis lower IQI values for the video datasets were obtained in comparison to photos in the case of Tainan, while they were similar in the case of Pescara del Tronto. Low video IQI values were caused by low resolution and smoke

presence in Tainan video frames, whereas in the case of Pescara del Tronto these were comparable since at-nadir photos were affected by a large GSD and the presence of motion-blur effects, generated during the acquisition of nadir photos by the high altitude and low shutter speed, respectively (see Subsection 2.1). The WFS dataset improved IQI values and reduced variance in comparison of RFS video dataset, since WFS approach filtered frames affected by external factors (e.g. texture-low zones, smoke presence and moving objects), clearly indicated by low IQI values in IQI series (Figure 12). Despite direct video 2D quality was lower than the one of photos, similar accuracies were obtained from the depictability of 2D damage-related analysis. In this analysis, also external factors were responsible for false positive errors and low accuracy in the classification of 2D damage-related features, rather than the video data quality characteristics. Moreover, the analyzed video frames were chosen from the RFS dataset; therefore, higher accuracies could be obtained using frames from the WFS dataset. Low resolution was the only video characteristic that affected 2D quality, other data-related quality artifacts, such motion-blur effects were instead identified in nadir photos. Therefore, sufficient 2D quality and accurate depictability of damage-related features of video data, demonstrated that they can perform 2D-based SDA as accurate as photos.

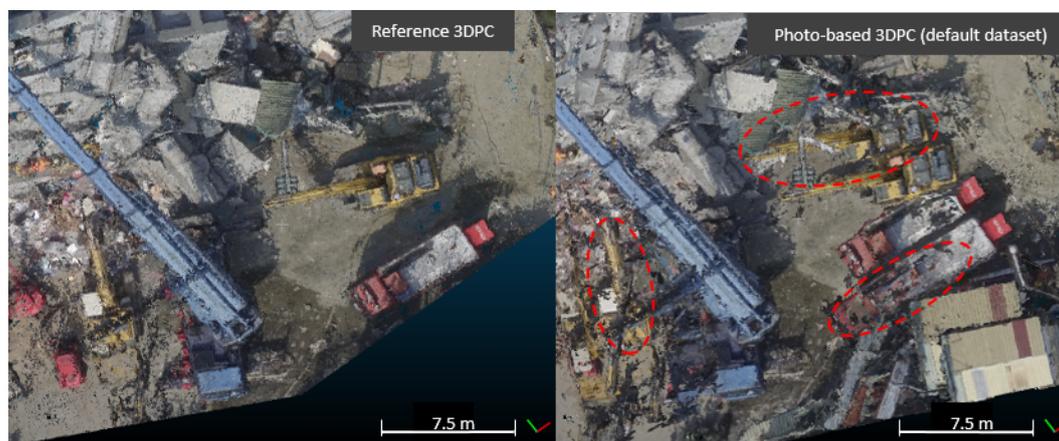
Figure 13. Displacement effect in 3DPC generated with the default photo dataset (combined nadir and oblique photos), due to a misregistration or differences in spectral and spatial characteristics between oblique and nadir datasets. Red dashed circles: noise in 3DPCs.

Concerning the 3D quality assessment, comparable qualities were obtained for video and photo-based 3DPCs. Photo-based 3DPCs of Tainan generated with the combined oblique and nadir dataset and its degraded-resolution datasets ((Table 2: Datasets 1 to 5), produced largely displaced 3DPCs that presented the lowest quality (Figure 13). A main possible cause is the large difference in the spatial and spectral characteristics of the combined datasets which affected the Automatic Tie Point selection during the initial 3D modeling step. A less probable cause is a mis-registration error due to the lack of GCPs for orienting oblique photos and their low z-variability (see Subsection 2.2 and 2.1). A solution would be a refinement procedure; however, this implies a time-demanding operation that hinders photo data usability. In contrast, 3DPCs generated independently from
