# Application of UAV-SfM photogrammetry and aerial LiDAR to a disastrous flood: repeated topographic measurement of a newly formed crevasse splay of the Kinu River, central Japan

**Abstract.** Geomorphic impacts of a disastrous crevasse splay that formed in September 2015 and its post-formation modifications were quantitatively documented by using repeated, high-definition digital surface models (DSMs) of an inhabited and cultivated floodplain of the Kinu River, central Japan. The DSMs were based on pre-flood (resolution: 2 m) and post-flood (resolution: 1 m) aerial light detection and ranging (LiDAR) data from January 2007 and September 2015, respectively, and on structure-from-motion (SfM) photogrammetry data (resolution: 3.84 cm) derived from aerial photos taken by an unmanned aerial vehicle (UAV) in December 2015. After elimination of systematic errors among the DSMs and down-sampling of the SfM-derived DSM, elevation changes on the order of  $10^{-1}$  m, including not only topography but also growth of vegetation, vanishing of flood waters, and restoration and repair works were detected. Comparison of the DSMs showed that the volume eroded by the flood was more than twice th

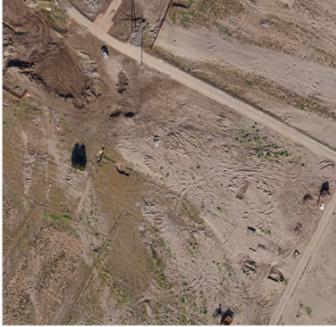
5 **Figure 5: Enlarged views of Fig. 3 images for comparison of the DSMs with different resolutions. (a) Original DSM for December 2015 (resolution: 3.84 cm). (b) Down-sampled DSM for December 2015 (resolution: 1 m). (c) Orthophoto taken in December 2015. (d) DSM for September 2015 (resolution: 1 m). Note that the trivial relief in (a) is largely removed in the down-sampled DSM in (b).**

15 For example, crops had grown or been cut in the agricultural lands, and sediments trapped in the canal had been removed, along with the obstacles within the crevasse channel. Numerous wheel tracks on the ground indicate that many vehicles were driven across the study area after the flood, even where marked modification of the topography was not observed. Most of these tracks are no longer visible in the down-sampled SfM-derived DSM (Fig. 5b).

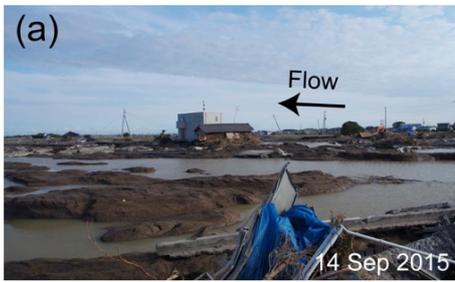
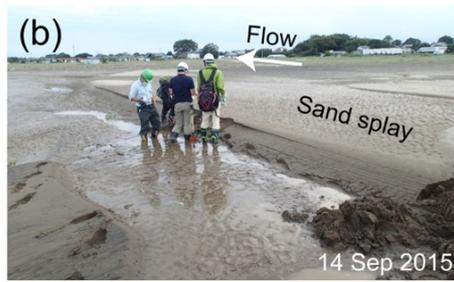
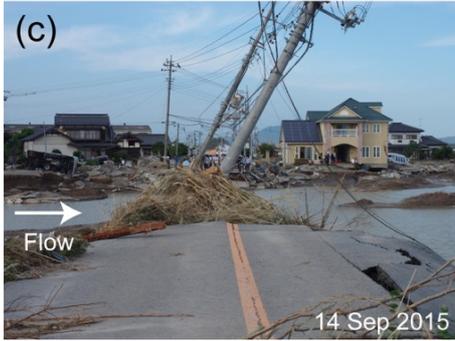
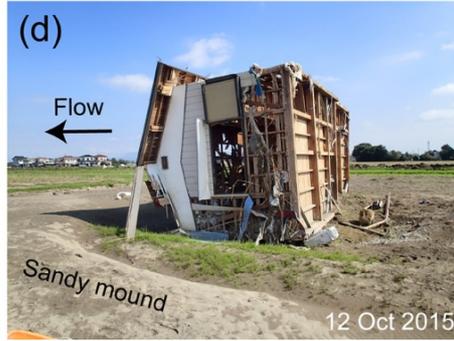
Figure 9: Photos of the study area. (a) Crevasse channel (breach scouring) near the levee. Note the building still standing after the flood in the center of the photo. (b) Sand splay in the southern part of the study area. (c) Damaged prefectural road beside the breached levee. (d) Overturned and transported house. Note the sandy mound in the downstream direction from the house. See

The levee breach caused changes to the topography up to 300–500 m away from the levee: sand splays were deposited, and a crevasse channel appeared; the channel was elongated eastward and then curved southward following the shallow valley, but it was obscure downstream (Figs. 9a, 9b). The crevasse channel was deep, distinguishable ditches in its most upstream part, and structures and other artificial features near the breached levee were damaged or destroyed (Fig. 9c).
