1 Effects of the 25 April 2015 Nepal earthquake in the Tibetan  
2 border region of China and increased post-seismic hazards

16 **Abstract:** The seismic effects in Nyalam, Gyirong, Tingri and Dinggye counties along  
17 the southern border of Tibet were investigated during 2-8 May, 2015, a week after the  
18 great Nepal earthquake along the Main Himalaya Thrust. The intensity was VIII in the  
19 region and reached IX at two towns on the Nepal border; resulting in the destruction of  
20 2,700 buildings, seriously damaging over 40,000 others, while killing 27 people and  
21 injuring 856 in this sparsely populated region. The main geologic effects in this steep  
22 rugged region are collapses, landslides, rockfalls, and ground fissures; many of which  
23 are reactivations of older land slips. These did great damage to the buildings, roads and  
24 bridges in the region. Most of the effects are along four incised valleys which are  
25 controlled by N-S trending rifts and contain rivers that pass through the Himalaya

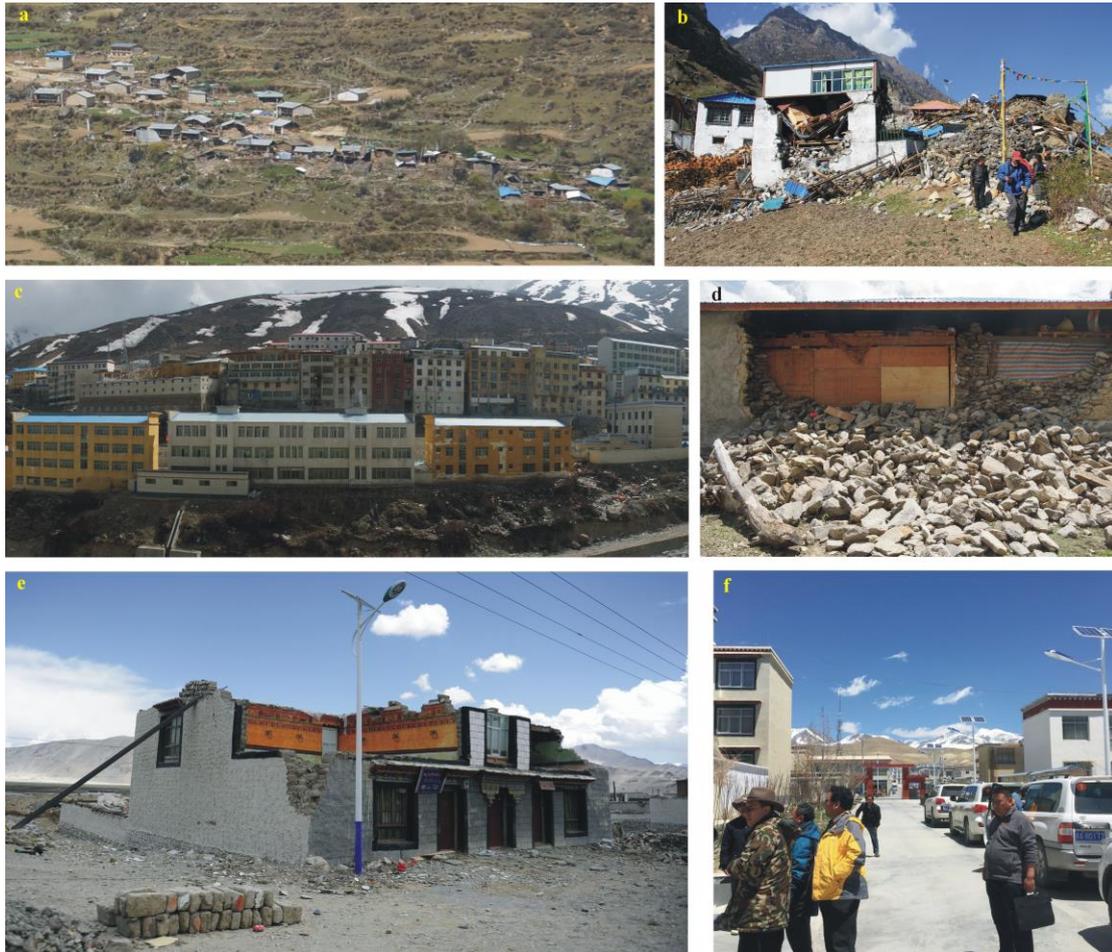
Fig. 3 The building damage resulting at different earthquake intensities: a, Many of the old stone pile or mud-brick houses collapsed, but the new brick houses rarely collapsed at Gangba Village in Sale Town in the intensity VIII zone; b, Similar building damage at Zhuobude Village of Rongxia Town in the intensity VIII zone; c, Most of buildings of brick-concrete structure did not collapse, but many walls showed obvious damage at Nyalam city located in the intensity VIII zone; d, Some walls of the stone-piled or mud-brick houses collapsed at Rema Village, Jilong County, in the intensity VII zone; e, Similar building damage at Chentang Town, Dinggyê county, in the intensity VII zone; f, Most of the houses remain intact and only few or individual walls of buildings had apparent small cracks at Jilong county city in the intensity VI zone.

227 The specific structural damage is usually related to the material and type of  
228 building construction in these areas where the heaviest destruction occurred near the  
229 Nepal border. In this region of few trees most of the houses are of simple stone and  
230 adobe construction and these fared poorly during the earthquake; with the majority  
231 being destroyed near Nepal (Figs. 3b, 3d, 3e, 4c). Houses with cement bonded stone or  
232 brick construction survived much better (Figs. 3a, 4d) and those of good brick or  
233 reinforced concrete construction suffered the least (Figs. 3c, 4f) and provided a contrast  
234 with those of poorer materials (Figs. 3a, 4e).

242 resistance, whereas for the newly built cement-bonded stone, brick or concrete  
243 structures it was no more than intensity VIII and the rating lies between (Figs. 3 and 4).  
244 For example, in Jifu Village about 2.4 km south of Jilong, all the houses built of stone  
245 block masonry were almost completely destroyed, whereas most newly built ones of  
246 cement-bonded stone or brick are still standing with only minor cracks in the walls (Fig.  
247 4c-d), and the same variation also is seen at the Sale Town Primary School (Fig. 4e).  
248 The inhabitants of this area had to be quickly moved to temporary settlements (Fig. 4b).  
249 Perhaps some poorer buildings weakened by the first earthquake were collapsed by the  
250 second one or the newer buildings had more seismic resistance than realized. Some  
251 undetected ground slippage at a few locations throughout the region also may have

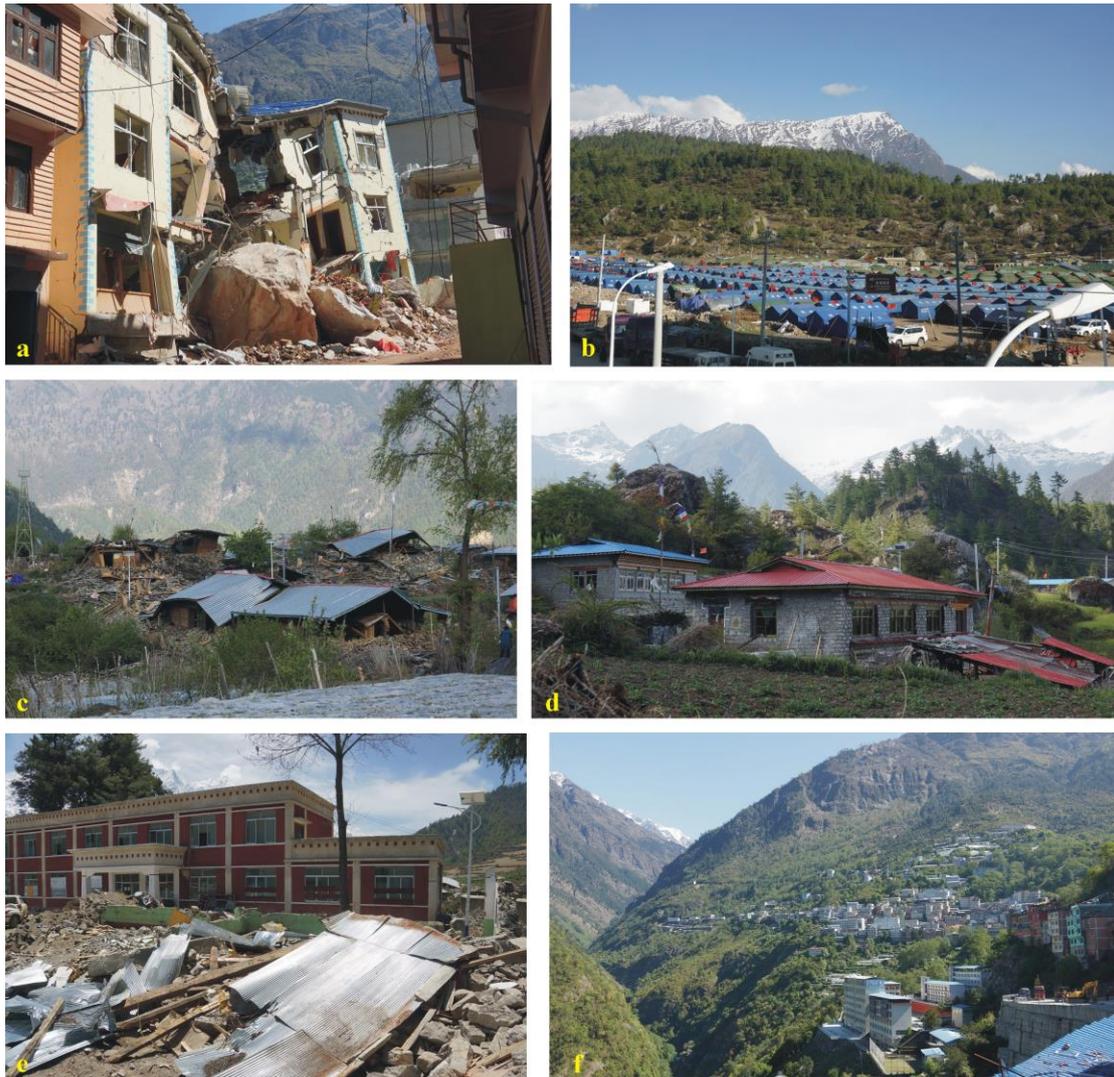
Fig. 4 Typical earthquake damage in southern Tibet and comparison of houses of different construction (locations shown in Fig. 5). Huge rockfall that smashed the resident committee office building at Disigang Village, about 0.7 km south of Zhangmu, where seven persons were killed (intensity IX) (site 1, Fig. 5a); b, A temporary settlement for earthquake survivors at Jilong; c, Destroyed houses of stone block masonry or adobe construction in Jifu Village southwest of Jilong (intensity VIII) (site 8, Fig. 5b); d, Houses of cement-bonded stone or brick construction in Jifu Village (intensity IX); e, Destroyed old houses and standing new buildings at Sale Town Primary School (intensity VIII) (site 7, Fig. 5b); f, Few collapsed houses at Zhangmu due to the brick structure or reinforced concrete construction (intensity IX).

352 All of Zhangmu is located on a group of old landslides (Figs. 4a, 7a and 7b).  
353 Discontinuous tension fissures, which are tens to hundreds of meters long, about 10 cm  
354 wide and 2 to 4 m deep, were found at its upper edge and on its sides after the  
355 earthquake (Figs. 8a and 8b). These fissures indicate the possibility of the failure of the  
356 entire landslide group.

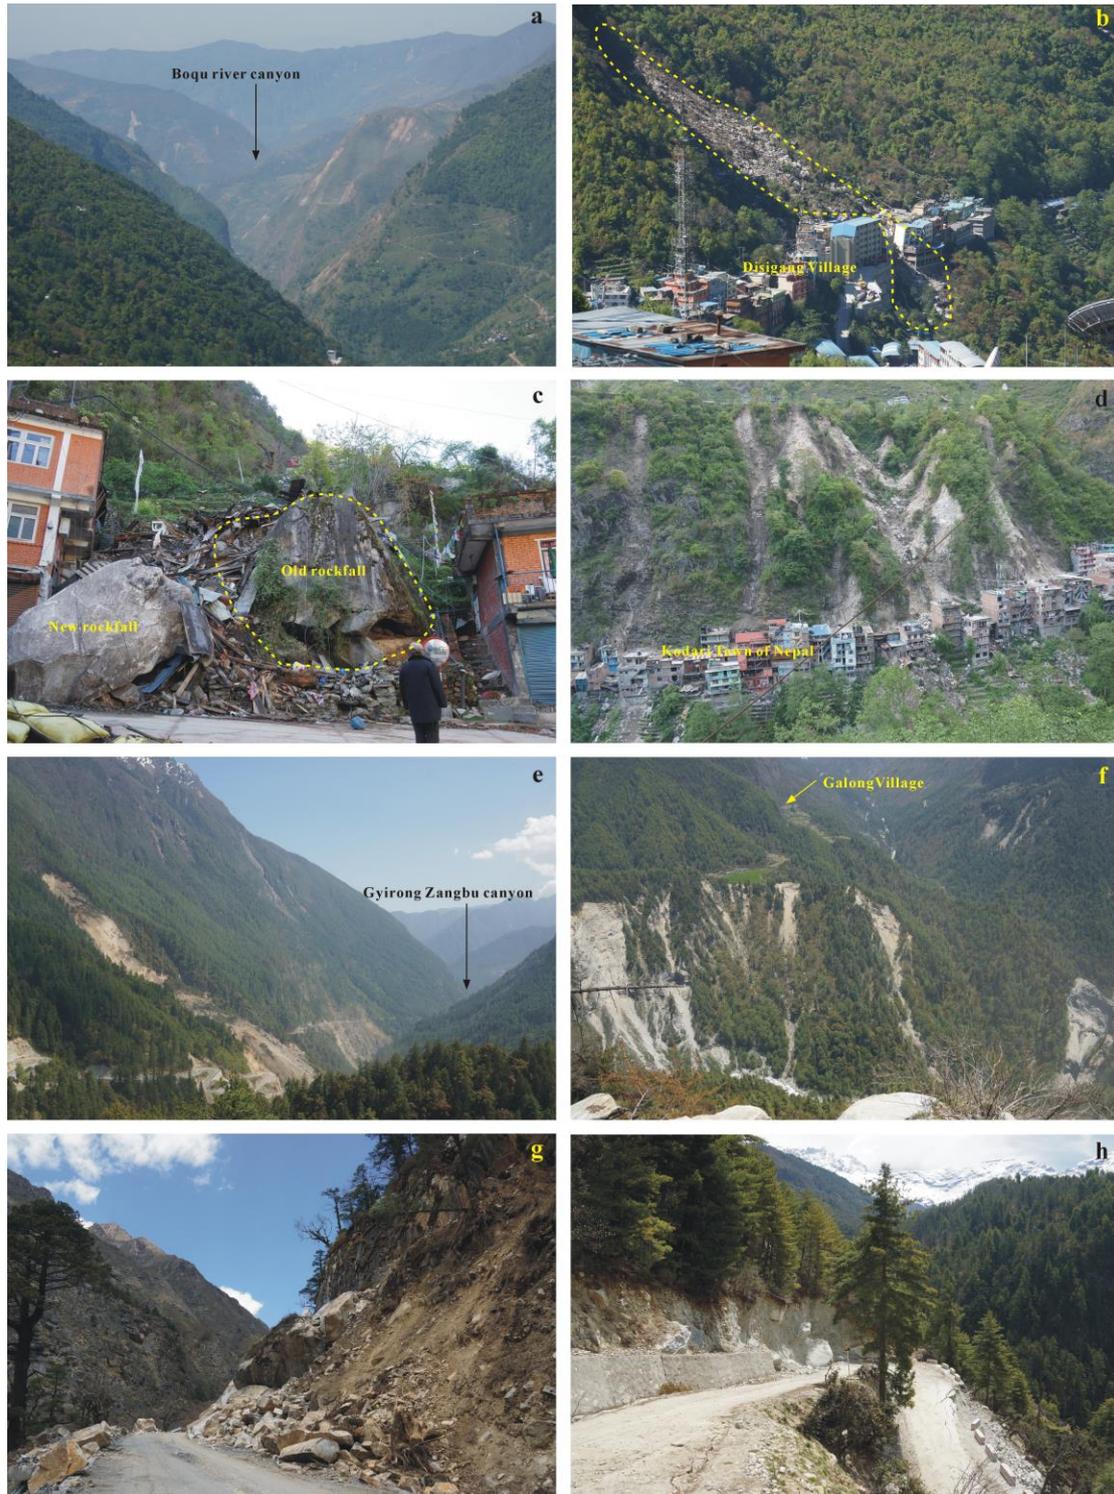
Fig. 6 Geologic effects caused during the Nepal earthquake: a, collapses in the Boqu valley; b, collapse at Disigang Village in the Boqu valley (Site1, Fig. 5a); c, new and old rockfalls at Disigang Village in the Boqu valley (Site1, Fig. 5a); d, destroyed buildings in Kodari, Nepal in the Boqu valley (Site in Fig. 4a); e, large landslide in Chongse Village in the Gyirong Zangbu valley (Site1, Fig. 5b); f, collapses in Galong Village in the Gyirong Zangbu valley (Site 7, Fig. 5b); g, collapses along highway from Gyirong County to Jilong Town in the Gyirong Zangbu

valley (Site 4, Fig. 5b); h, collapses and fissures along the highway from Jilong to ChongseVillage in the Gyirong Zangbo valley (Site1, Fig. 5b).

139 2,000-3,000 m, which is very favorable for various landslips during seismic events.  
140 Furthermore, there is an overall tendency for the number and size of collapses,  
141 landslides, and rockfalls to increase towards Nepal along these valleys.  
142 Remotely-sensed images issued by Google Earth after the earthquake show that the  
143 Gyirong Zangbo and the Buqu River valleys contain the maximum density and scale of  
144 collapses and landslides (Figs. 5a, 5b, and 6a-6h).

150 (3) Surface damages occur often in weak, soft geologic material and unstable  
151 geomorphic positions: joint or fault-formed, high, steep bedrock cliffs and slopes (Figs.  
152 6b and 6e); high, steep slopes of loose Quaternary sediment forming river terraces,  
153 proluvial fans, and benches (Figs. 6d and 6f) and; unstable slopes and highway road  
154 cuts (Figs. 6g and 6h). These landslides mostly occur on slopes steeper than 35-45  
155 degrees.
