Monitoring of the reconstruction process in a high mountainous area affected by a large earthquake and subsequent debris flows

Abstract

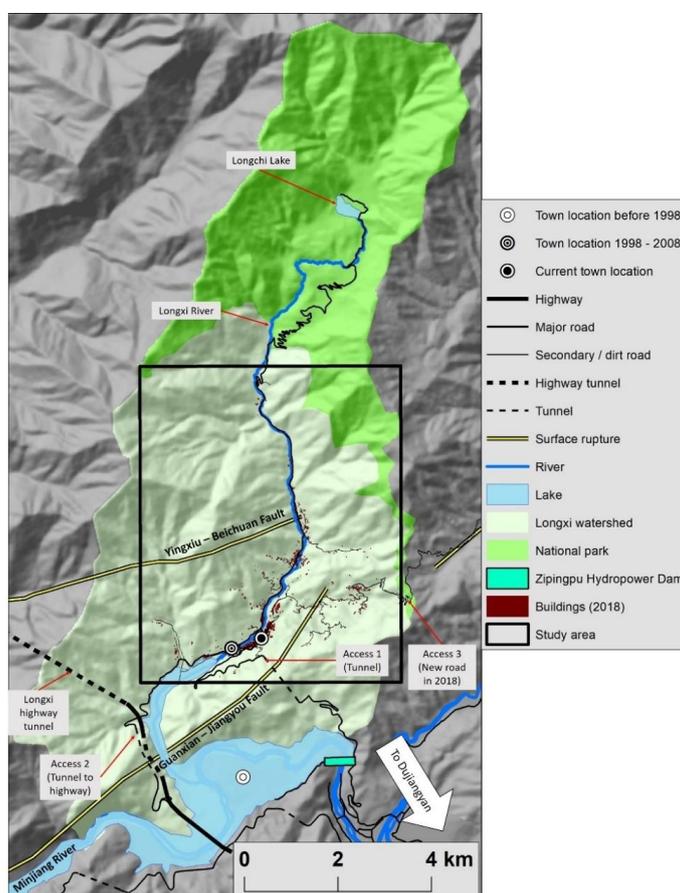
Figure 1: The location of the study area. The roads and buildings reflect the situation in 2018. Buildings outside the study area polygon were not mapped.

activities of the nearby Dujiangyan city, and the surrounding area, including the Longchi valley. In May 2009 the 7.3 km long Longxi tunnel (Figure 1) was completed for the Duwen Highway, which greatly helped disaster relief and reconstruction by reducing travel time greatly. A new tunnel was made to connect the Longxi watershed and the highway as an alternative access (Figure 1, access 2).
145 Most of the reconstruction was finished by 2010, when in the same year a storm triggered debris flows from most of the sub-catchments, severely damaging the newly constructed buildings.

economic interest caused by the closing of the national park. In 2018, a new road was made to connect the neighboring watershed (Figure 1, access 3). Till the beginning of 2019, there was no official announcement about the time to reopen the national park and repair the access to the highway.

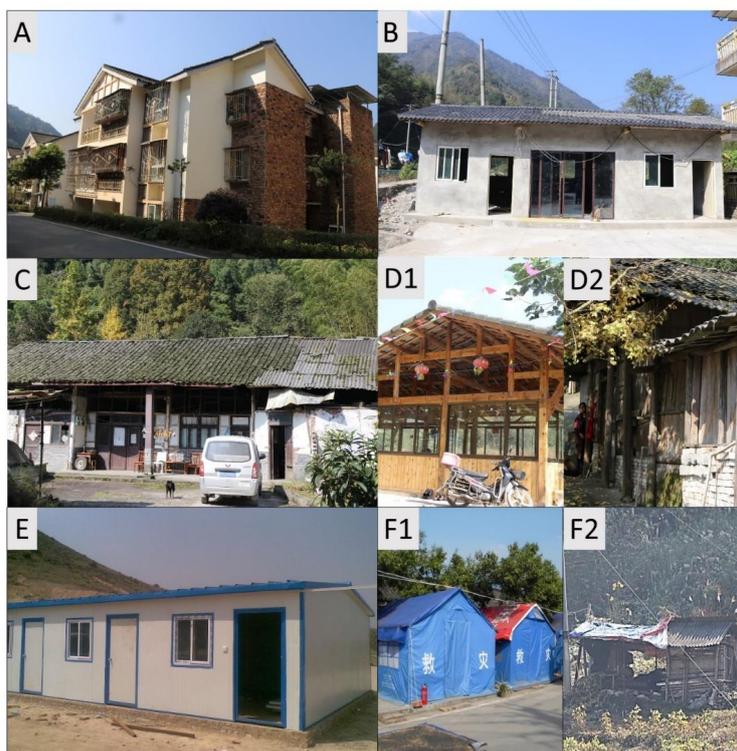
Figure 2: Examples of building construction types in the study area. **A:** RC frame (RCF) structure residences built by the reconstruction teams from Shanghai city. **B:** reinforced masonry (RCM) building of a hostel. **C:** wood and brick residence (WB). **D1:** wooden structure (W) serving as restaurant. **D2:** wooden residence with walls made by wooden plates and bricks. **E:** pre-fabricated metal (PFM) temporary houses. **F1:** tents distributed by the government. **F2:** a shack made from wood, asbestos tiles and waterproof cloth.

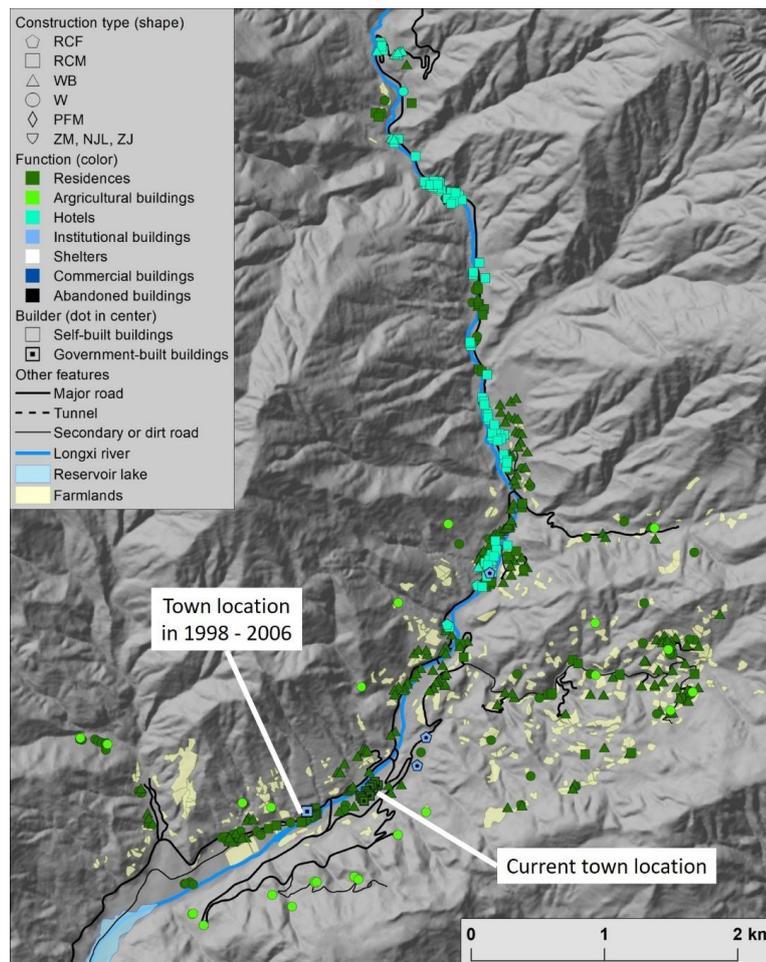
Figure 3: Map of the buildings, roads, land use and mitigation measures in 2007.

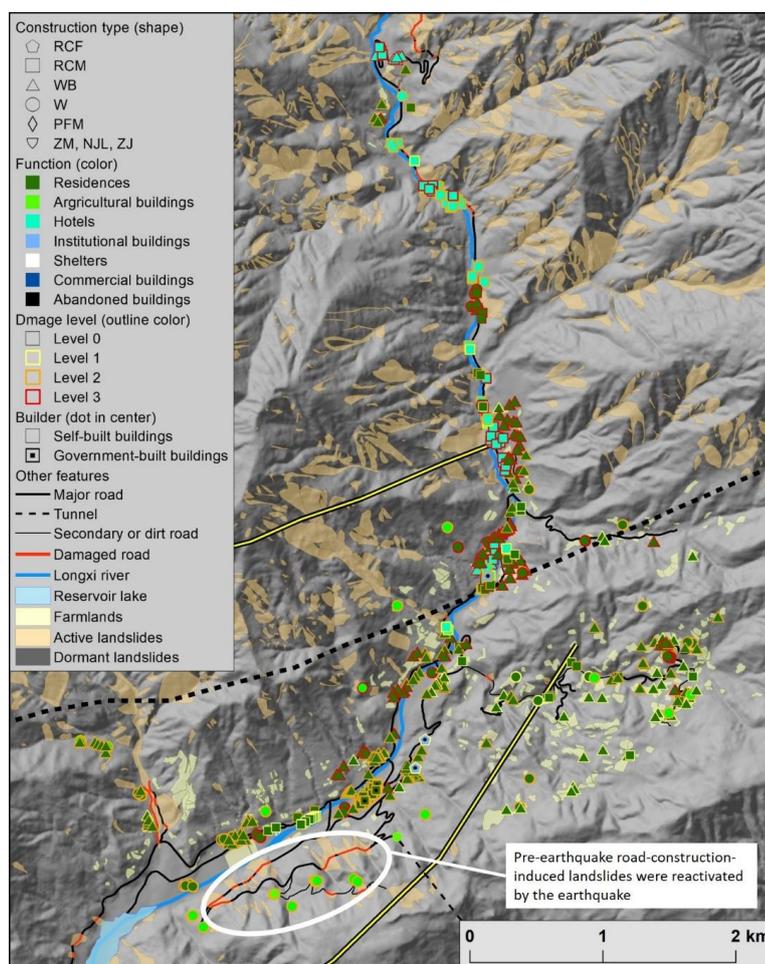
Figure 4: The damage map and the co-seismic landslide inventory.

255 The remaining 81 buildings were repaired and functioned normally in 2009 and 2010, thus were classified as moderately damaged (Figure 4). A total of 1597 landslides were induced by the earthquake in the study area, and 29 of the 142 destroyed buildings were hit by co-seismic landslides. A summary of the building damage is shown in Table 4.

A damage pattern controlled by fault rupture was found, and building damage was more serious on the hanging wall or within one-kilometer distance of the Yingxiu – Beichuan fault rupture (indicated by a thick dotted line in Figure 4 and 6). The landslide area density was much higher in this zone as well.

Road stretches with a combined length of 3.7 km, which was 11% of the road network of 33.5 km, were blocked by co-seismic landslides (Figure 4). The earthquake reactivated human-induced landslides which were caused by road construction in the south. Fresh bare surfaces of the landslides could be observed from the 2005 image and they were almost fully covered by vegetation in the image
290 of 2007.

The local residents mostly constructed the shelters next to their destroyed houses, even when this was very close to co-seismic landslides. The largest planned settlement with pre-fabricated buildings along with some native shacks was sited on the lower part of the alluvial fan of one of the largest sub-watersheds, the Bayi catchment, which later posed a high debris flow threat, as 29% of its watershed area was covered by co-seismic landslides (Figure 4 B).

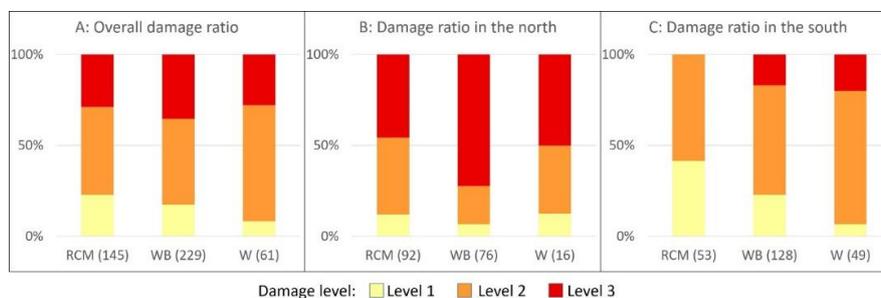
Figure 5: Damage ratio statistics of the three major structural types. The numbers in brackets under the x axis indicate the total numbers of buildings. A: damage ratio of all the earthquake-affected buildings. B:

275 **damage ratio on the northern side of the dotted line in Figure 5. C: damage ratio on the southern side of the
dotted line in Figure 4.**

265 Relatively more single floor buildings were destroyed by the earthquake than 2-floor buildings. The significance in building floors is very obvious for the RCM construction type, as 35% of the 1-floor buildings survived the earthquake while only 13% of the 2-floor buildings were repairable. No significant difference in damage levels related with different construction types was observed. The damage ratios of the three major types (*RCM*, *WB* and *W*), are shown in Figure 5.

280 Both sides showed a clear difference in damage level, as the ratio of buildings being destroyed in the north was much higher (Figure 5 B and C) than in the south. The damage was not influenced by the construction types in the north, because the shaking was so strong that it exceeded the resistance of all types (Figure 5 B). The southern side showed a significance difference in damage for the construction types, as the loss of RCM buildings had the lowest loss ratio and wooden buildings had the highest
285 (Figure 5 C).

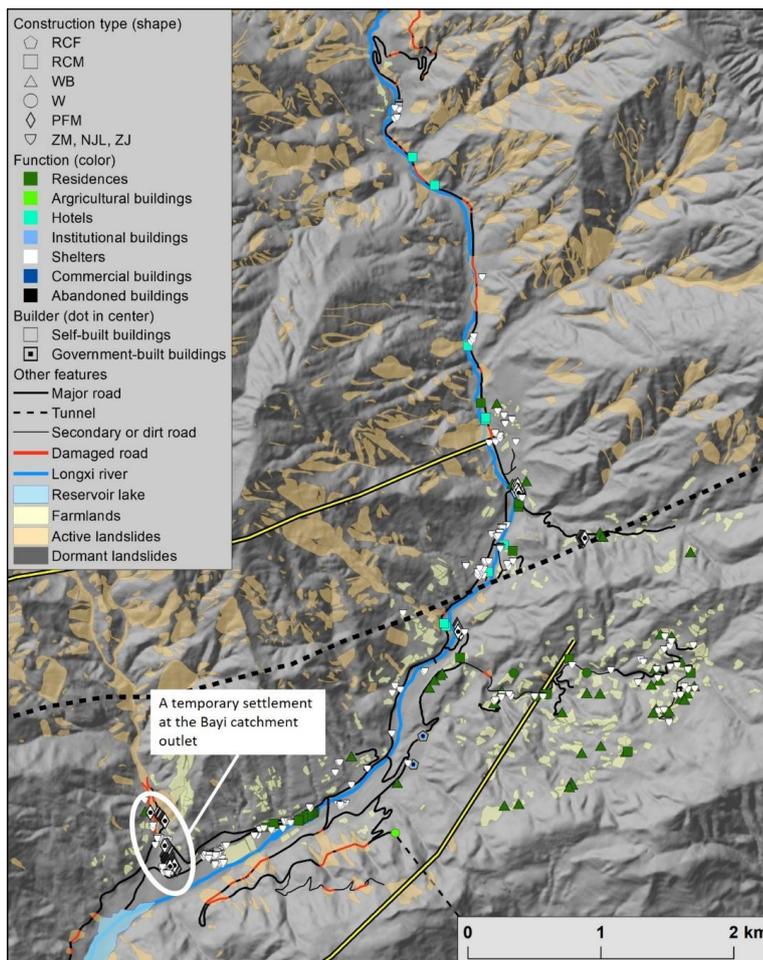
310 **Figure 6: Map of the buildings that survived the earthquake and location of temporary shelters.**

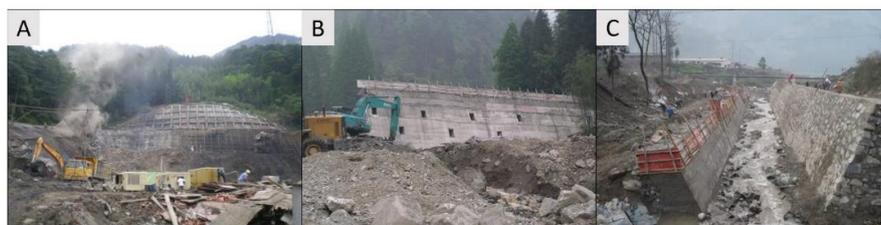
Figure 7: Mitigation works that were under construction in 2010. A: stabilized slope near the newly built primary school in Longchi town. B: check dam being built in the Bayi sub-catchment after a debris flow in 2009. C: drainage channel being built at the outlet of the Bayi catchment after the debris flow in 2009.

335 catchment and a drainage channel was made near the outlet (Figure 7 B & C).

475 mitigation works. There were 2 million USD worth of buildings protected by the reinforced slopes
shown in Figure 7 A and Figure 8. The check dams and the drainage at the catchment outlet did not
count as protection due to their poor quality (Figure 7 B & C and Figure 8). After the 2010 debris flow
disaster the landslide activity decayed significantly (Tang et al., 2016). In 2011 the total value of
potential exposed buildings reduced to 15.4 million USD because of the loss caused by the 2010
480 disaster. The mitigation value reduced to 0.8 million USD because of the destroyed check dams and
drainage. In 2013 the total value of the potentially exposed buildings was 13 million USD, and 8.7
million USD was under the protection of 5.8 million worth mitigation structures. The potentially
exposed value remained stable at 12.4 to 12.7 million USD from 2015 to 2018, with 12 to 12.1 million
USD protected. The total spending on mitigation works increased to 5.9 million USD. It is difficult to

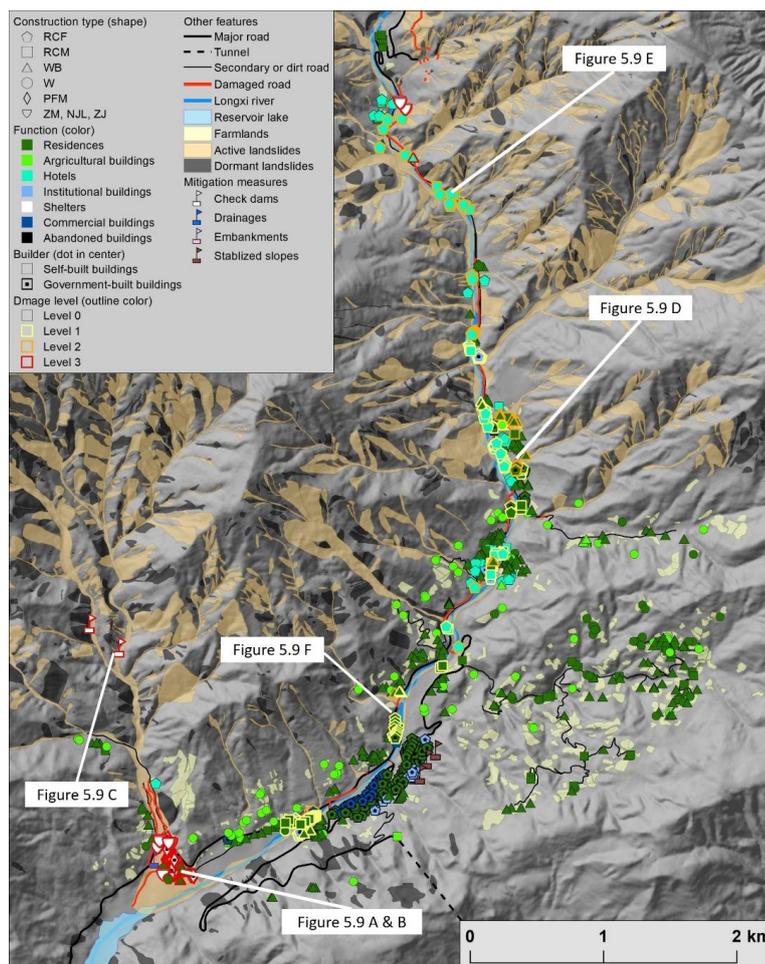
375 **Figure 9: The 2011 inventory and the active landslides in 2010.**

The Worldview-2 image from 2011 was used to map the changes caused by the large debris flow disaster that occurred in August 2010 (Figure 9). The most catastrophic debris flow event was triggered
345 by a storm on 14 Aug 2010 with a maximum recorded rainfall intensity of 75 mm/h measured by rain gauges in the town (Xu et al., 2012). About 341 new landslides were triggered and 1151 of the co-seismic landslides were reactivated in this study area during this event, producing several massive debris flows which joined in the valley of the Longxi River (Yu et al., 2011), reaching the Zipingpu
350 lake. Sedimentation was 5 – 7 m at about 300 meters upstream of the town (Figure 9) (Sichuan Geology Engineering Reconnaissance Institute, 2011). Nearly one-fourth of all buildings in the study area were impacted by debris flows and subsequent floods. The losses were largest for those buildings located either close to the river or near sub-catchment outlets (Figure 9). Among all the 213 affected buildings, 70 were destroyed, 41 were severely damaged and 102 were moderately damaged. The most

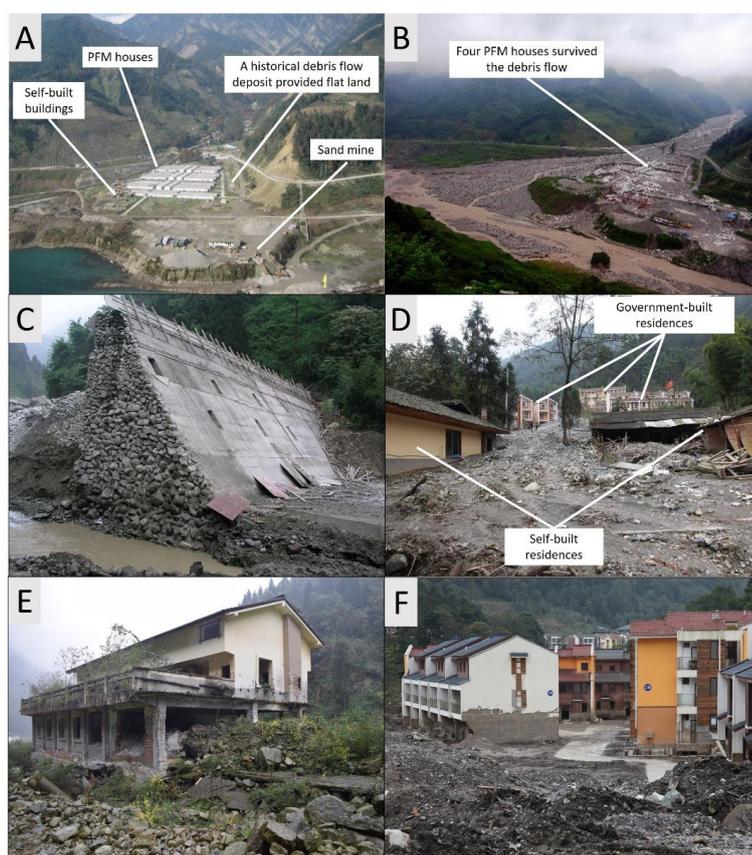
Figure 10: Losses caused by the Aug 14, 2010 debris flows. The locations of the examples are shown in Figure 8. **A:** The temporary settlement at the Bayi sub-catchment outlet in 2009 (Luo et al., 2010); **B:** The shelters destroyed by a debris flow from the Bayi sub-catchment (Luo et al., 2010); **C:** One of the two under designed check dams in Bayi sub-catchment which were destroyed (Liu, 2010); **D:** Residences reconstructed on old debris flow deposits were damaged; **E:** A hotel beside the Longxi River was struck; **F:** government-built apartment buildings beside the river were damaged.

355 severe loss occurred at the outlet of the Bayi sub-catchment, where 64 shelters were completely razed and 4 shelters were moderately damaged by a large debris flow (Figure 10 A & B). The drainage and the poorly constructed check dams in Bayi sub-catchment constructed in earlier years by the government did not prove to be adequate and were destroyed (Figure 10 C). The total number of buildings in the area reduced to 712 (Table 3). Two government offices, a water treatment plant and a
360 water pumping station were affected, with 9 RCF buildings moderately damaged. The debris flows and floods also damaged 35,000 m² of farmlands and 7.5 km of roads were destroyed (Figure 9).

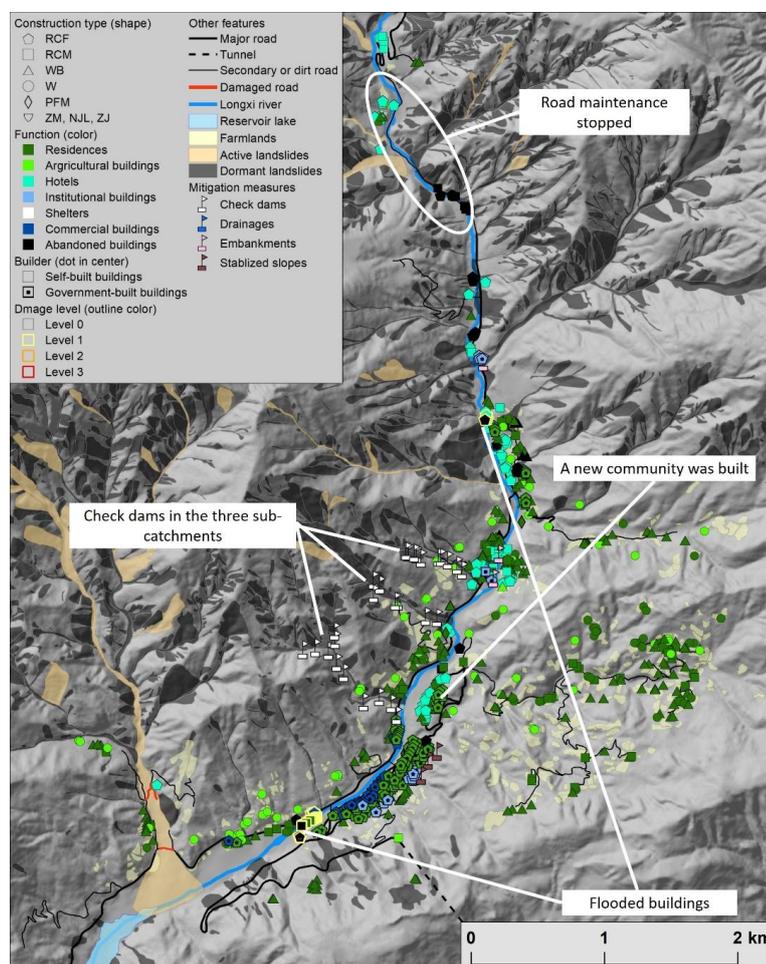
Figure 11: The inventory of 2013 and active landslides in 2013.

The WorldView image of 2011 and the Pleiades image collected in April 2013 were used to map the changes between 2011 and 2013, which represents the situation shortly after the post-debris-flow reconstruction was completed in 2012. All the temporary buildings were removed by 2012. A total of 370 buildings, that were threatened by debris flows or floods, were abandoned. The government constructed another 25 buildings to replace these (Figure 11) and also local people constructed 67 new buildings.

Some self-built buildings were removed during the construction process. The total numbers of functioning buildings were reduced to 678 (Table 3). Many mitigation measures, such as check dams, sediment retention basins, and debris flow early warning systems, were implemented in the three most dangerous sub-catchment and concrete embankments were installed along parts of the river (Figure 11).

mitigation structures of the three sub-catchments (Figure 11) built after 2010 have a worth of
 430 approximately 30 million Yuan (Chengdu Bureau of Land and Resources, 2018). We were not able to
 acquire prices of farmlands, forests and other indirect factors. Therefore the analysis was limited to
 economic value, investment and direct loss caused by hazards. Severely damaged and destroyed
 buildings were counted as direct economic loss.

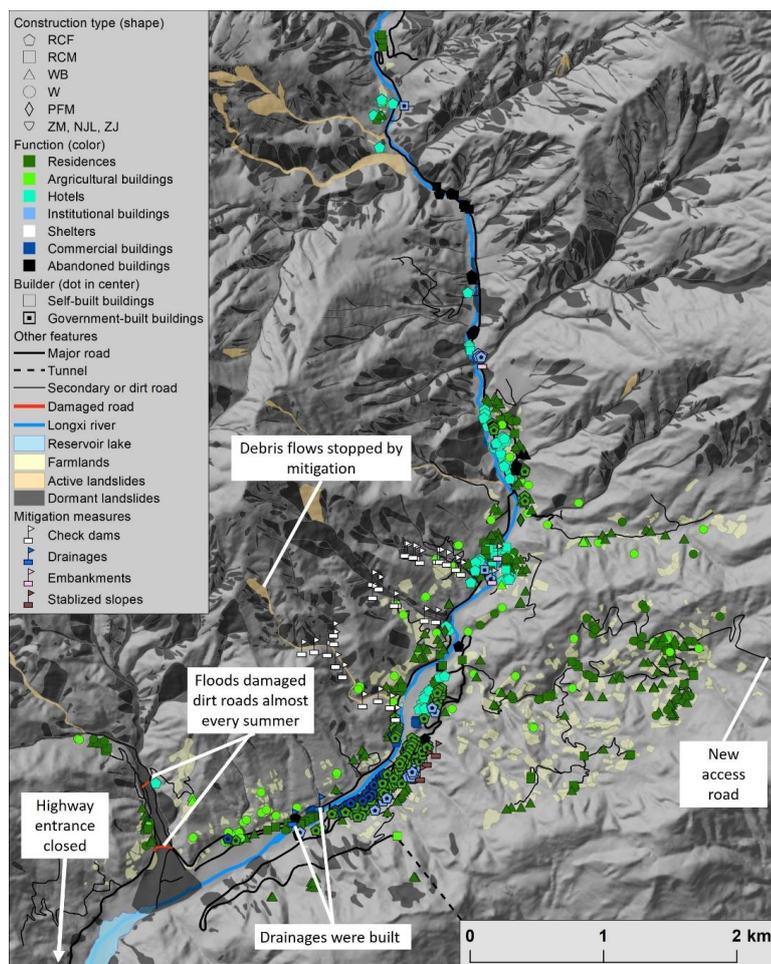
Figure 12: The inventory of 2018 and active landslides in 2018.

The last two change maps were made by interpreting the 2015 SPOT 6 image and the 2018 Pleiades image. From 2013 to 2018 the Longchi society developed in a stable manner without any major disruption, thus we only described the inventory of 2018 (Figure 12). In this period 21 new buildings were constructed by local people. The total number of buildings in the area grew to 699 (Table 3). The
405 road length increased to 46.2 km, as many dirt roads were made to access farmlands. The tunnel connecting the highway was closed due to water leakage (Figure 1, access 2). The government decided to stop its maintenance, probably because of a low economic interest caused by the loss of tourism. Only the old tunnel (Figure 1, access 1) could be used, which caused a delay in traveling to Dujiangyan city by car of 40 minutes. A secondary road was made in 2018 connecting the neighboring catchment
410 and provided a second access road for the Longxi watershed (Figure 12).

Landslides and floods did not cause any major loss since 2013. A few debris flow watersheds were treated with mitigation structures (Figure 12). Two elevated drainage channels were installed in 2015 in the southern part to redirect floods produced by two small catchments into the river directly. The Bayi catchment produced floods that damaged dirt roads in almost every summer during this period.

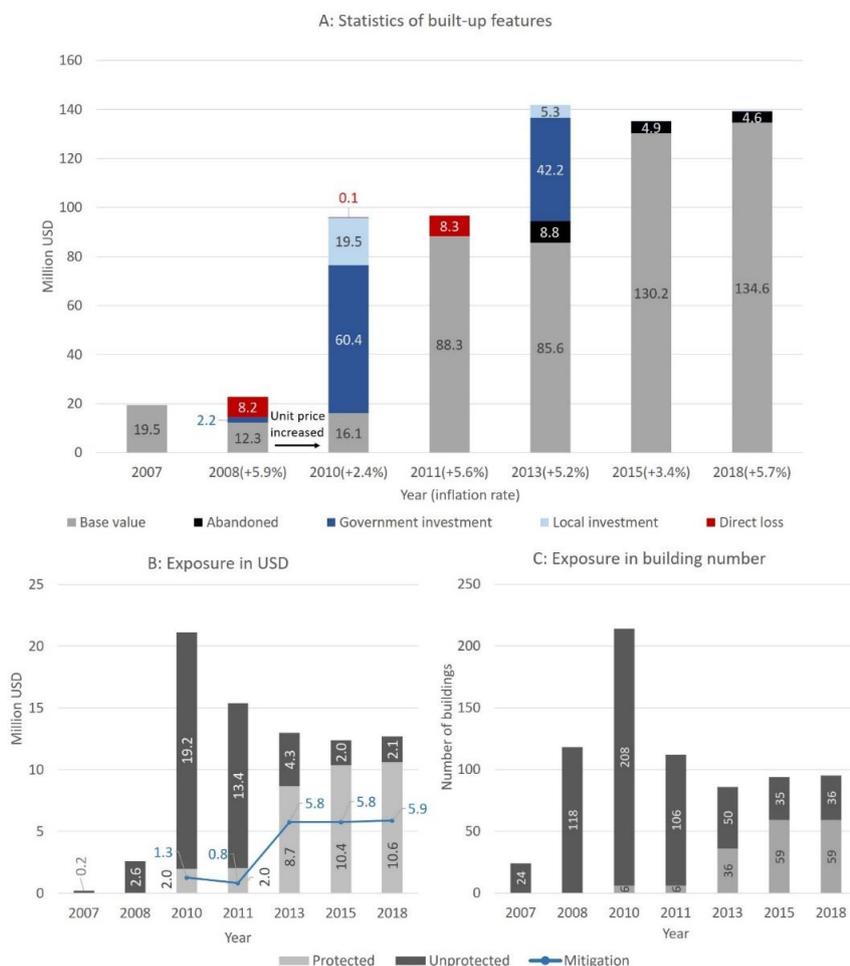
445 **Figure 13: A: the total built-up values, investments and direct economic losses over the period between 2007 and 2018 in the Longxi area. B: The total building value that was at risk of being impacted by debris flows and floods. The values were adjusted with the inflation rate. C: The total number of buildings that was at risk of being impacted by debris flows and floods.**

The total value of all buildings was estimated to be about 19.5 million USD in 2007 (Figure 13 A). The earthquake caused 8.2 million USD direct loss in 2008, which was 42% of the value in the previous year. The temporary shelters in 2008 were worth 2.2 million USD, making the total building value in

2008 reaching 14.5 million USD. A 0.1 million USD loss was caused by the debris flow in 2009. As a
 440 result of the fast reconstruction, the total value increased rapidly to 96 million USD in 2010, which was
 nearly 5 times the value in 2007.

This was caused by the increase in the number of apartment buildings and the overall improvement in construction type, particularly the RCF buildings accounted for 75% of the total value. The disaster in August 2010 caused a loss of 8.3 million USD, making the building value dropped to 88.3 million USD
450 in 2011. It is notable that the direct loss in 2010 was slightly more than the loss caused by the Wenchuan earthquake. New buildings and the mitigation structures raised the total value to 133.1 million USD in the 2013 inventory. A gradually small increase in the total values was observed from 2013 to 2018, which was caused by currency inflation and new buildings.
