## Hidden Hazards: the conditions that potentially enabled the mudflow disaster at Villa Santa Lucía in Chilean Patagonia

**Abstract.** The evaluation of potential mass wasting in mountain areas is a very complex process because there is not enough information to quantify the probability and magnitude of these events. Identifying the whole chain of events is not a straightforward task, and the impacts of mass wasting processes depend on the conditions downstream of the origin. Additionally, climate change is playing an essential role in the occurrence and distribution. Mean temperatures are continuously rising to produce long term instabilities, particularly on steep slopes. Extreme precipitations events are more recurrent as well as heat waves that can melt snow and glaciers, increasing the water available to unstabilized slopes.

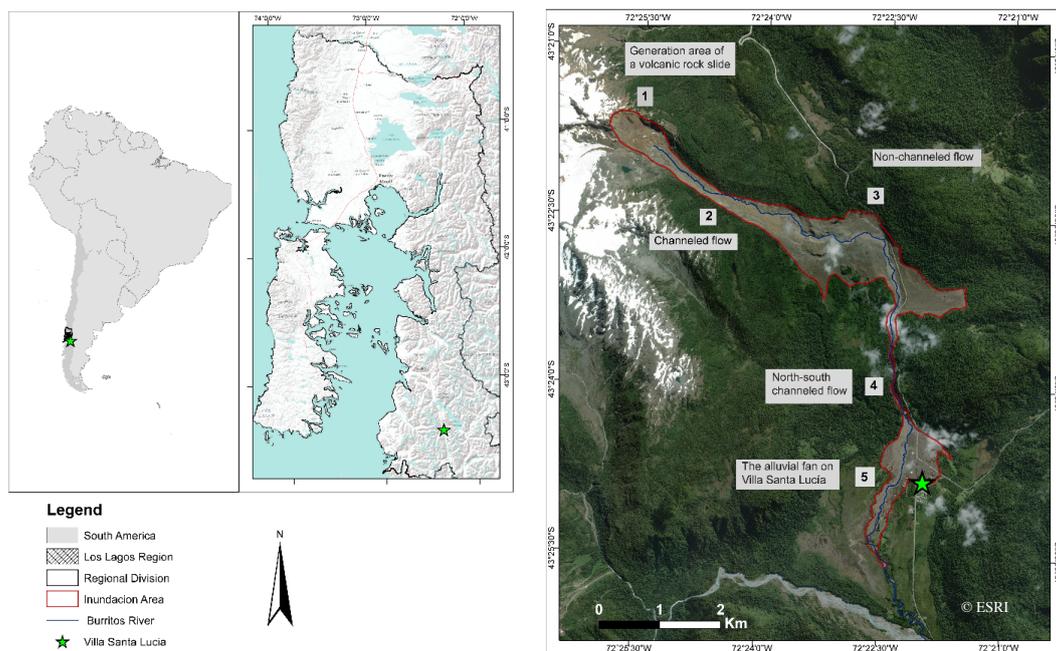
Figure 1: Study area and extension of the inundation (South America and Los Lagos Region layer from <https://tapiquen-sig.iimdo.com>, Burritos River blue line layer from <http://datos.cedeus.cl/>, background © ESRI).

Additionally, the soil was almost saturated, which added water to the mix, transforming the avalanche flow into a mudflow. Moreover, dense forest was present, which added a significant amount of biomass to the mix. Then the mudflow reaches an area with low slopes at a distance of 8.6 km from its origin through the Burritos River to the east. In its trajectory, the mudflow crossed Route 7 (Carretera Austral) in a stretch estimated of 2 km and filled an old wetland. In that sector, the flow was channeled in a canyon oriented north-south toward Villa Santa Lucia in a section of 1.5 km (Figure 1 and 3, point 4). Once the flood reached Villa Santa Lucia, it slowed down and deposited the sediment in a radial fan of 600 to 1,000 m with a height of 1 to 5 m (Figure 1 and 3, point 5).

Through field observations, we identified five key sections that describe what happened in Villa Santa Lucía (Figure 1 and 3).

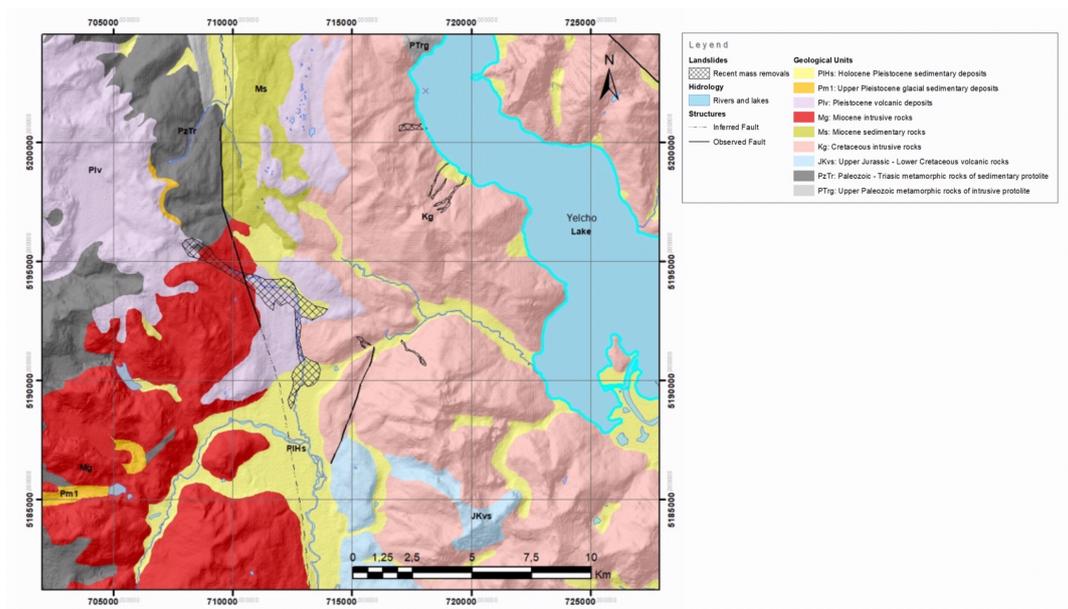
130 Figure 2: Geology of the study area (Modified from Sernageomin (1995))

The study area consists mainly of 9 geological units (Figure 2). The dominant geological unit corresponds to an intrusive rock (Cretaceous and Miocene age) composed of tonalites, granodiorites, granites, diorites, among others. Moreover, the basement material is an old metamorphic rock. This unit is composed of micaceous shales, amphibolites, mafic, and ultramafic rocks. Volcanic and volcanoclastic rocks represent, in part, the NO-SE volcanic cord, called the Cordon Yelcho Volcanic Complex (Sernageomin, 1995). While sedimentary rocks, mainly sandstone, shales, conglomerates, are presented as intercalations. Recent sedimentary deposits are mainly associated with rivers, alluvial, colluvial, morenic, and glaciolacustrine deposits (Aguilera et al., 2014) (Figure 2).

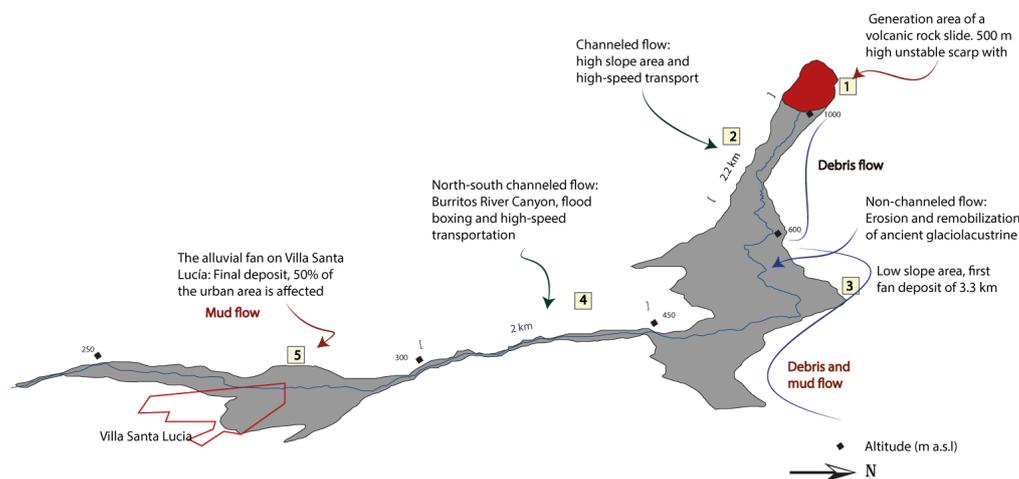
Figure 3: Flow trajectory scheme and details of the five key sections identified by Sernageomin and our fieldwork.

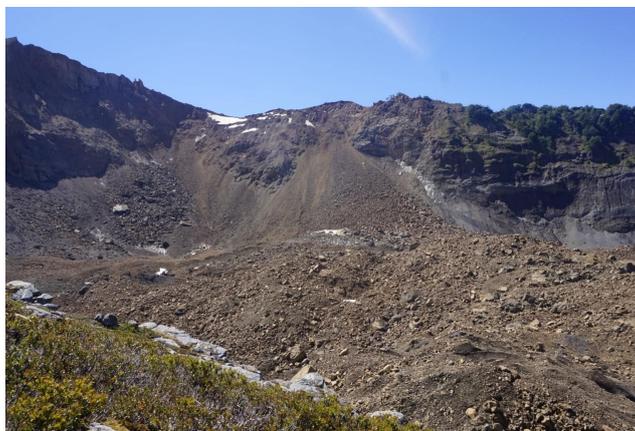
Figure 4: Area of slope failure slid and deposit.

1. Generation area: It has a range of peaks between 1,000 to 1,400 m a.s.l., with the main escarpment of 900 m long and 520 m wide. The north wall has maximum slopes between 77 to 81° (Figure 3 and 4)

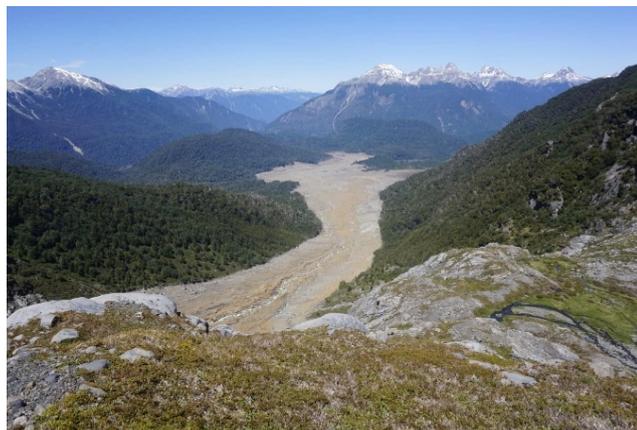
Figure 5: Channeled flow at the foothills.

2. Channeled flow: Corresponds to the upper segment at the foothills, the flow is channeled and traveled 2 km. The flow width was between 200 to 400 m wide. Using photo-interpretation of the digital elevation models (SAF, 2017) and aerial photos, Sernageomin personnel (Sernageomin, 2018c) estimated an approximate wave of 20 m height (Figure 3 and 5).

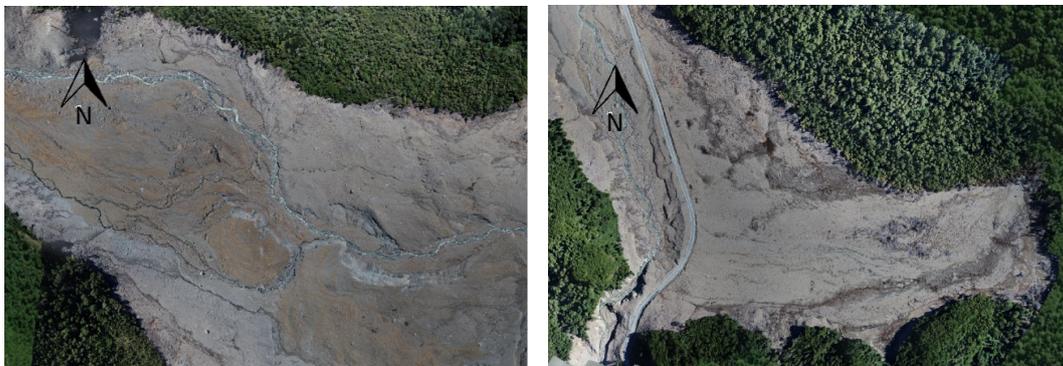
Figure 6: Aerial photo of non-channeled flood deposited in an old wetland captured with an InspireII UAV.

3. Non-channeled flow: This section has a length of 2.3 km in a west to east direction until the Burritos river changes its orientation to a north-south direction. The elevation goes from 600 to 380 m a.s.l. The slopes decrease slowing down the flow, which deposited sediments. The non-channeled flow width reaches 1.4 km. In this sector,  
195 the flow went over the road (Carretera Austral) to the east in 1.3 km affecting an old wetland (Figure 3 and 6).

The speed of the flow at the Burritos river canyon (Figure 6) and at the beginning of Villa Santa Lucía when the  
flow opens (Figure 7) is approximately 20 m s<sup>-1</sup> (Sernageomin, 2018c)

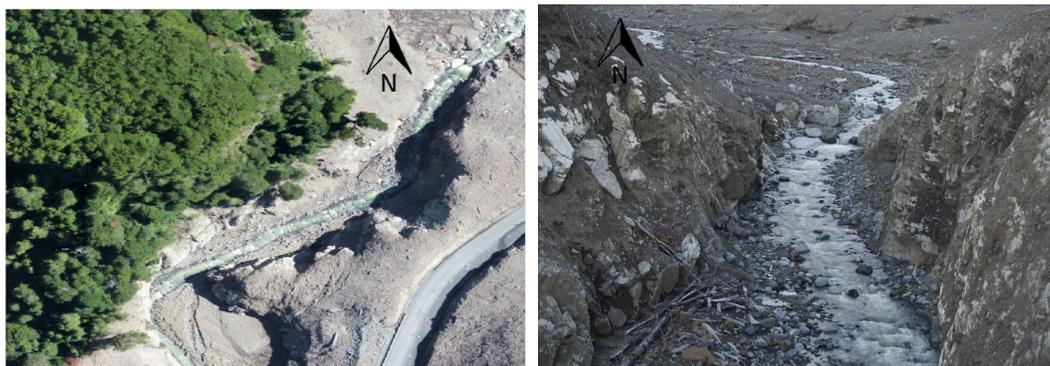
Figure 7: Aerial photo of the channel in the last section before entering Villa Santa Lucia (left) captured with an InspireII UAV. Picture of the channel facing downstream (right).

4. North-south channeled flow: The flow descends through the enclosed channel at the Burritos river canyon from  
200 380 to 250 a.m.s.l. on a 2 km long section (Figure 3 and 7).

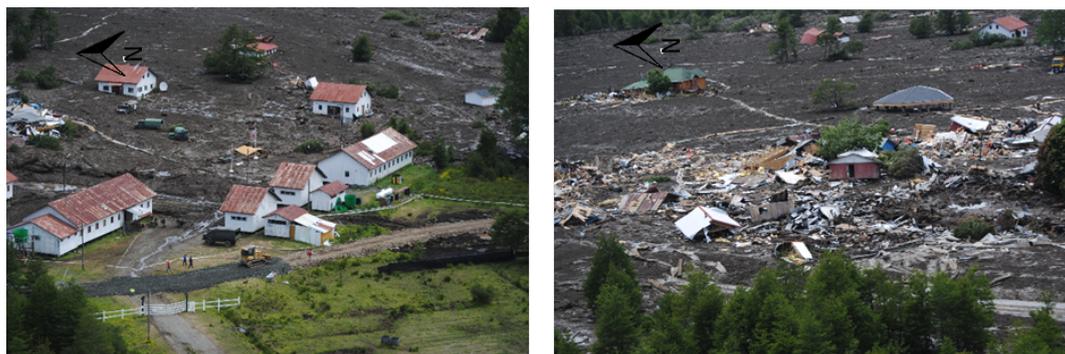
Figure 8: Villa Santa Lucia after the mudflow (Used with permission from Sernageomin (2018c)).

5. The alluvial fan on Villa Santa Lucia: due to the lost in confinement the flow expands with a radial distribution  
205 in a southeast-southwest direction of 600 to 1,000 m (Figure 3 and 8)

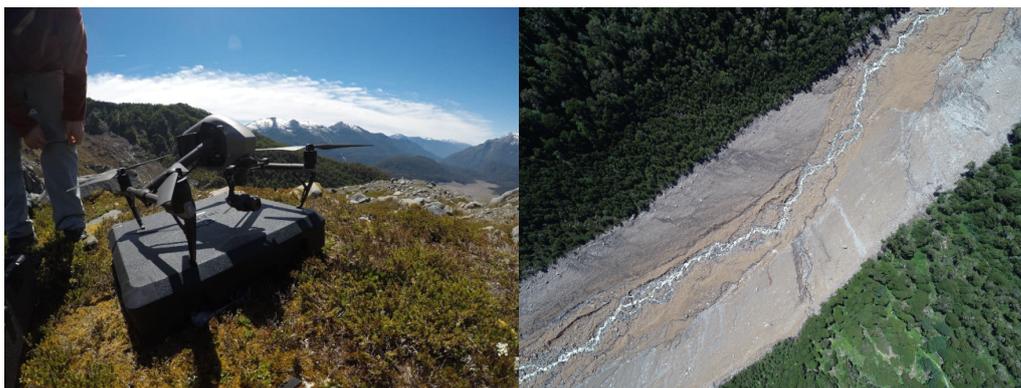
Figure 9: UAV mapping survey

220 A fieldwork campaign was carried out in January 2019 to map in high resolution the area using an unmanned aerial  
vehicle (UAV). We used aerial photogrammetry to produce a high-resolution DEM for some parts of the study area.  
Aerial photogrammetry allows creating 3D models from 2D images, obtaining geometric characteristics of the  
objects they represent. We used a UAV Inspire II with a Zenmuse X4 camera to capture aerial images (Figure 9).  
We did not have differential GPS at the moment of this survey to take control points to correct the DEM generated.  
225 Therefore, we just used this DEM to corroborate that the DEMs with lower resolution and freely available were able  
to capture specific features such as canyons or small changes in slopes that could affect the hydrodynamic  
simulation and the path of the flood. We also generated a high resolution mosaic to observe details of the flood. We

used the software Agisoft PhotoScan Professional 1.4 desktop to process the images. The software performs the  
restitution of images by spatial coincidence between the elements represented in each image.

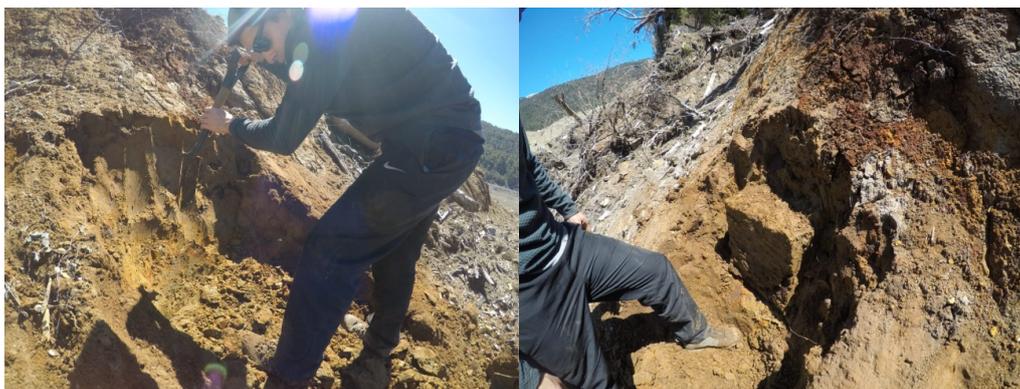
Figure 10: Extraction of an undisturbed soil sample

235 Additionally, we extracted an intact soil sample (Figure 10) to determine the physical and mechanical parameters  
extracted from an undisturbed sample following the American Society of Testing Materials ASTM D3080 (ASTM,  
2017a).

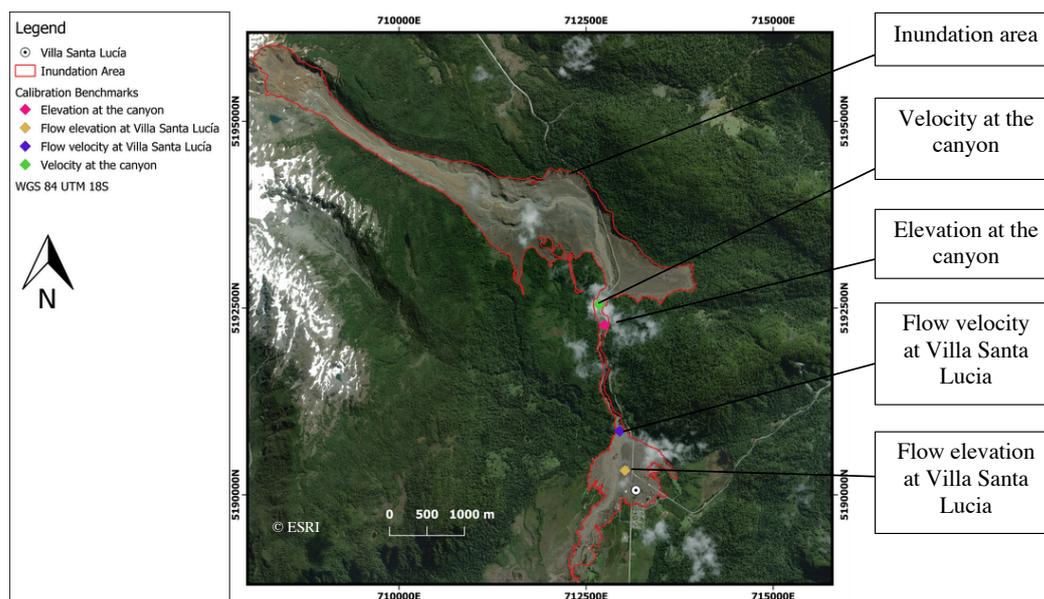
285 Figure 11: Location of the parameter estimation for the calibration of the models (Background © ESRI)

For the calibration of the models, we used three criteria (1) Flood area, which was mapped after the event using aerial imagery (SAF, 2017); (2) Flow heights estimated by Sernageomin in Villa Santa Lucía and at the beginning of

the canyon; and (3) Flow velocities in the canyon curve and at the beginning of Villa Santa Lucia (Figure 11). See Table 1 for the values.

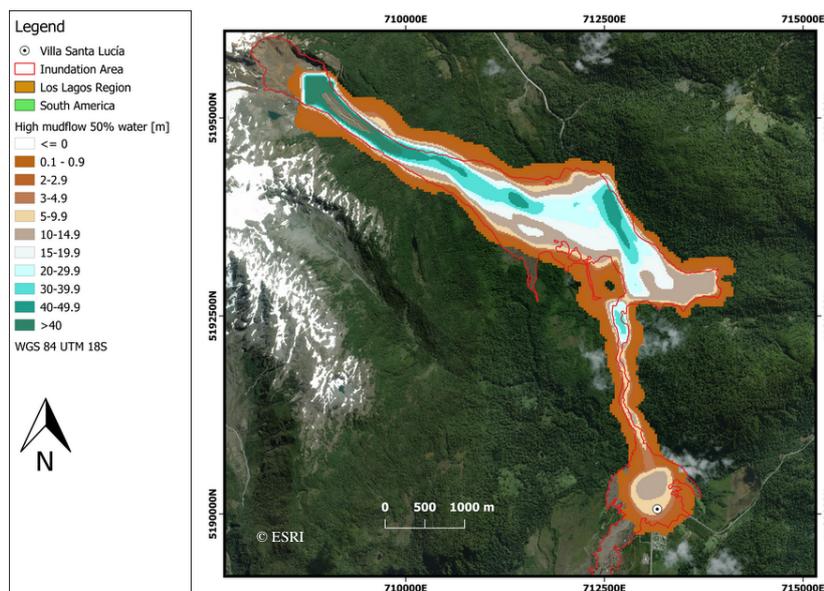
Figure 12: R-avaflow modeling results for a concentration by volume of 50%.

335 The best set of parameters is 5.75, 2, 0.022 and 0.0005 for the drag coefficient, base friction angle, environmental resistant coefficient, and fluid friction coefficient, respectively, and the corresponding map result is in Figure 12.

Figure 12 shows good agreement with what was reported by (Sernageomin, 2018c). However, the mixture is still  
 340 largely fluidized, and it does not follow the edges of the inundation. For this reason, we performed simulations with  
 the same input parameters but a varying percentage of initial water. We changed the percentage of water from 20%  
 to 70%. The error for the heights, speeds, and pressures calculated in each model are in Figure 13.

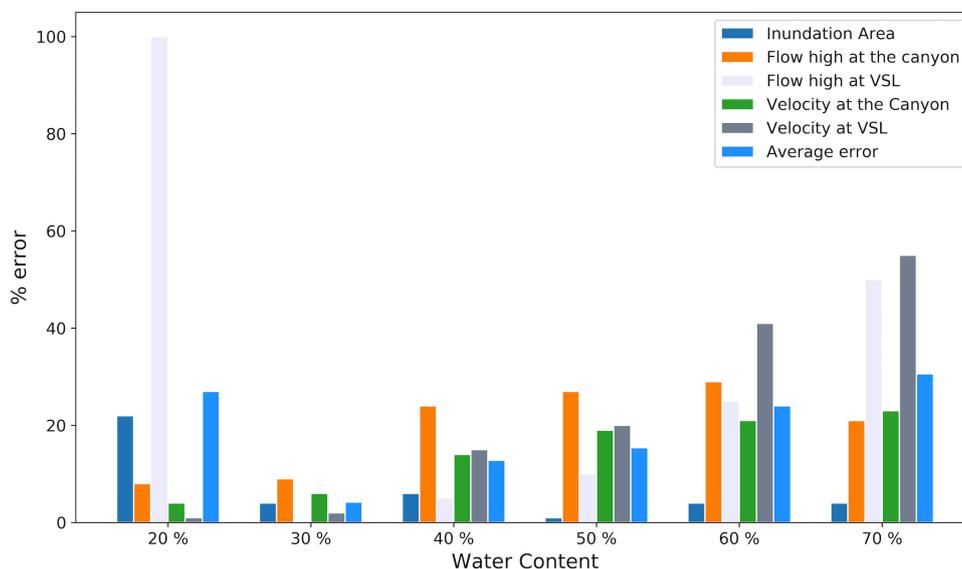
345 Figure 13: Error obtained with different water content and the best set of parameters obtained in the first calibration.

From Figure 13, we concluded that a mudflow with a volume of water of 30% could reproduce best the VSL event (Figure 14).

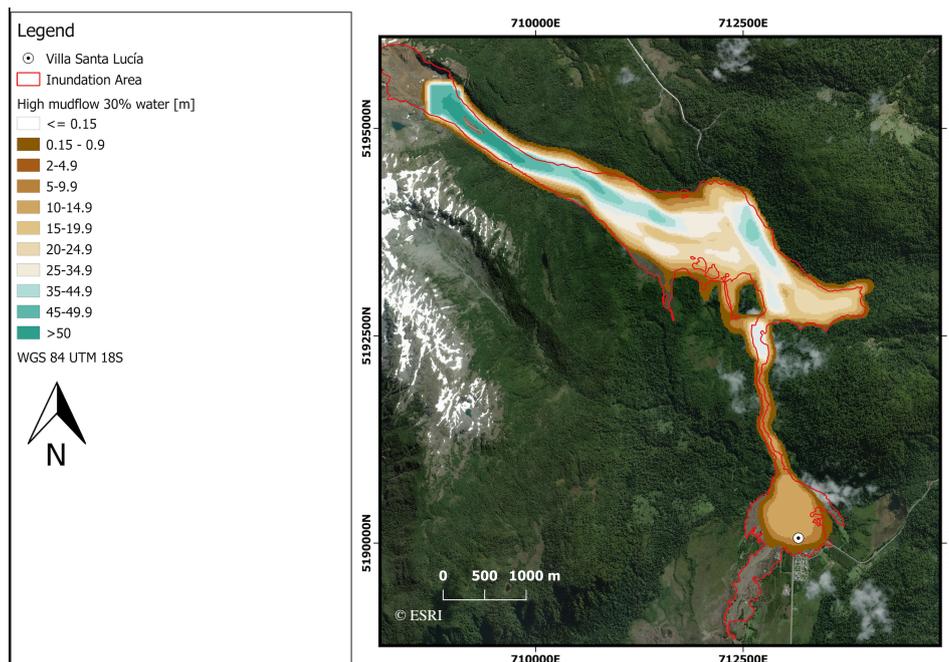
Figure 14: Best simulation results using the calibrated parameters for r-avaflow and water content of 30%

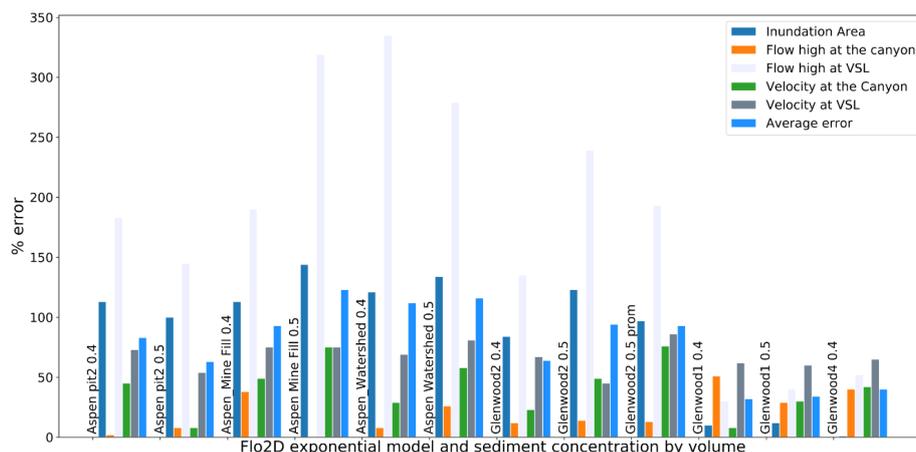
360 Figure 15: Sensitivity analysis for different dynamic viscosity and shear stress models (FLO-2D, 2018)

355 For the laminar resistance  $k$ , we used the default number 3000. The influence of the value of  $K$  does not affect simulations significantly compared to other parameters related to flow resistance (Hsu et al., 2010). The specific gravity of sediments  $G_s$  is equal to  $2.65 \text{ g cm}^{-3}$ . For the sediment concentration by volume, we used values between 40% to 50%, which correspond to hyper-concentrated flows. The error for the heights, speeds, and pressures calculated in each model are in Figure 15. Moreover, Figure 16 shows the extension of the best model using Flo2D.

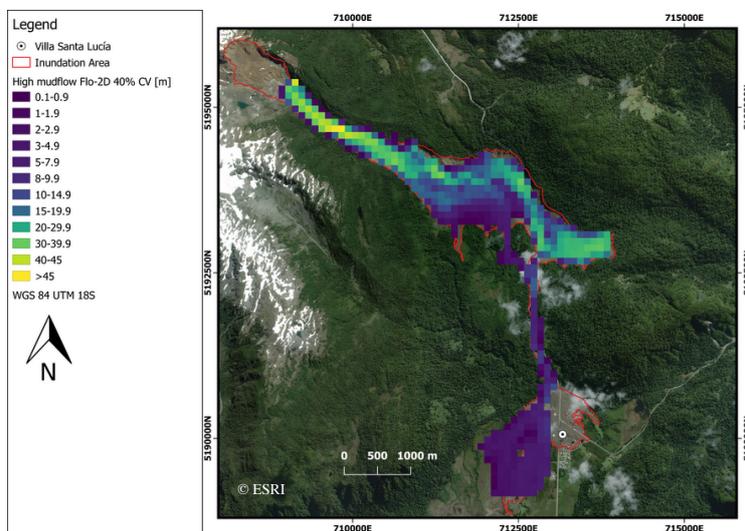
Figure 16: Result for Glenwood 1 using a 40% concentration by volume (Background © ESRI)
