1 **The catastrophic landfill flowslide at Hongao dumpsite on December 20, 2015 in Shenzhen, China**

6 **Abstract** A catastrophic flowslide occurred at Hongao dumpsite at approximately 11:40 AM on Dec 20,
7 2015, in Guangming New District of Shenzhen, China. The flowslide damaged 33 buildings and caused
8 total death toll of 69 and 8 missing, with the absence of extreme weather condition and seismic activity.
9 The slope failure was analyzed on the basis of multi-temporal remote sensing images, site investigation, *in-*
10 *situ* tests, laboratory experiment, and numerical analysis. The preliminary results showed that the volume
11 of the flowslide deposit was 2.32×10^6 m³ and the volume of dumpsite filling was 6.27×10^6 m³ at the time
12 of the event, which is three times larger than the maximum design capacity. The flowslide had the
13 characteristics of high travel speed and long run-out distance, of which the displaced material was primarily
14 silty soil from nearby construction sites with high moisture content. The primary causes of the failure were

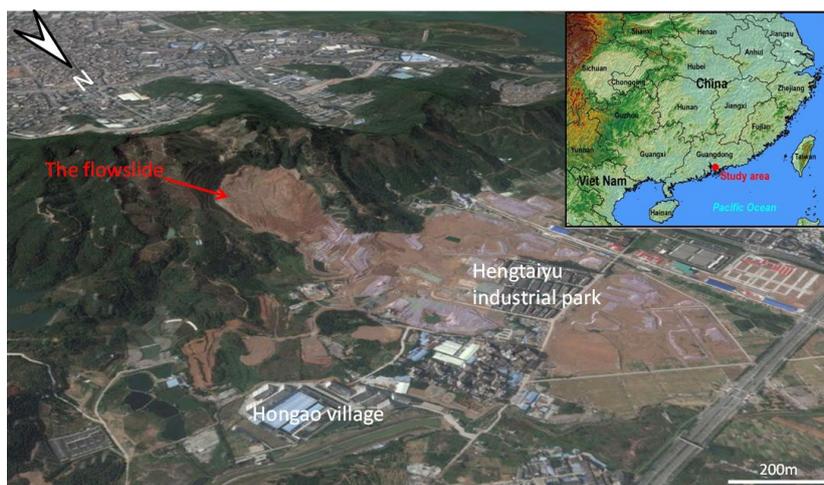
118 Fig. 2 Location of the study area and overview of the post-sliding dumpsite (Google Earth image taken on
119 Feb 2016).

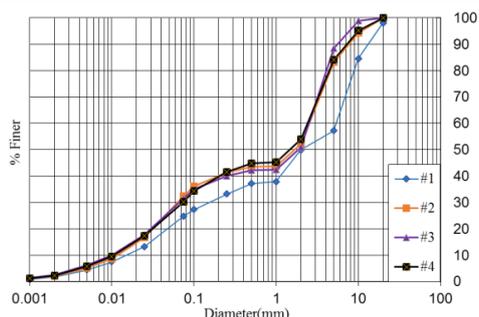
Fig. 4 Particle size distribution curves of the waste filling.

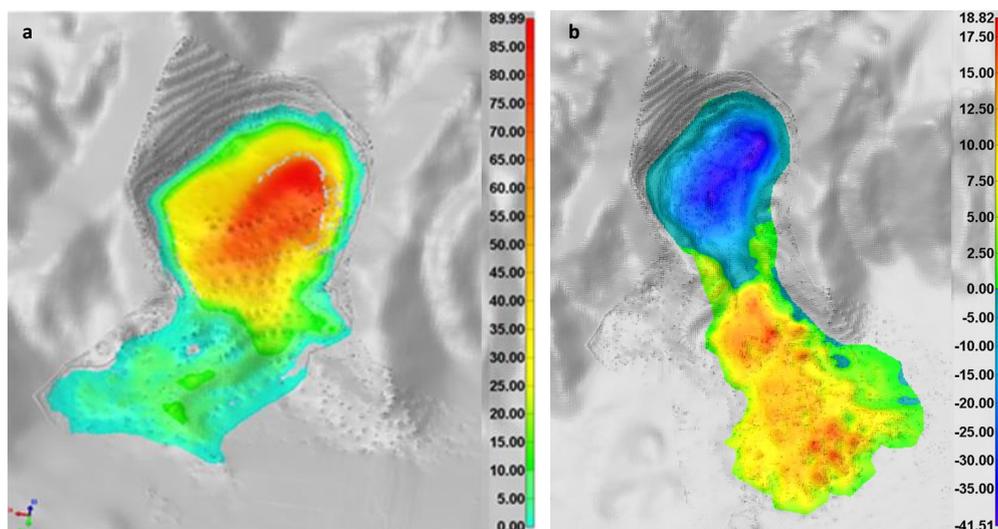
169 drainage channels installed on the hillslope, and the eighth bench was still under construction during the
170 flowslide. The thickness of the dumpsite was estimated as 90 m with total volume of $6.3 \times 10^6 \text{ m}^3$ (Fig. 9a)
171 by extracting the difference between the pre- and post-filling DEMs.

172
173 Fig. 9 a The thickness distribution of the dumpsite based on the pre-/post-disposal DEMs; b The elevation
174 variations of the dumpsite estimated between the pre-/post-sliding DEMs.

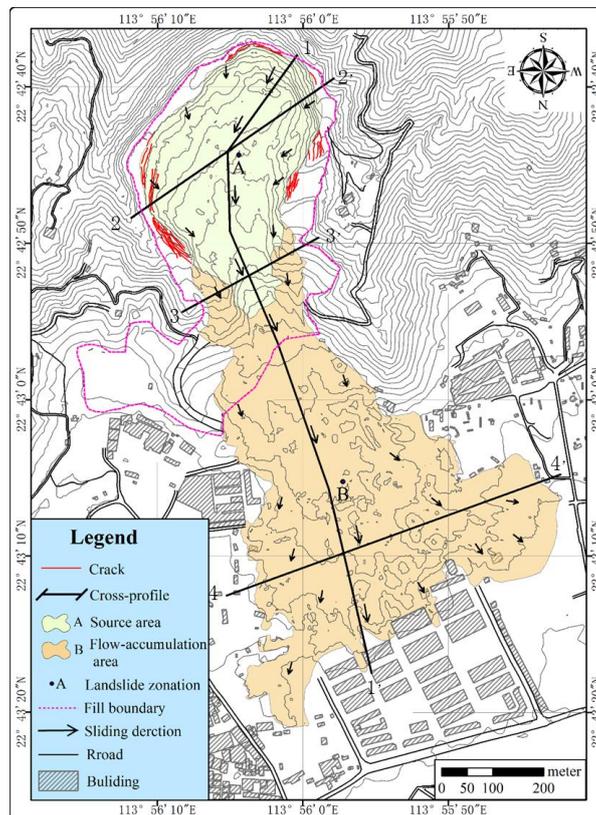
Fig.11 The topographic map of the flowslide.

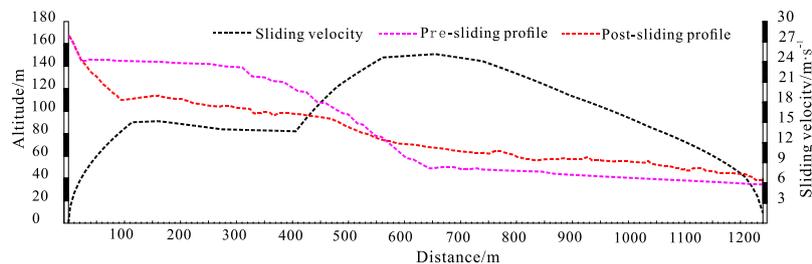
Where v is the sliding velocity (m/s), g is the gravitational acceleration (m/s^2), H and L is the elevation difference and horizontal distance (m) between the crown and toe of the flowslide, respectively, and f is the equivalent friction coefficient referred as the ratio between the height and run-out distance of the flowslide ($f = H/L$). The equivalent friction coefficient of the dumpsite flowslide is 0.092. The relations of the run-out distance, elevation difference, and equivalent friction coefficient can be defined in light of the flowslide geometry (Fig. 13). The sliding velocity was calculated and presented in Fig. 23.

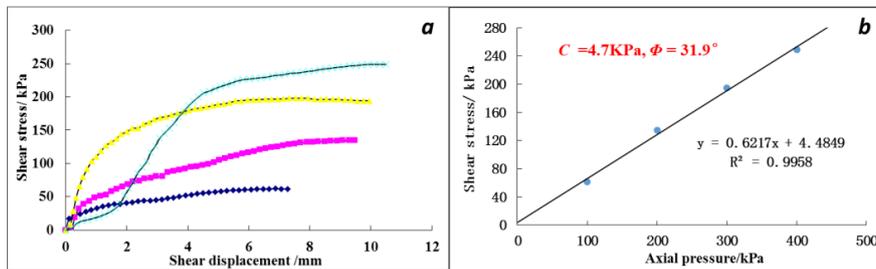
294 Based on *in-situ* tests for waste filling density and moisture content as well as the laboratory compaction
295 test, it was found that the dry density varies from 1.25 to 1.48 g/cm³ and void ratio ranged between 0.83
296 and 1.31. Standard compaction test results suggested that the optimal water content of the waste filling was
297 15.31% with the highest dry density of 1.79 g/cm³. The surface of the waste filling was in loose state with
298 degree of compaction of the dumpsite ranged from 69.83% to 82.68%. Undrained shear test estimated that
299 c and Φ of the waste filling is 4.7 kPa and 31.9°, respectively (Fig. 24), which is considerably higher than
300 gradient of the retaining slope.

Fig. 24 Shear strength of the waste filling specimen obtained by undrained shear test.

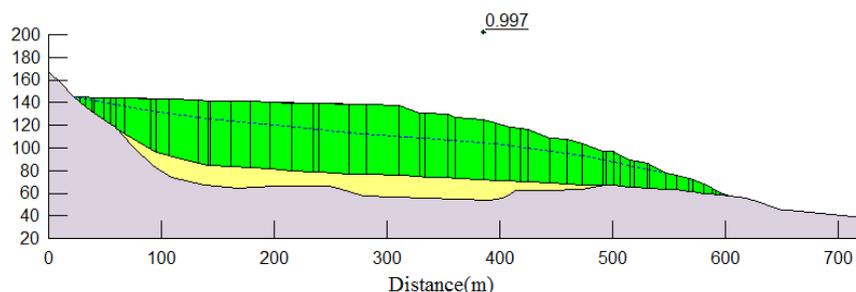
Fig. 26 Estimated FoS for the 2D numerical model.

317 The results of slope stability analysis is presented in Table 5. Based on the numerical analysis, it was found
 318 possible for the development of a sliding surface above the bedrock in the lower portion of the waste filling.
 319 It is evident that the permeability of the waste filling was considerably low, which may result in saturation
 320 in the lower portion of the waste filling. As no clear drainage passage were found for the waste filling, the
 321 displaced material may remain undrained during the flowslide so that the shear strength was significantly
 322 reduced. The substantial difference in the shear parameters obtained from laboratory test and numerical
 323 analysis indicated that the conventional numerical analysis is not appropriate for analyzing the failure
 324 mechanism of the flowslide. Additionally, the uncertainty of groundwater condition affects the analysis.
