## Lessons learnt from analysing the causes of casualties in the Sichuan Changning $M_s$ 6.0 earthquake

**Abstract.** This paper summarizes the  $M_s$  6.0 earthquake disaster that occurred in Changning, Sichuan Province, China, on 17  
10 June 2019. Additionally, a description of the disaster emergency response is provided. As determined by on-site investigation  
and analysis, the direct causes of earthquake casualties are summarized. Among them, 66% of the casualties can be attributed  
to substandard seismic protection, 25% to improper earthquake risk avoidance, 6% to earthquake-induced geological disasters,  
and 3% to pre-existing diseases exacerbated by the earthquake. Responding to the causes of these four casualty types, we  
15 summarize 4 lessons, which are to build in accordance with seismic protection requirements; strengthen publicity and  
education awareness of earthquake emergency evacuation and training for the population; investigate and evaluate potential  
geological disaster sources in the stricken area, along with conducting prevention and control; establish cooperation with health

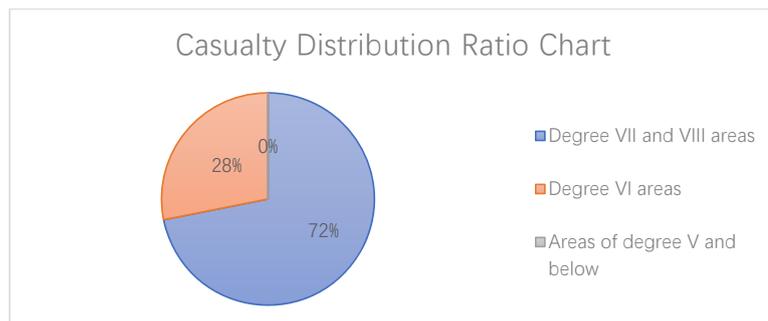
**Figure 2: Casualty distribution ratio chart.**

Among the casualties, 23 people were located in the degree VII and VIII areas of earthquake intensity. Nine people were located in the degree VI area of earthquake intensity. No reports of death, critical injuries or serious injury were found in the areas of degree V or below, as shown in Fig. 2. Casualties were characterized by a concentration in high-intensity areas, consistent with the intensity division.

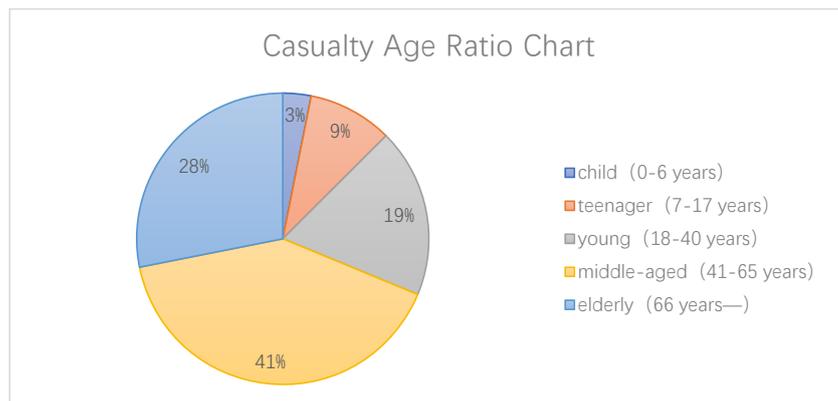
**Figure 3: Casualty age ratio chart.**

The oldest of the 32 casualties was 92 years old, and the youngest was only 3 months. The casualties comprised 1 child, 3 teenagers, 6 young people, 13 middle-aged people and 9 elderly people, as shown in Fig. 3. The proportion of young people and middle-aged people was more than half, and the proportion of elderly people was less than 30%. These rates do not reflect an age advantage in the process of evacuation. The reason may be that the earthquake occurred at midnight; all the casualties were indoors and may have fallen asleep, and there was almost no time to perform the necessary evacuation.

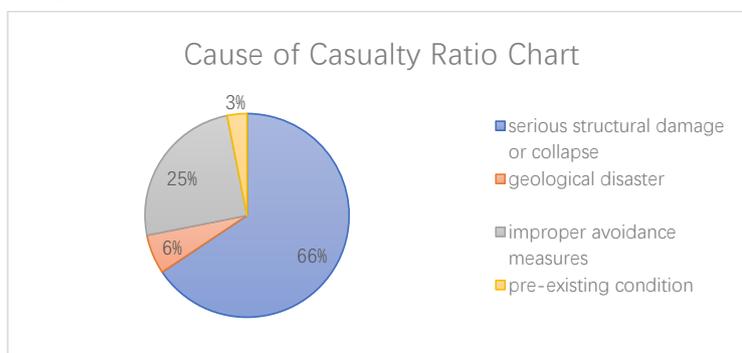
Figure 4: Cause of casualty ratio chart.

The causes of injury and death of 32 persons can be classified into four categories, as shown in Fig. 4. The first cause is that the structure of the house was seriously damaged or collapsed, and the debris caused injury or death to 21 people in total. Second, self-built houses were located on the unstable side of the slope, and the earthquake caused boulders to roll down and destroy the houses, affecting 2 people. Third, after the earthquake, people fled and escaped in a panicked state. Due to improper evacuation measures, 8 people were injured (there was no death in this case). Fourth, one victim suffered from cardiovascular and cerebrovascular diseases and succumbed to cerebral haemorrhage due to mental stress and excessive physical exertion during the process of evacuation transfer.

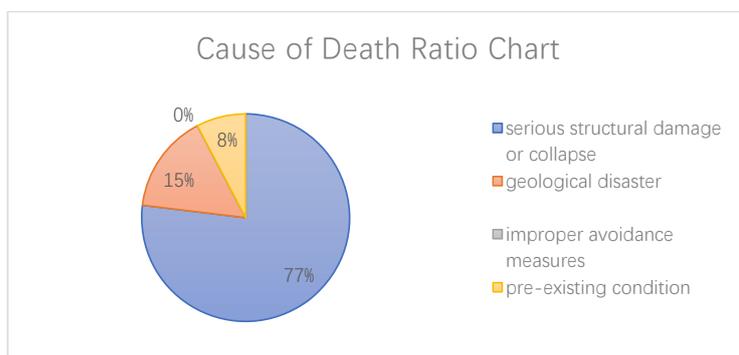
Figure 5: Cause of death ratio chart.

110 Among the 13 deaths, serious damage or collapse of the house structure resulted in 10 deaths, 2 people were killed by rockfall, and 1 victim died of illness, as shown in Fig. 5.

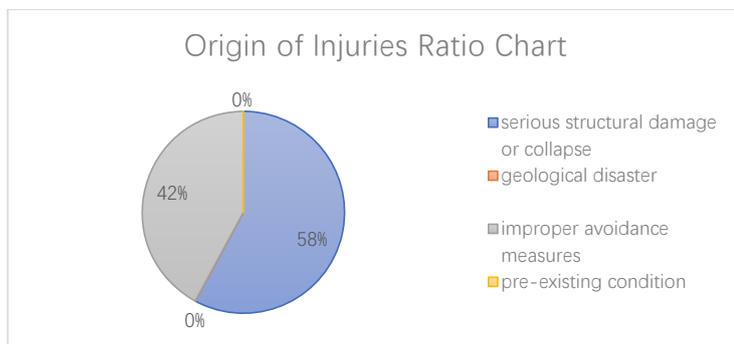
Figure 6: Origin of injuries ratio chart.

Among the 19 critically injured and seriously injured patients, 11 were injured due to serious damage or collapse of the house structure, and 8 were injured due to improper evacuation measures, as shown in Fig. 6.
