Geotechnical stability analysis, fragility of structures and velocity of movement to assess landslides vulnerability

O. Cuanalo, E. Bernal, and G. Polanco

Tecnosolum, Ingeniería y Cimentaciones, S. A. de C. V., Villahermosa, Tabasco, Mexico

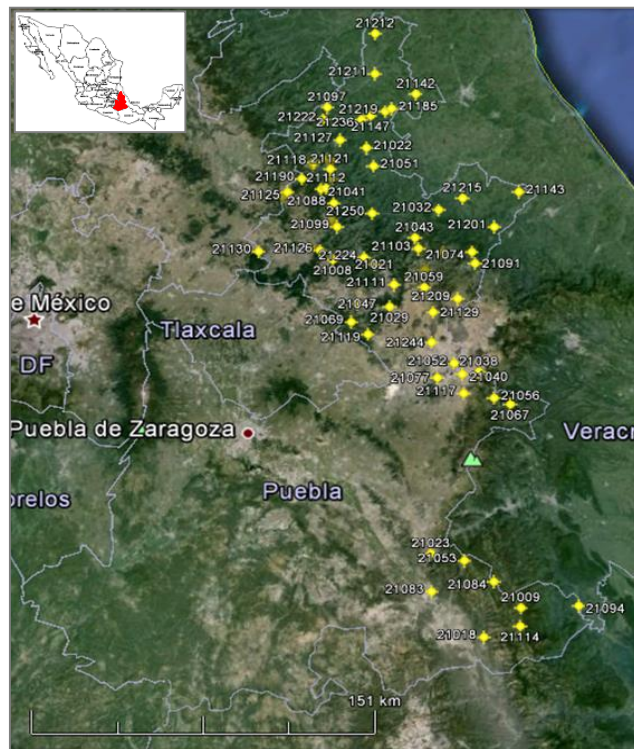
Figure 5. Locations of Weather Stations at mountainous regions of Puebla.

Table 4 shows landslides at mountainous region of Puebla in the period 1999–2013, and Figs. 5 and 6 presents location of Weather Stations and some graphics of monthly rainfall, respectively.

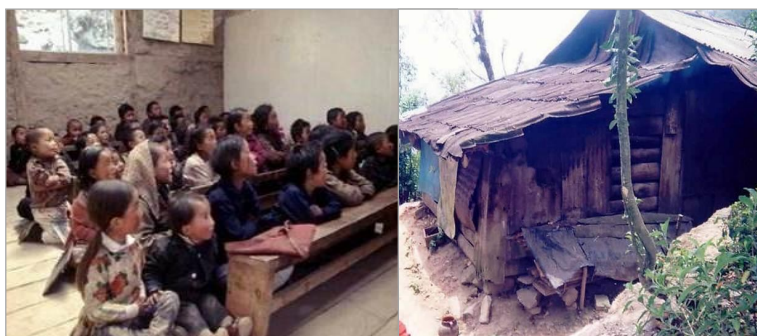
Figure 7. Vulnerable ethnic groups at the mountainous region of Puebla, México.

When there are no records or enough relevant historical information that have occurred in a specific area, phenomenon in study (as in several mountainous regions of Mexico inhabited by ethnic groups, who build their houses with cardboard, wood or plastic and any natural phenomenon can be a major disaster, Fig. 7), it has the disadvantage of not being able to perform a statistical analysis to properly evaluate the hazard nor the vulnerability (Malamud et al., 2004). So that to establish the physical and functional vulnerability, the authors developed the concept of Exposure Level (EL) and Expected Damage Degree (EDD) of elements at risk at the mountainous region of Puebla, both will be describe below:

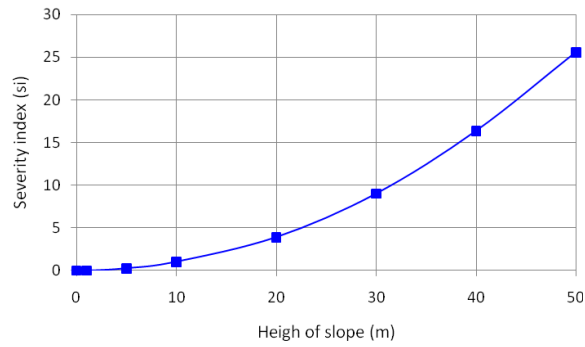
Figure 8. Height of slope vs. Severity Index.

Puebla's landslides in 1999, show that slopes with more than 10m of height produced more damages on infrastructure and human lives losses. Therefore, the authors defined the severity index (SI) like a unit if the slope height is 10 m (Fig. 8).

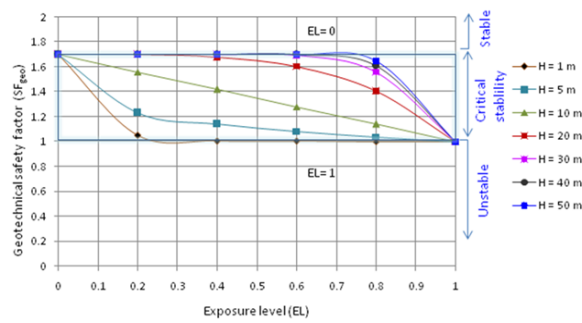
Figure 9. Exposure level vs. Geotechnical safety factor.

Equation (4) is proposed to determine physical and serviceable vulnerability from exposure level (EL) and the expected damage degree (EDD). The first factor evaluated from the geotechnical safety factor (SF_{geo}) and the slope height (H); the second one as a function of the type of constructions (degree of fragility) and of the velocity of landslide, Figs. 9 and 11, respectively.

The exposure level (EL) proposed determine from the height of slope (H) and the safety factor obtained by geotechnical stability analysis (SF_{geo}), Fig. 9 and Eq. (3).

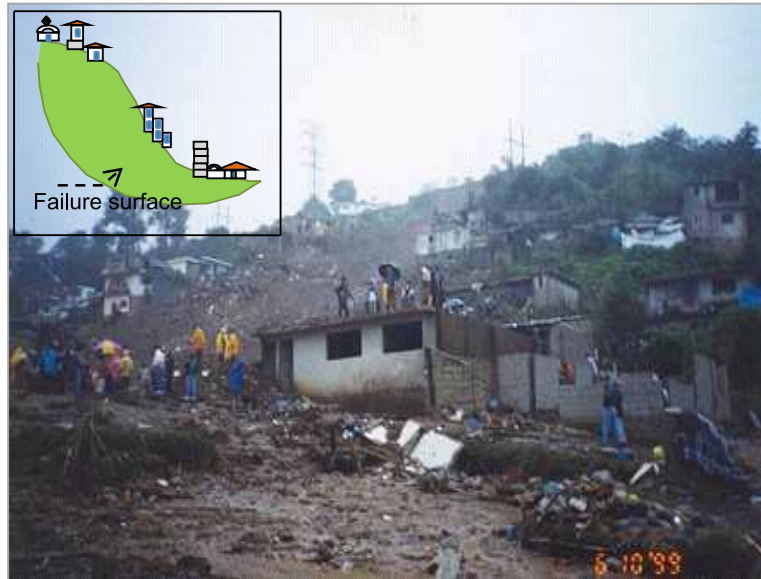
Figure 10. Elements at risk within the failure block (La Aurora landslide, Teziutlán Puebla, México).
