# Integrated risk assessment due to slope instabilities at the roadway network of Gipuzkoa, Basque Country

**Abstract.** Transportation corridors such as roadways are often subjected to both natural instability and cut slope failures, with substantial physical damage for the road infrastructure and threat to the circulating vehicles and passengers. In the early 2000s, the Gipuzkoa Regional Council of the Basque country in Spain, marked the need for assessing the risk related to the geotechnical hazards at its road network, in order to assess and monitor their safety for the road users. The Quantitative Risk Assessment (QRA) was selected as a tool for comparing the risk for different hazards on an objective basis. Few examples of multi-hazard risk assessment along transportation corridors exist. The methodology presented here consists in the calculation of risk in terms of probability of failure and its respective consequences, and it was applied to 84 selected points of risk (PoR) of the entire road network managed by the Gipuzkoa Regional Council. The types of encountered slope instabilities which are treated are rockfalls, retaining wall failures, and slow moving landslides, . T

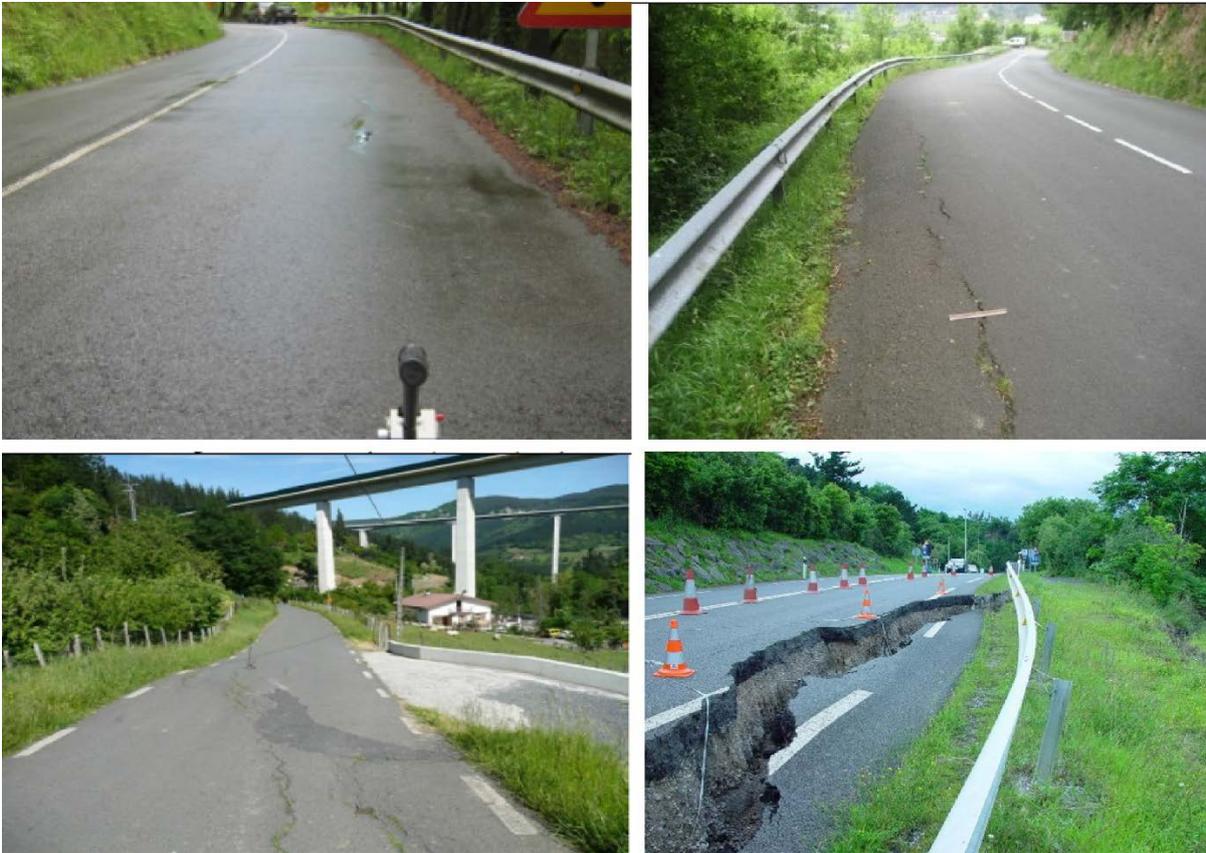
**Figure 5: The four damage levels identified at the roads of Gipuzkoa: (top-left) No/Slight damage, (top-right) Moderate damage, (down-left) Severe damage, and (down-right) Partial/total destruction.**

We inspected the in-situ damage, in order to establish the relation between the velocity and the road damage. Four levels were identified, as shown in Figure 5 and described qualitatively in the following:

- Damage level A (landslides of low intensity): There are rarely cracks and deformations. No speed reduction is required while driving. Crack sealing and resurfacing is periodically performed for periods longer than 1 year.

- 5 • Damage level B (landslides of moderate intensity): Damage includes pavement deformation and cracks and/or roadside destruction, without affecting the functioning of the road. If proper signalling is present, the chance of an accident is very low. Traffic conditions can be normally maintained if regular sealing and resurfacing is performed, until a more permanent solution.

- 10 • Damage level C (landslides of high intensity): Pavement deformation is substantial, including the presence of steps and puddles, and partial rupture of the platform affecting partly or entirely traffic lanes and/or the roadside. The normal functioning of the road is disturbed. Traffic is not interrupted, although restrictions such as alternative pass and traffic lights regulation are required. Accidents might occur if the vehicles enter the affected zone, without previous signalization. The normalization of the traffic conditions requires slope stabilization and road repair.

- 15 • Damage level D (landslides of very high intensity): Displacements are of the same order of magnitude as for level C, however with the vertical component prevailing giving place to complete destruction and loss of the pavement continuity. This situation is typical for roads situated on the crest or on the boundaries of landslides. The operation of the road is seriously affected. There is a high likelihood of an accident due to vehicles falling into the generated depressions. Important stabilization works and reconstruction of the road are required.

To establish damage proxies for the calculation of the expected consequences we correlated the observed road damage with the indications of the inclinometers at 24 reference PoR. The correlation was found to be positive, as, in most cases, increasing displacements were associated with more severe damage. In particular, the maximum horizontal monthly velocity and the cumulative displacement were used as the two proxies for the damage. For the establishment of the thresholds that relate the damage level with the terrain displacements, we tried to maximize the right predictions (when the observed damage level is the same with the calculated damage level), and at the same time to achieve a balance between damage underestimation and overestimation. The proposed thresholds are summarized in Table 9. Out of the 24 PoR, 20 yield right predictions, 1 presents damage overestimation and 3 damage underestimation (out of which one inclinometer measures has low reliability). Partial/total destruction occurs when the criteria for severe damage are fulfilled plus either one of two further criteria: the road is located inside the landslide scarp or a shear crack has being formed (the scarp manifests itself as a semi-circular form on the pavement).

Damage levels	MHDR (mm/month)	ACDR (mm/a)	Landslide intensity	Further criteria
A: No / slight damage	<3	<30	low	
B: Moderate damage	3-10	30-100	moderate	
C: Severe damage	>10	>100	high	
D: Partial/total destruction	>10	>100	very high	Road inside landslide scarp and/or shear crack
